Dynamic Coast - National Coastal Change Assessment: Cell 2 - Fife Ness to Cairnbulg Point

Please reference this report as follows: Fitton, J.M., Rennie, A.F., and Hansom, J.D. (2017) Dynamic Coast - National Coastal Change Assessment: Cell 2 - Fife Ness to Cairnbulg Point, CRW2014_02.

Dynamic Coast – Scotland's National Coastal Change Assessment

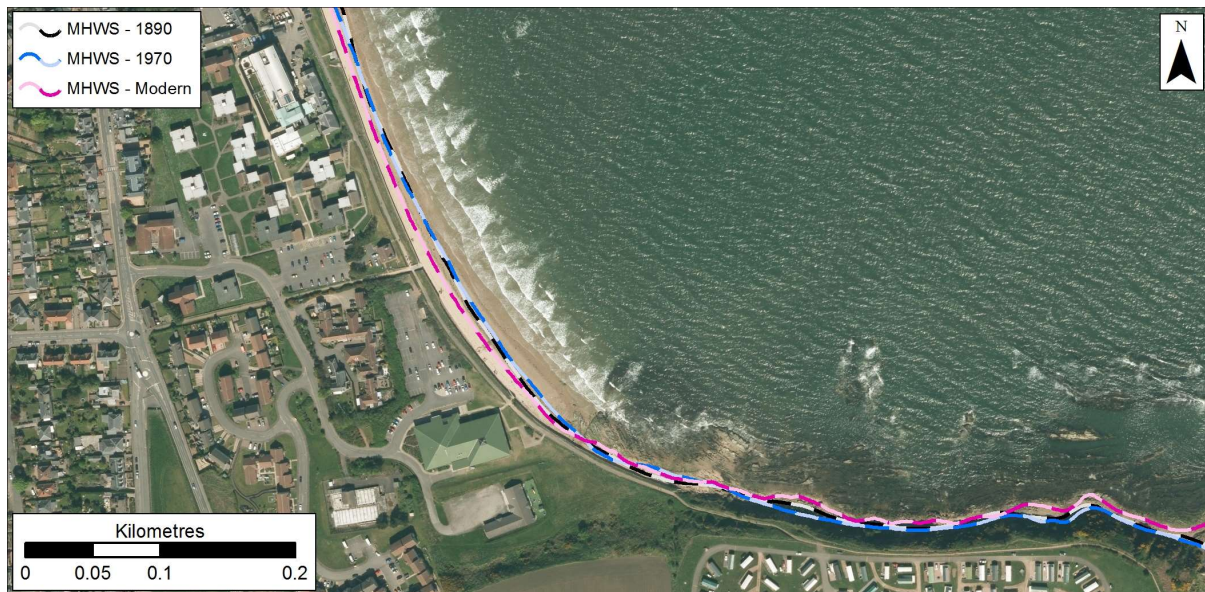
Figure 2.3: MHW position in 1890, 1970s, and Modern datasets at St. Andrews East Sands. Getmapping are our current providers of Scotland-wide digital aerial imagery © Getmapping plc.

Historic Change: The beach at St Andrews East Sands lies to the south of the Kinnes Burn and extends 700 m from the breakwater to the rocky foreshore outcrops at the south end of the beach. The beach changed little between 1893 and 1993, with only very modest fluctuations plotted along its length. Between 1993 and 2009 whilst the northern part of the beach retreated small amounts or remained largely stable, the southern part retreated by up to 10 m (0.6 m/yr) over this time period (Figure 2.3).

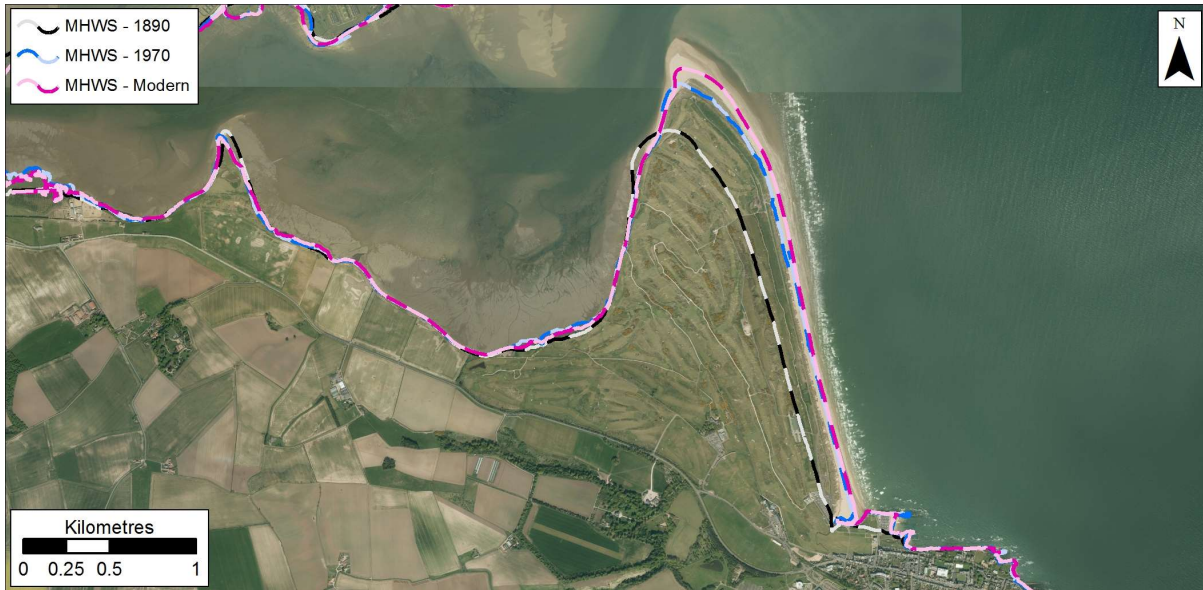
Figure 2.4: MHW position in 1890, 1970s, and Modern datasets at St. Andrews West Sands. Getmapping are our current providers of Scotland-wide digital aerial imagery© Getmapping plc.

Historic Change: St Andrews West Sands lie to the north of the town and enclose the Eden Estuary to the west. In 1896, the links were around 180 hectares, however by the early 1990s an additional 50 hectares had been gained and by 2009 a further seven hectares, all through natural processes (Figure 2.4). The additional area since 1896 has provided sufficient land for almost half of the Jubilee Course, the access road and several car parks. At the southern end of West Sands, the beach accreted some 150m in the intervening century, and towards the northern limit, Out Head had advanced seawards by over 250 m (2 m/yr). The eastward movement of Out Head has occurred in conjunction with erosion of its western edge, where some 60 m of retreat occurred over the same period. Along the Eden estuary coast some apparent accretion of the salt marshes as the shoreline turns towards the west is observed with MHW advancing seawards some 50 m (0.5 m/yr).

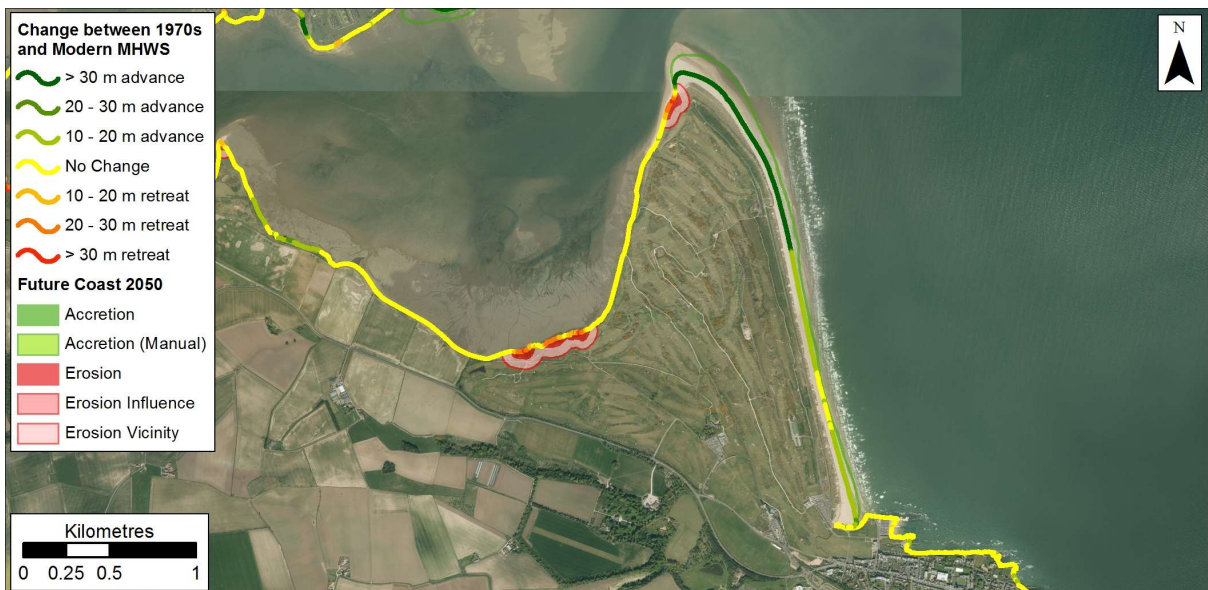
Figure 2.6: Possible future coastline position in 2050 based on rates between 1970 and Modern MHWs data at St. Andrews West Sands. Getmapping are our current providers of Scotland-wide digital aerial imagery© Getmapping plc.

Vulnerability Assessment: The vulnerability assessment projects the past rates into the future to give a sense of the potential impact in areas of increased risk by 2050. Within the dunes at St Andrews there are two areas where there has been significant erosion and/or landward migration of MHWs, firstly to the northern Eden Estuary coast and secondly to the south within the area of the salt marsh (Figure 2.6). If the past rates continue then the MHWs of 2050 is anticipated to move up to 40 m inland and will overlap onto areas of the golf course in the south. In the north, any anticipated erosional footprint is some 20 m away from any golf course assets. Both the West Sands

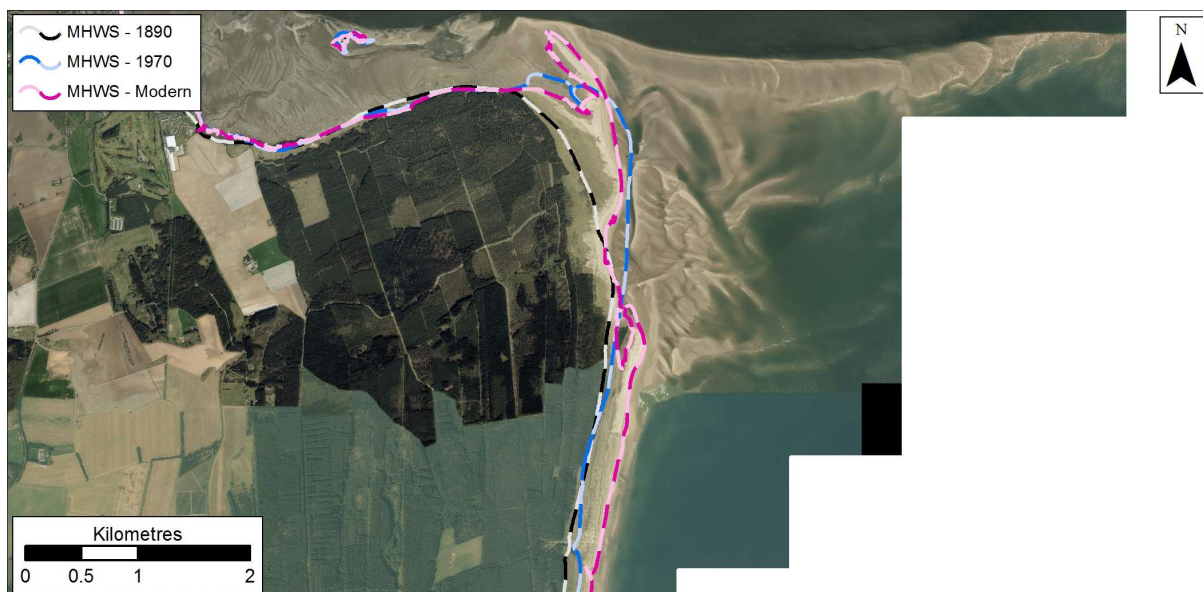
Figure 2.7: MHWS position in 1890, 1970s, and Modern datasets at North Tentsmuir. Getmapping are our current providers of Scotland-wide digital aerial imagery © Getmapping plc.

Between 1988 and 2009 the main east-facing coast of Tentsmuir advanced up to 280 m (9.8 m/yr). Further south, some of the earlier spectacular losses on the Eden Estuary coast have been partially mitigated and a 500 m spit (Shelly Spit) has developed since 1988 (Figure 2.8). To the north at Tentsmuir Point a spit has also formed since 1980 (Figure 2.7), fuelled (in part) by erosion of adjacent sections of beach. Within this area 80 ha have been gained between 1890 and 1980; reducing to 56 ha by 2009. This shoreline contains the Tentsmuir Coastal Defences Scheduled Monument, a National Nature Reserve, Special Area of Conservation, Special Protection Area and Site of Special Scientific Interest.

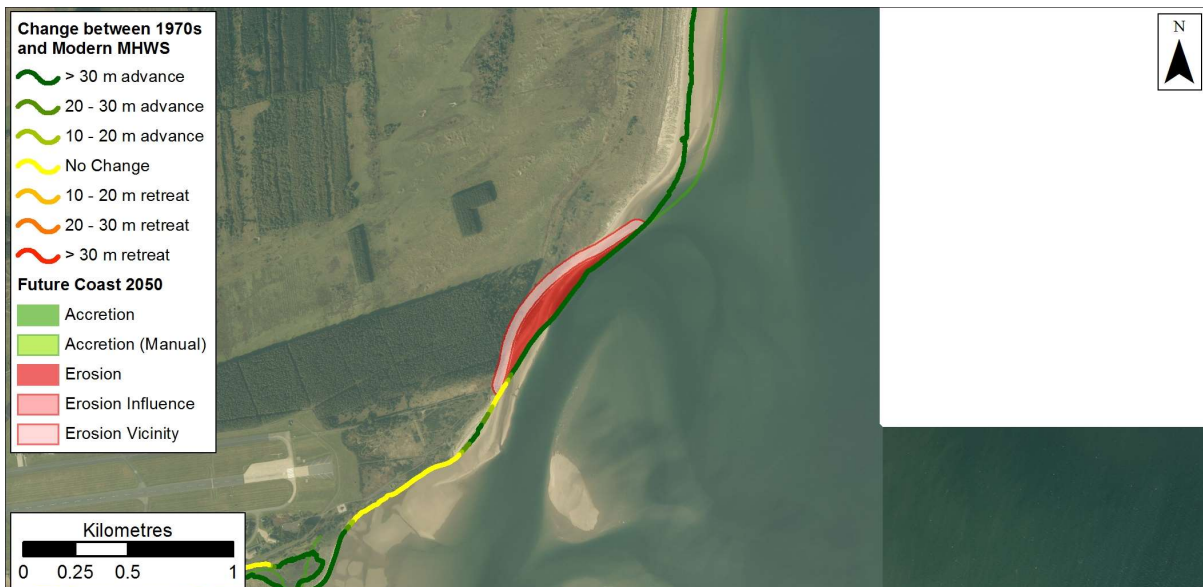
Figure 2.9: Possible future coastline position in 2050 based on rates between 1970 and Modern MHWs data at South Tentsmuir. Getmapping are our current providers of Scotland-wide digital aerial imagery© Getmapping plc.

Vulnerability Assessment: The anticipated position of the 2050 MHWS at Reres Wood is some 100 m inland from its current position, affecting some designated habitats and potentially influencing the area of flood risk (Figure 2.9). Whilst the modern MHWS has advanced a distance seaward over the recent period, this has partly been offset by the losses experienced since the 1890s. The recent rates are unlikely to continue since the northward extension of Out Head will likely result in northward deflection of the Eden main channel giving rise to a future erosional trend at Reres Wood. This effect is plotted on the vulnerability map.

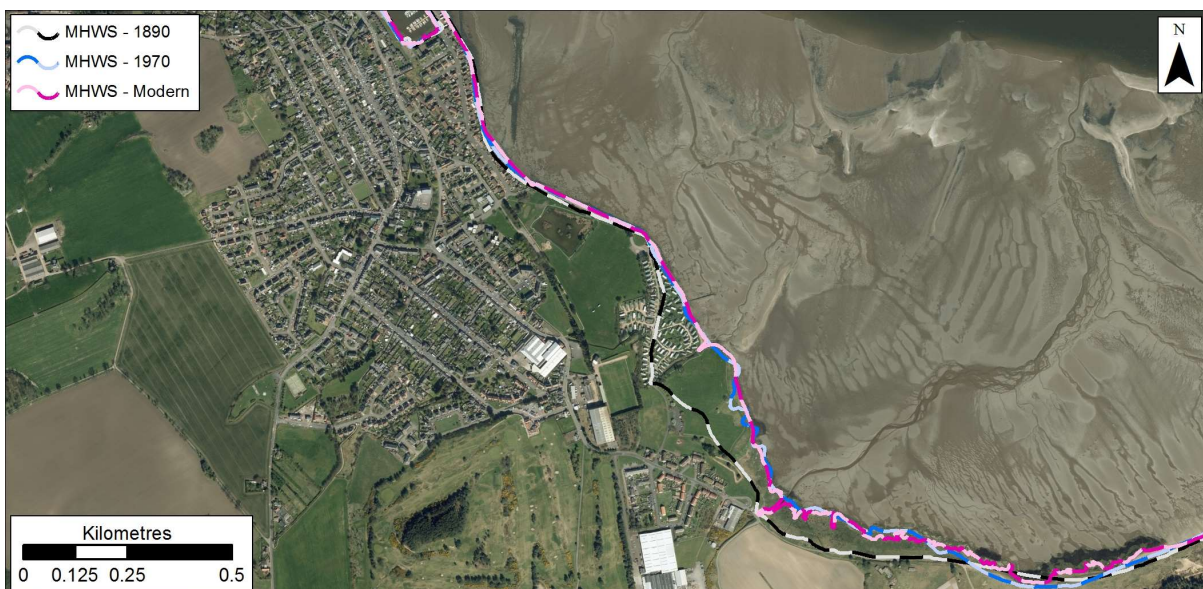
Figure 2.11: MHWS position in 1890, 1970s, and Modern datasets at Tayport. Getmapping are our current providers of Scotland-wide digital aerial imagery© Getmapping plc.

Historic Change: A comparison of the coastal changes at the Tayport Links caravan park (to the east of Tayport) shows that much of the park is located on claimed land. Since the 1980s the recreational ground is defended and although the defences at the caravan site appear to be less formal, they have moved the MHWS seawards around 5m between 1980 and 2009 (Figure 2.11).

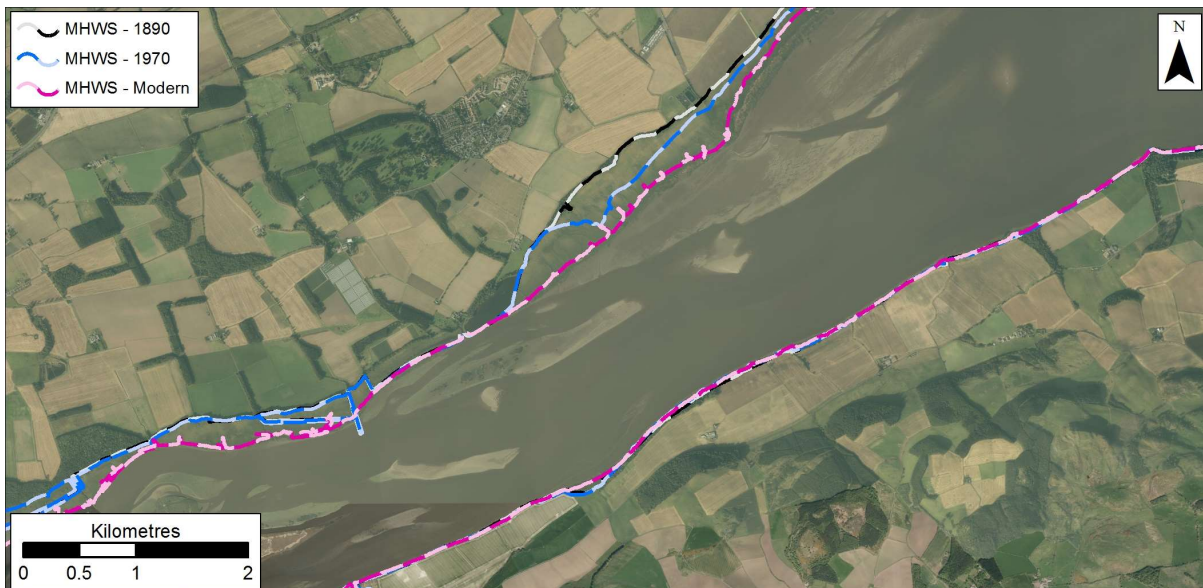
Figure 2.12: MHWS position in 1890, 1970s, and Modern datasets at Carse of Gowrie. Getmapping are our current providers of Scotland-wide digital aerial imagery © Getmapping plc.

Historic Change: Whilst the southern shore of the Tay to the west of Tayport is backed by a rocky and generally steep hinterland that show close coincidence of MHWS over the time steps used here, much of the northern side of the Tay between Port Allen and Templehall Farm has seen remarkable changes since 1894 (Figure 2.12). The reed beds flanking the shore have extended into the Tay and seawards/eastwards over the 81 years in a pattern that continues to this day. The consistent pattern is remarkable with MHWS moving south towards the channel peaking at over 300 m prior to 1975. The accretion extends some 5km down the north bank of the Tay from Daleally to south of Inchturle village but is at its greatest upriver. This historic accretion continues and has accelerated between 1975 and 2011. Some 51 ha of land has been formed between 1894 and 1975, and a further 189 ha up to 2011. At 5.25 ha/yr, these rates of accretion are amongst the fastest in Scotland.

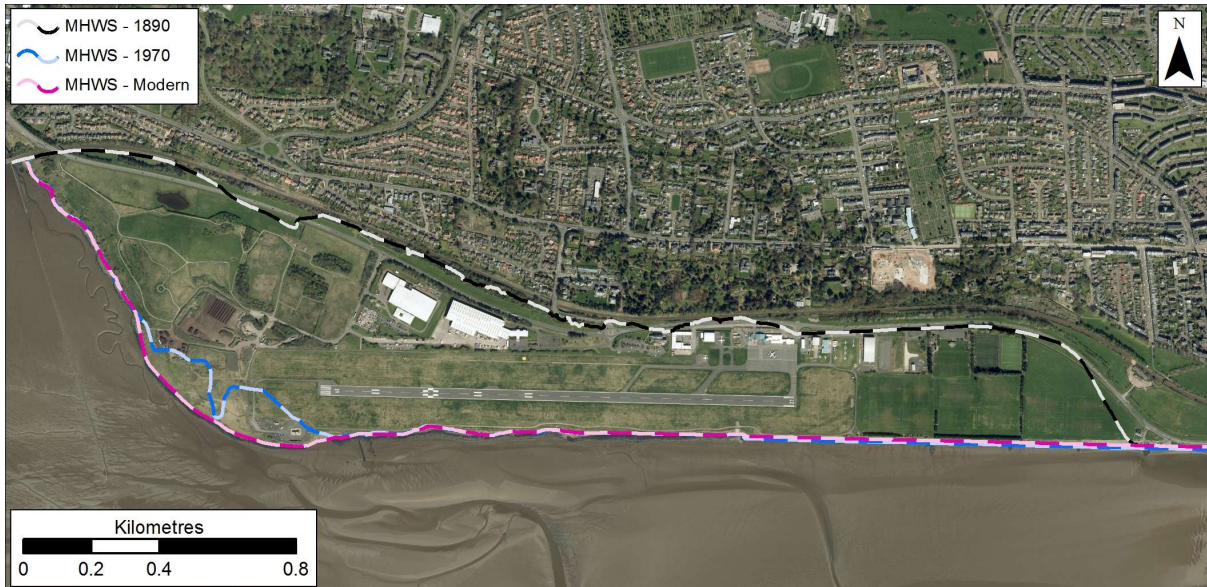
Figure 2.13: MHWS position in 1890, 1970s, and Modern datasets at Dundee Airport. Getmapping are our current providers of Scotland-wide digital aerial imagery © Getmapping plc.

Historic Change: The shoreline west of Dundee ran alongside the railway line in 1900, but large areas of Invergowrie Bay were claimed long before the 1991 map which largely still reflects the current position of the defended shoreline (Figure 2.13). The claimed area was the site of the municipal refuse which resulted in migration west into the bay. The main phase of land claim has slowed and the area now supports playing fields and Dundee airport. Further land claim has occurred between 1990 and 2014 at the western end of the runway.

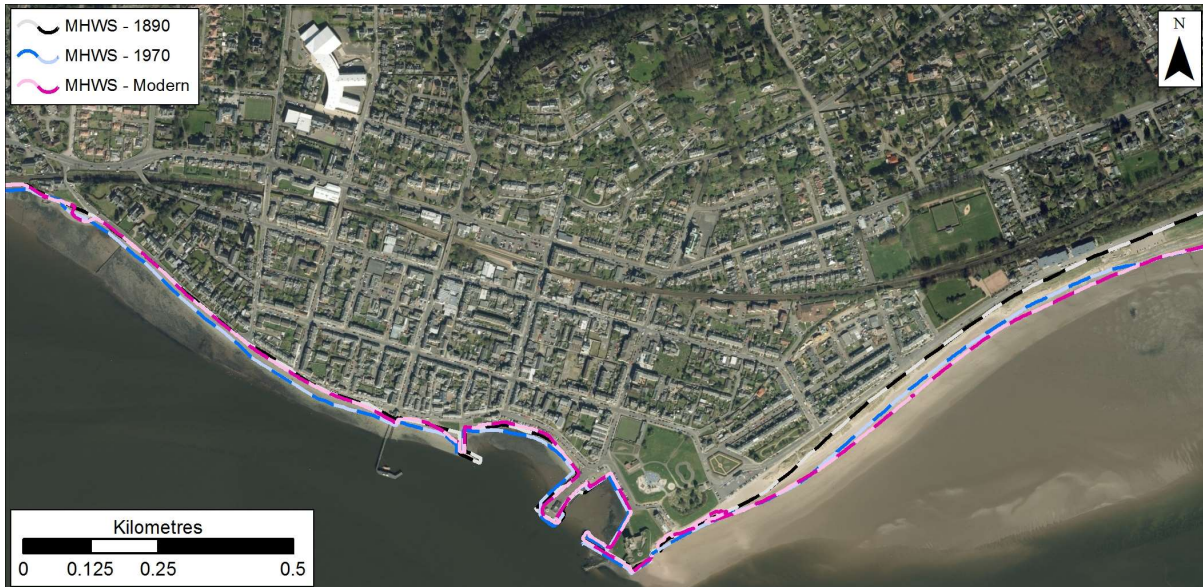
Figure 2.14: MHWS position in 1890, 1970s, and Modern datasets at Broughty Ferry. Getmapping are our current providers of Scotland-wide digital aerial imagery© Getmapping plc.

Historic Change: The shoreline along the western side of Broughty Ferry as far as the castle rock has remained largely stable since the 1890s, despite some minor movements of MHWS (Figure 2.14). Given the proximity of dense housing, the shore has been defended for a long time. Immediately east of the castle rock a short section of seawall gives way to dunes that have undergone substantial reconstruction over the recent past, and the modern MHWS has migrated a short distance landward over a short section of shore. To the east, a small foreland along the esplanade has developed since 1890s at what is locally called the “grassy beach” where some 30m has been lost between 1994 and 2012. This section of shoreline is part of the Dundee and Broughty Ferry Potentially Vulnerable Area. Broughty Castle is a property in care and a scheduled monument. To the east of the castle the foreshore is part of the Firth of Tay and Eden Estuary Special Protection Area and the Monifieth Bay SSSI.

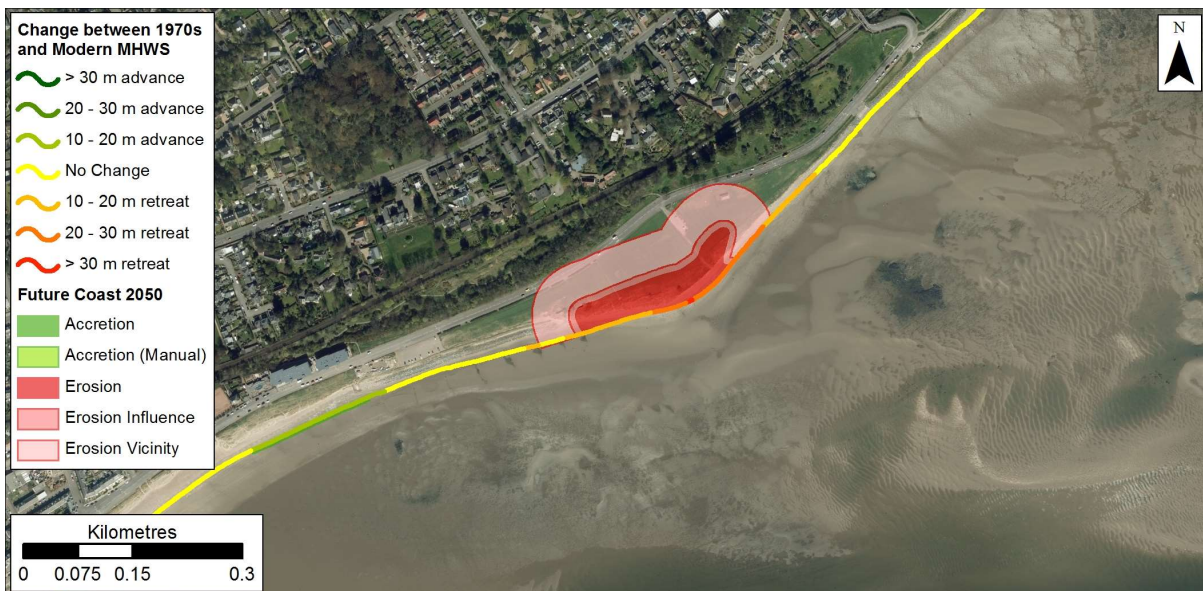
Figure 2.15: Possible future coastline position in 2050 based on rates between 1970 and Modern MHWS data at Broughty Ferry. Getmapping are our current providers of Scotland-wide digital aerial imagery© Getmapping plc.

Vulnerability Assessment: The vulnerability assessment projects the past rates into the future to give a sense of the potential impact in areas of increased risk by 2050. Much of the Broughty Ferry shoreline is defended, and the dune-backed shore east of castle rock is relatively stable although the dunes are known to cap a low concrete wall that supports a path and fronts the roadway. Further east toward the Dighty Burn exit at the “grassy beach”, some 200 m of shore lies within the future erosion area and a non-residential building lies within the erosion influenced zone (Figure 2.15).

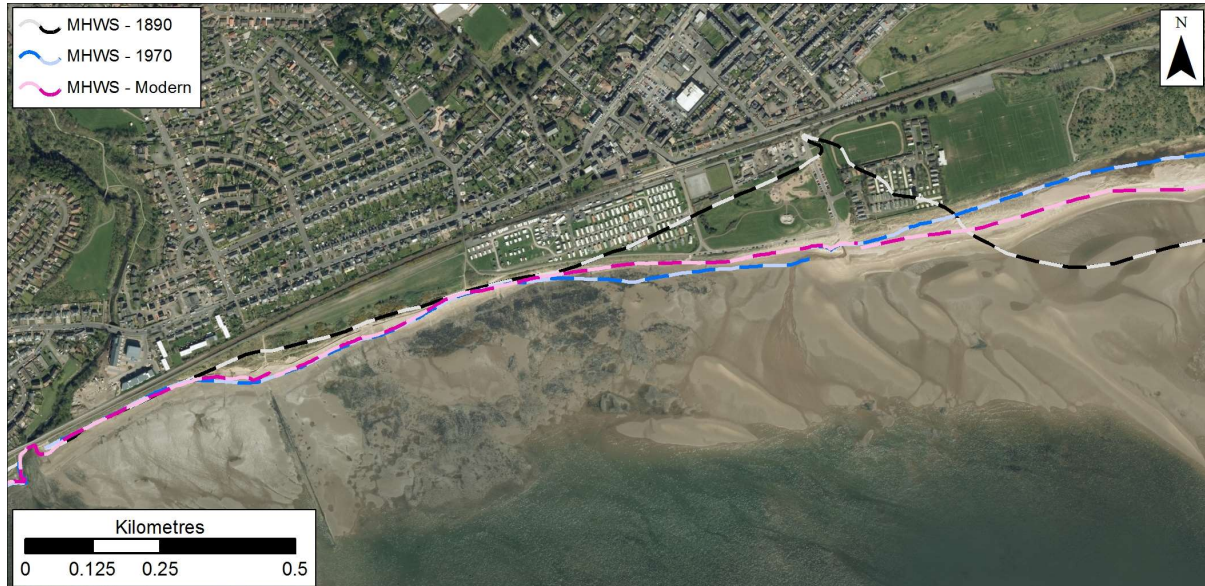
Figure 2.16: MHWS position in 1890, 1970s, and Modern datasets at Minifieth. Getmapping are our current providers of Scotland-wide digital aerial imagery © Getmapping plc.

Historic Change: The shoreline east of the Dighty Burn to Monifieth shows a combination of accretion and land claim since 1901, the largest of which lies to the east of the caravan park and was a former refuse site for Tayside Region (Figure 2.16). Between the Dighty Burn and the caravan park is a short section of boulder defences protecting the railway line, beyond which is a dune area

defended by a linear wooden palisade (and groyne) that is currently (2017) undermined and overtopped. This gives way to the former refuse site to the east. Largely infilled by 1994, the MHWS has moved landward to the extent that boulder defences were inserted over several years between the 1970s to 1990s as far as the edge of the Barry Buddon Range and its extensive dune systems. Monifieth is part of the Dundee, Broughty Ferry Potentially Vulnerable Area and Firth of Tay and Eden Special Area of Conservation.

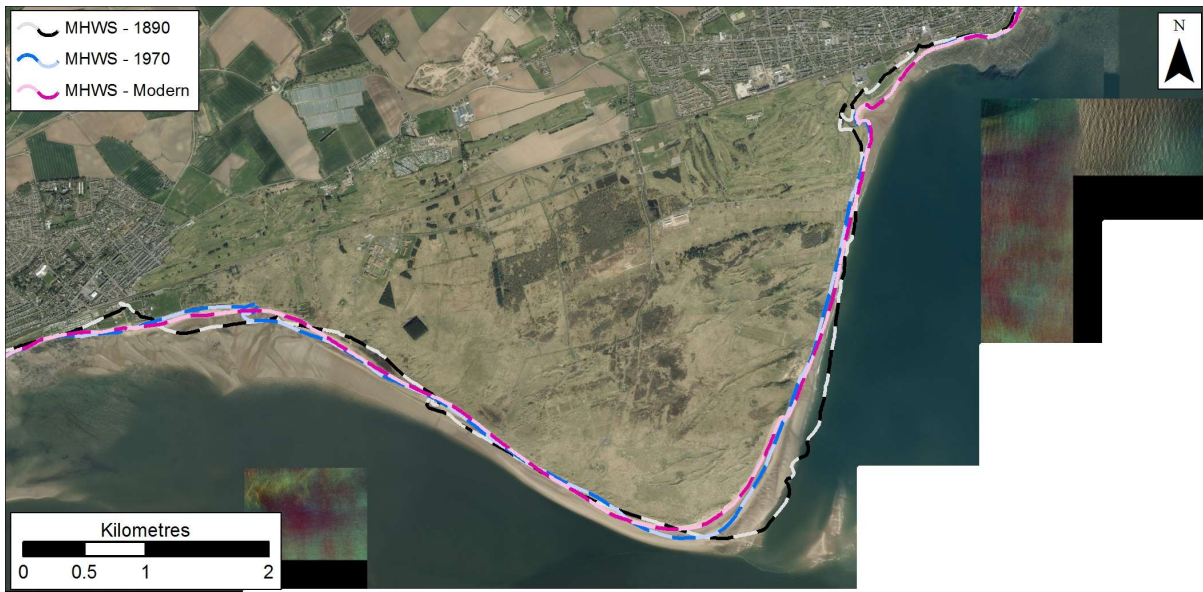
Figure 2.17: MHWS position in 1890, 1970s, and Modern datasets at Barry Links. Getmapping are our current providers of Scotland-wide digital aerial imagery© Getmapping plc.

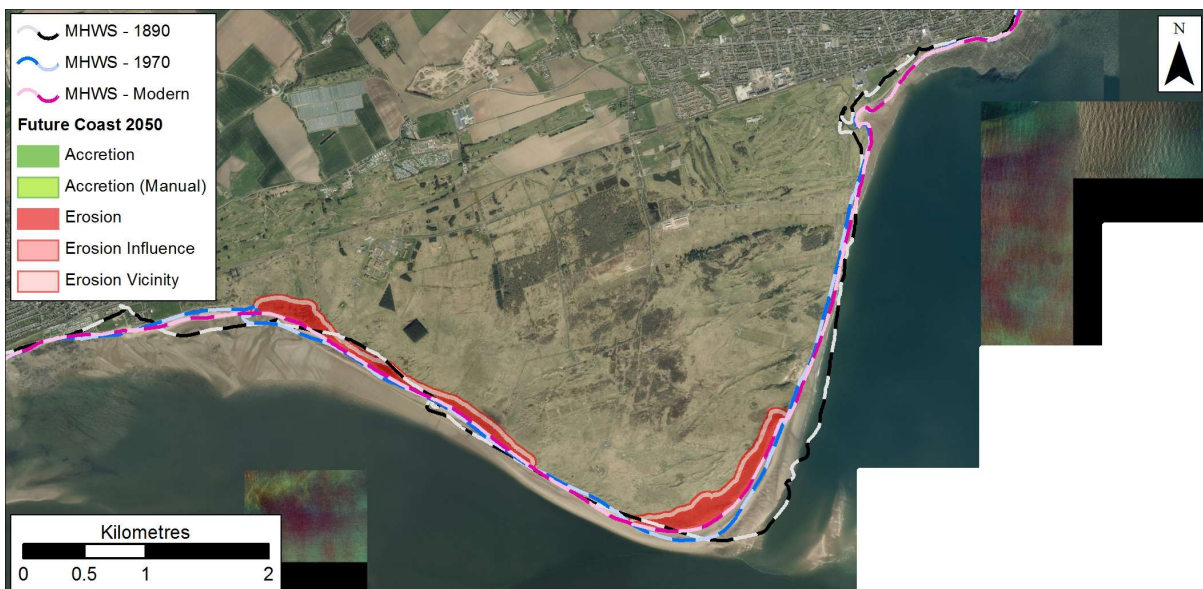
Figure 2.18: Possible future coastline position in 2050 based on rates between 1970 and Modern MHWS data at Barry Links. Getmapping are our current providers of Scotland-wide digital aerial imagery© Getmapping plc.

Vulnerability Assessment: The vulnerability assessment projects the past rates into the future to give a sense of the potential impact in areas of increased risk by 2050. The rates of erosion along both flanks of Buddon Ness have given rise to substantial areas of projected erosion zones, the largest of which extends 170 m inland from the Ness over a length of 1.8 km. The likely reason for such erosion is the extent of defenced shore to the east along the MoD –owned land and in the west at Monifieth, all of which have drastically reduced the supply of sediment to both sides of the Buddon Ness foreland.

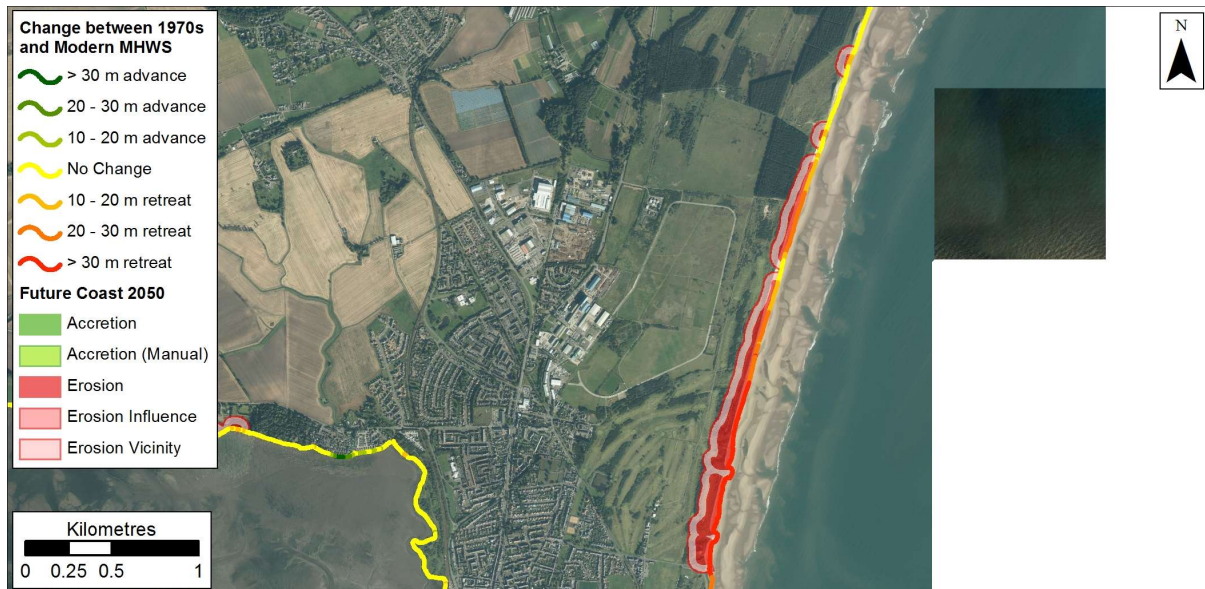
Figure 2.20: Possible future coastline position in 2050 based on rates between 1970 and Modern MHWS data at Montrose. Getmapping are our current providers of Scotland-wide digital aerial imagery © Getmapping plc.

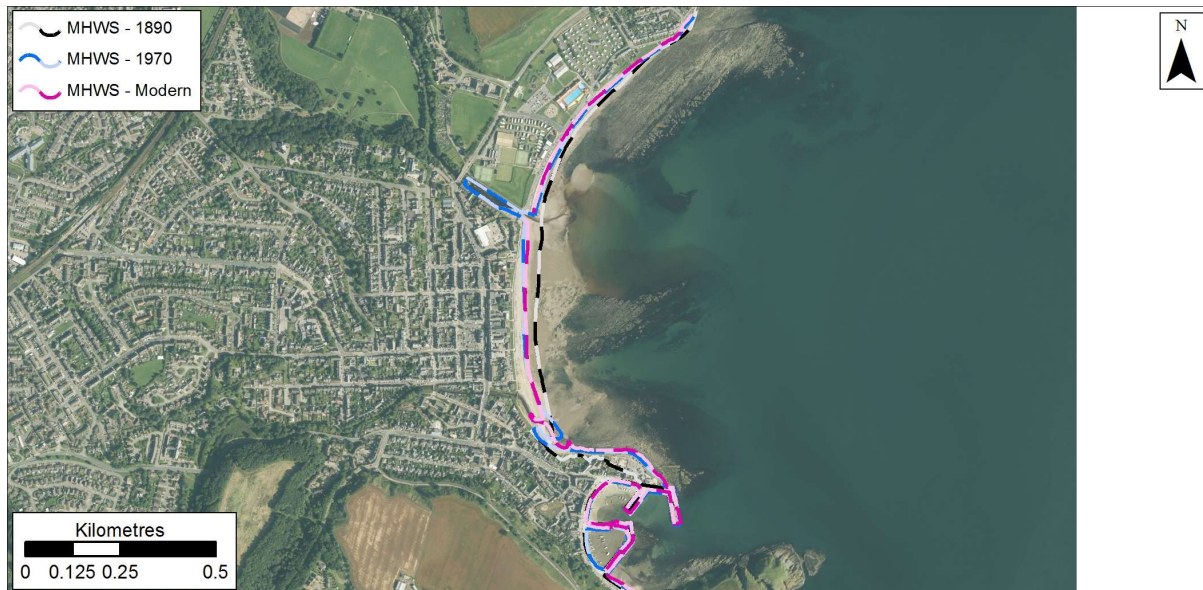
Figure 2.21: MHWS position in 1890, 1970s, and Modern datasets at Stonehaven. Getmapping are our current providers of Scotland-wide digital aerial imagery© Getmapping plc.

Historic Change: The shoreline at Stonehaven has retreated almost across its entire length between 1902 and 1988 in some cases by over 40 m (0.5 m/yr). The greatest losses are located at the mouth of the Cowie Water that enters the bay at its midpoint. To the north, losses have occurred but at a much lower rate. Between 1988 and 2013 the position of MHWS has changed less than 10 m in most cases across the entire bay (Figure 2.21). Stonehaven Bay is mostly protected by sea defences, but some sections remain vulnerable to flooding and some defences extend inland along the channels of the Cowie Water and Carron Water that exit into the bay.

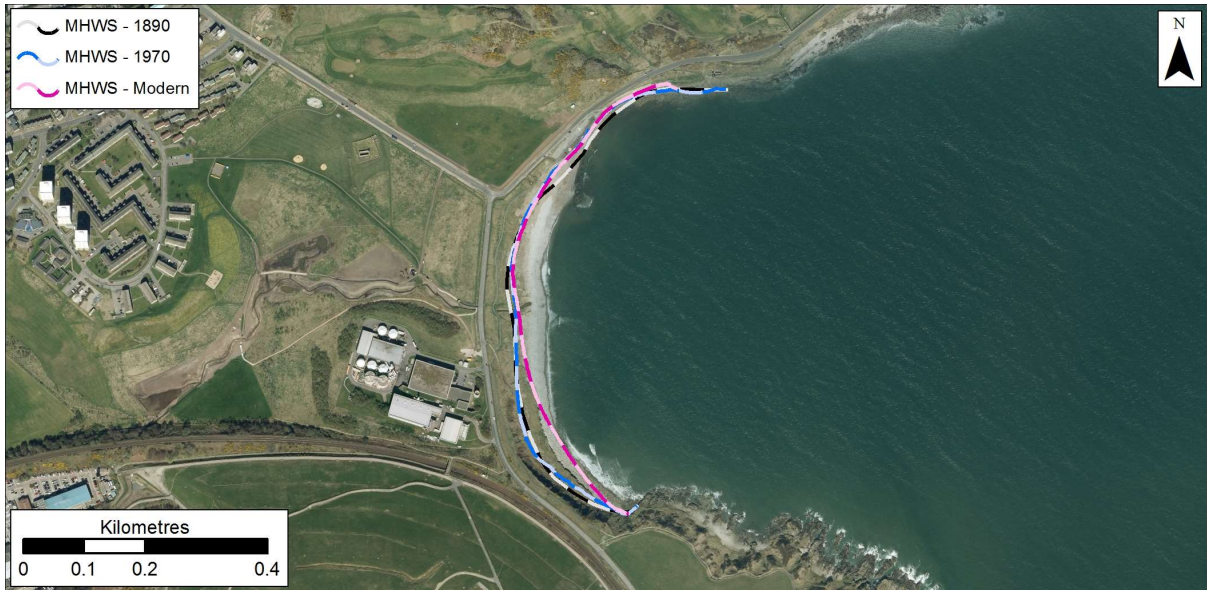
Figure 2.22: MHWS position in 1890, 1970s, and Modern datasets at Nigg Bay (Aberdeen). Getmapping are our current providers of Scotland-wide digital aerial imagery© Getmapping plc.

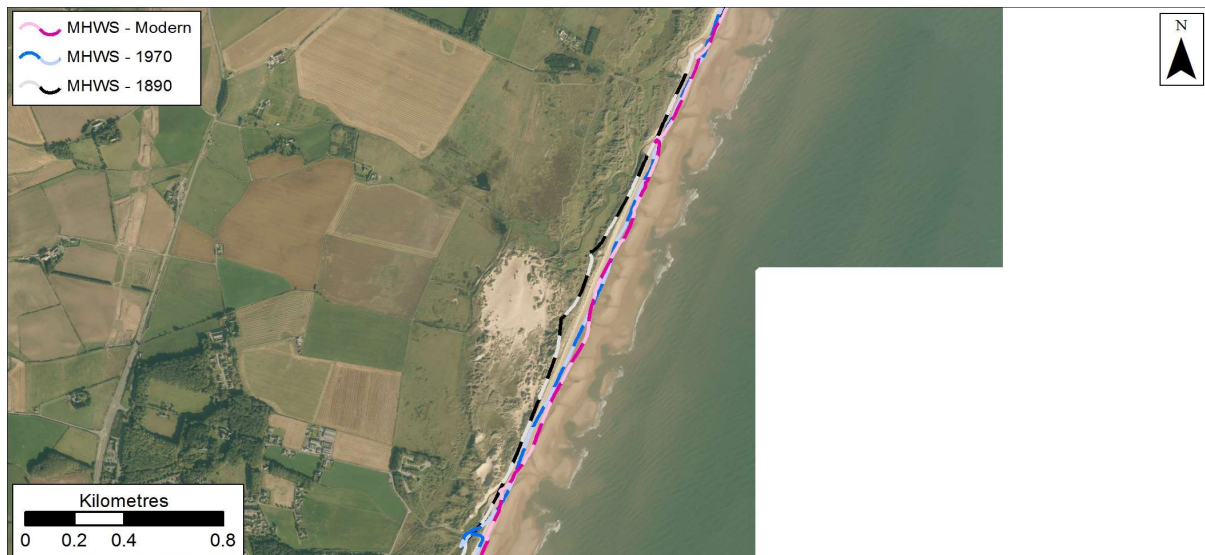
Figure 2.25: MHW position in 1890, 1970s, and Modern datasets at Menie. Getmapping are our current providers of Scotland-wide digital aerial imagery© Getmapping plc.

of the Trump Golf Course, the northerly deflection of the Menie Burn has resulted in two phases of damage to the third green since the course opened in 2012. The result has been 200 m of boulder protection retrofitted along the frontage of the third green that will likely cause future, but as yet undetected, erosion of downdrift areas along the northern part of the course. North of the Sand End Burn at the northern limit of the golf course, erosion dominates and continues for 2.5 km along the Foveran Links frontage where over 40 m have been lost in places (0.8 m/yr) before the mouth of the Ythan is reached (Figure 2.26 and Figure 2.27)

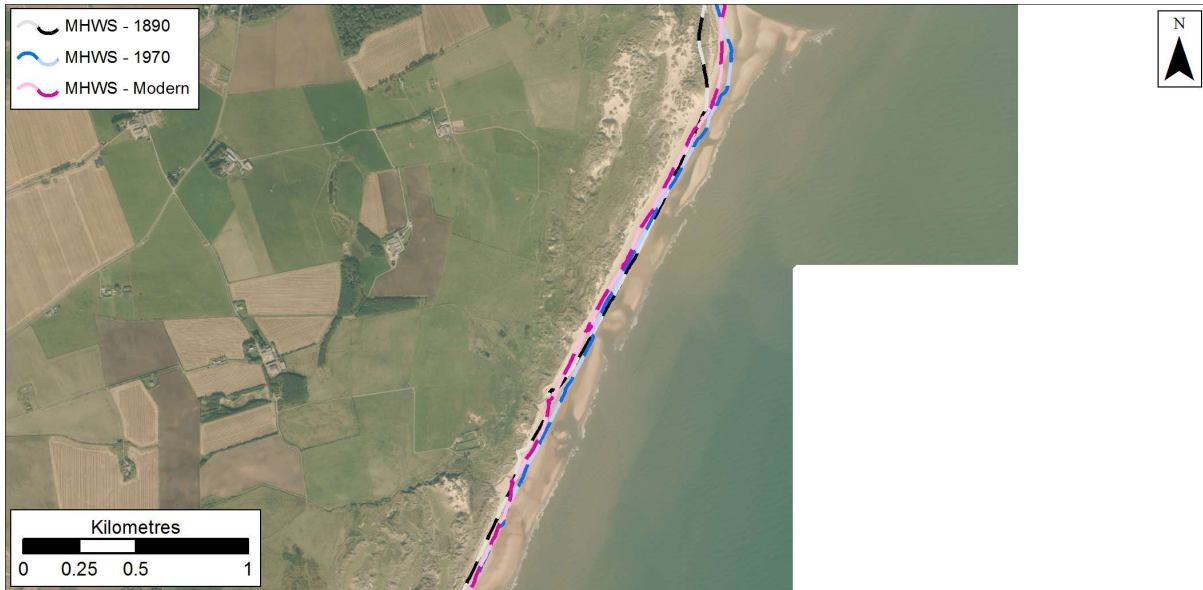
Figure 2.26: MHWs position in 1890, 1970s, and Modern datasets south of the River Ythan mouth. Getmapping are our current providers of Scotland-wide digital aerial imagery© Getmapping plc.

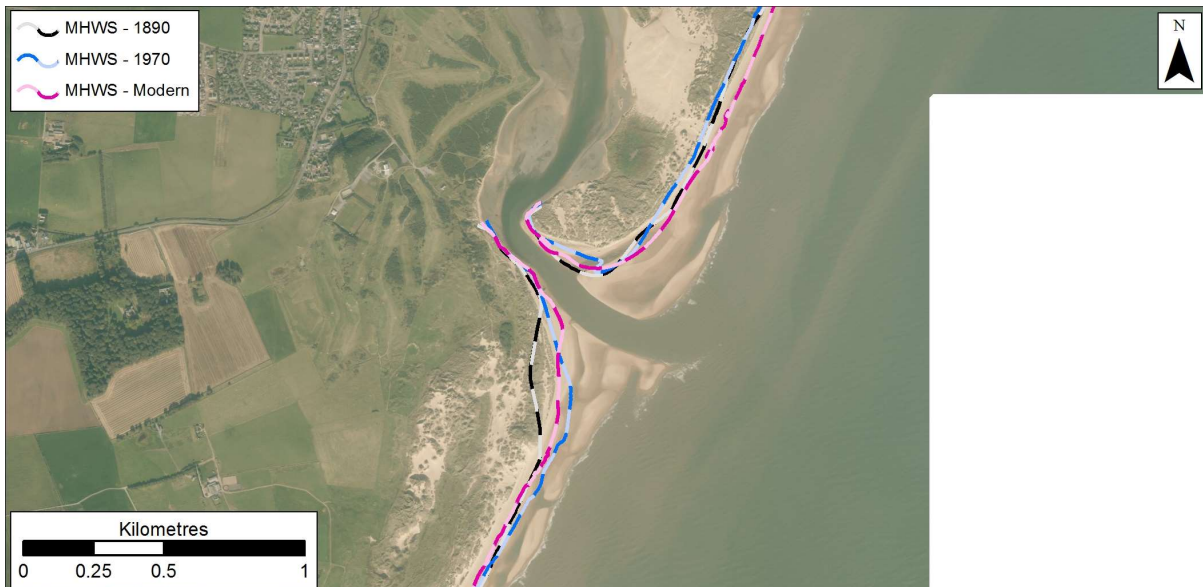
Figure 2.27: MHWs position in 1890, 1970s, and Modern datasets at the mouth of the River Ythan. Getmapping are our current providers of Scotland-wide digital aerial imagery© Getmapping plc.

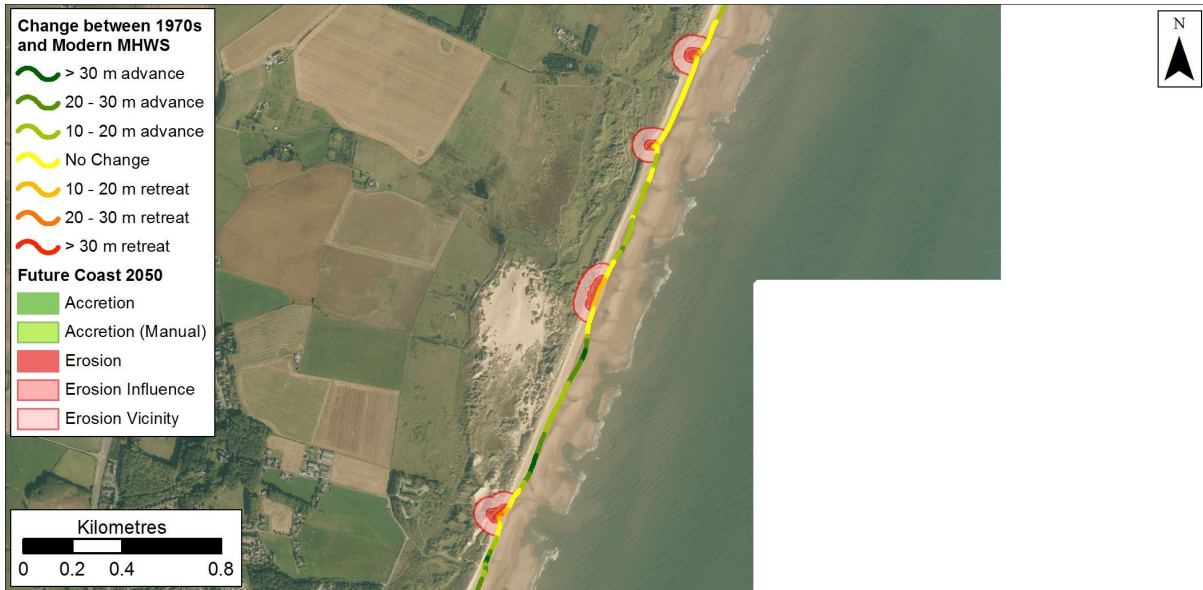
Figure 2.29: Possible future coastline position in 2050 based on rates between 1970 and Modern MHWS data at Balmedie. Getmapping are our current providers of Scotland-wide digital aerial imagery© Getmapping plc.

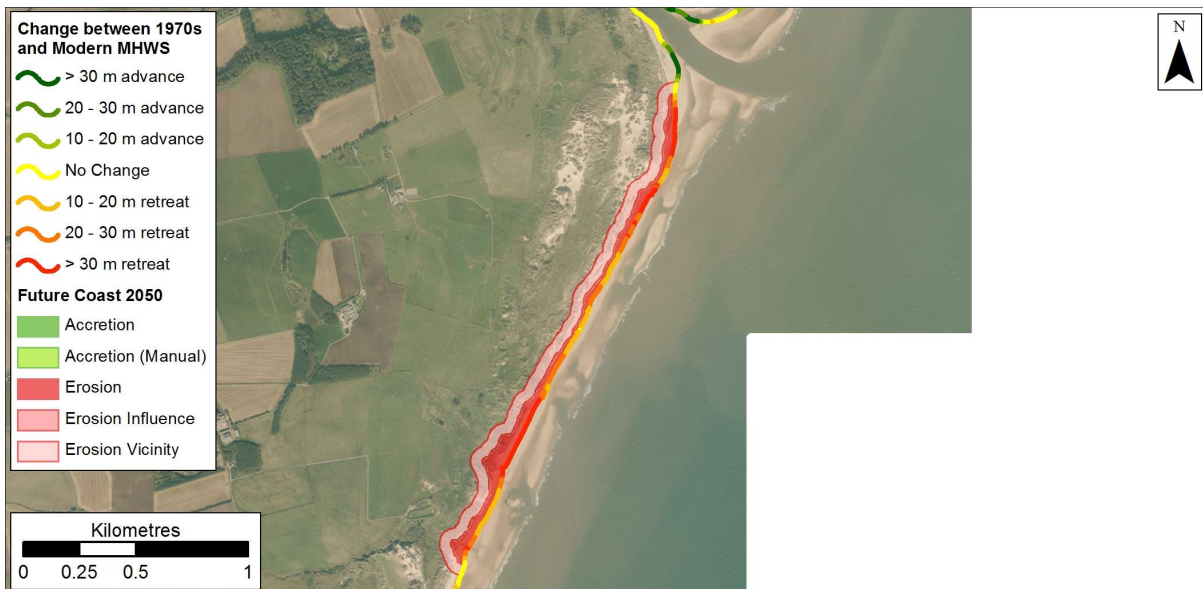
Figure 2.30: Possible future coastline position in 2050 based on rates between 1970 and Modern MHWS data south of the River Ythan mouth. Getmapping are our current providers of Scotland-wide digital aerial imagery© Getmapping plc.

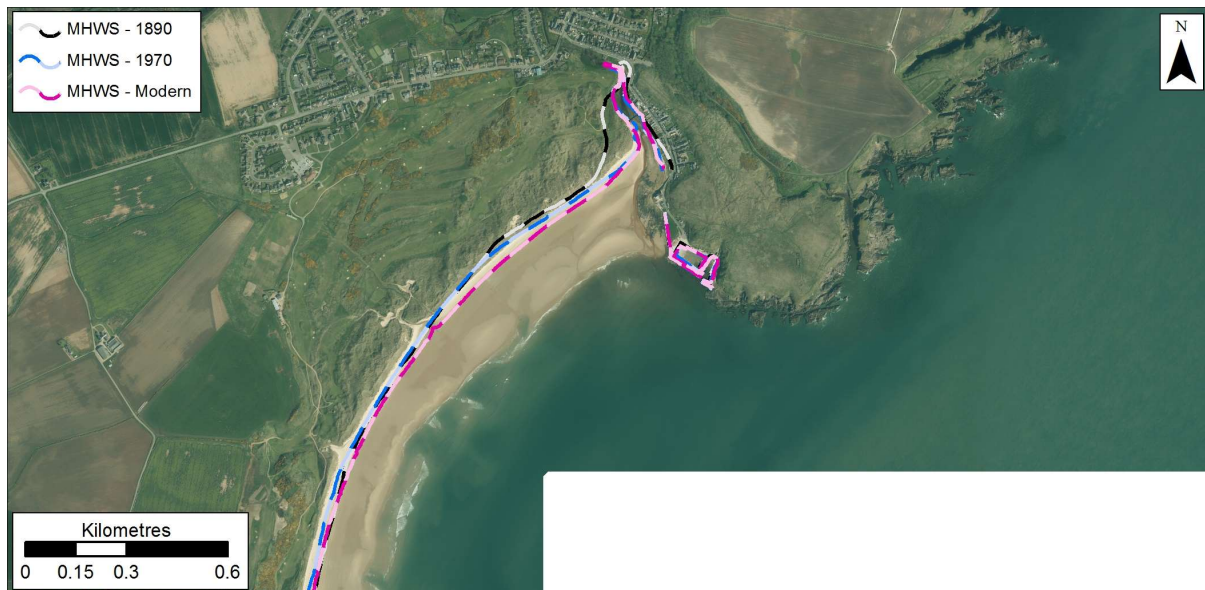
Figure 2.31: MHWs position in 1890, 1970s, and Modern datasets at Cruden Bay. Getmapping are our current providers of Scotland-wide digital aerial imagery © Getmapping plc.

required. However, it is known that minor erosion of less than 10 m affects Ladies' Bridge such that the access steps have been undermined, preventing access to the beach and remedial works are required to reinstate it. There are proposals to replace the bridge subject to funding being secured.

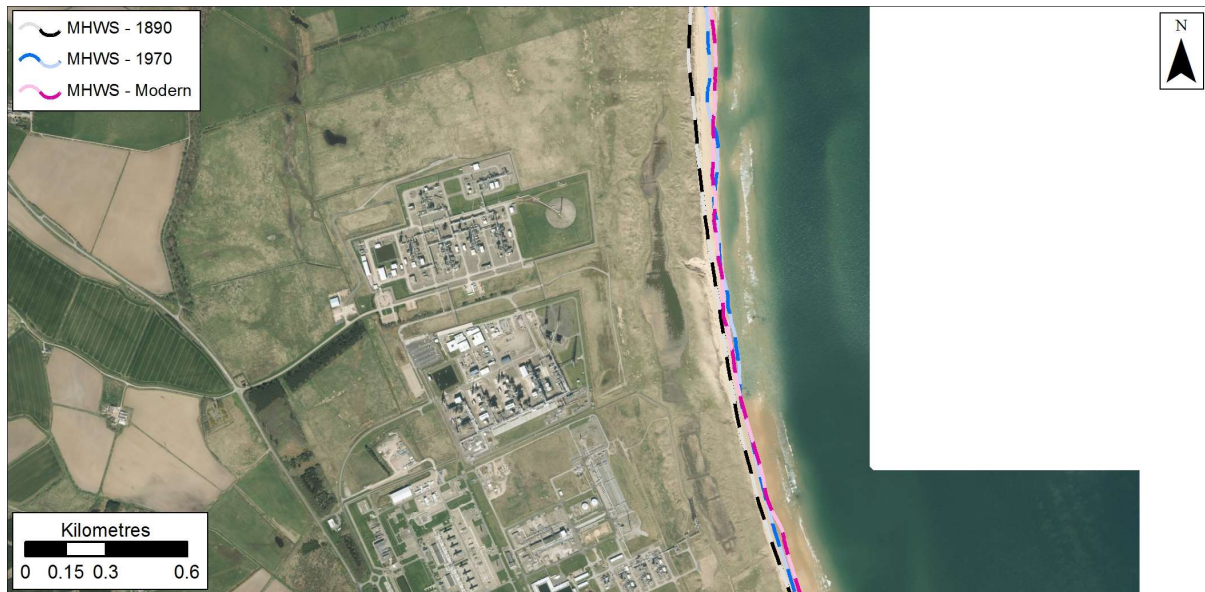
Figure 2.32: MHWS position in 1890, 1970s, and Modern datasets at the St. Fergus Gas Terminal. Getmapping are our current providers of Scotland-wide digital aerial imagery© Getmapping plc.

Historic Change: Accretion has dominated the shoreline at St Fergus between 1900 and 1971. To the north of the burn some areas advanced up to 70 m, whilst most advanced around 20-40m over this period. To the south of the burn, a small area of erosion has occurred where 35m was lost over the same period. Between the 1970s and 1980s the St Fergus Gas Terminal was constructed and several pipelines made landfall and were installed underneath the dunes which were successfully reinstated several times over that period. Since 1971, the dominance of accretion has reduced and erosion is more common, with greater than 20 m of retreat occurring since the 1970s (Figure 2.32). The modern shoreline here has not been updated since 1974 and so the true migration of MHW is problematic. Nevertheless, the position of the dune toe shown on the aerial photography suggests that MHW has migrated landward to reoccupy its 1890s position. The pattern of change is not uniform but fluctuates along the shoreline, perhaps reflecting the instability caused during the removal and replacement of the dunes following the repeated pipeline installations. To the north end of St Fergus Bay the modern position of MHW lies landward and up to 40m of erosion has occurred into the backing dune field. This section of coast contains the Peterhead Potentially Vulnerable Area and Loch of Strathbeg Site of Special Scientific Interest and Ramsar site.

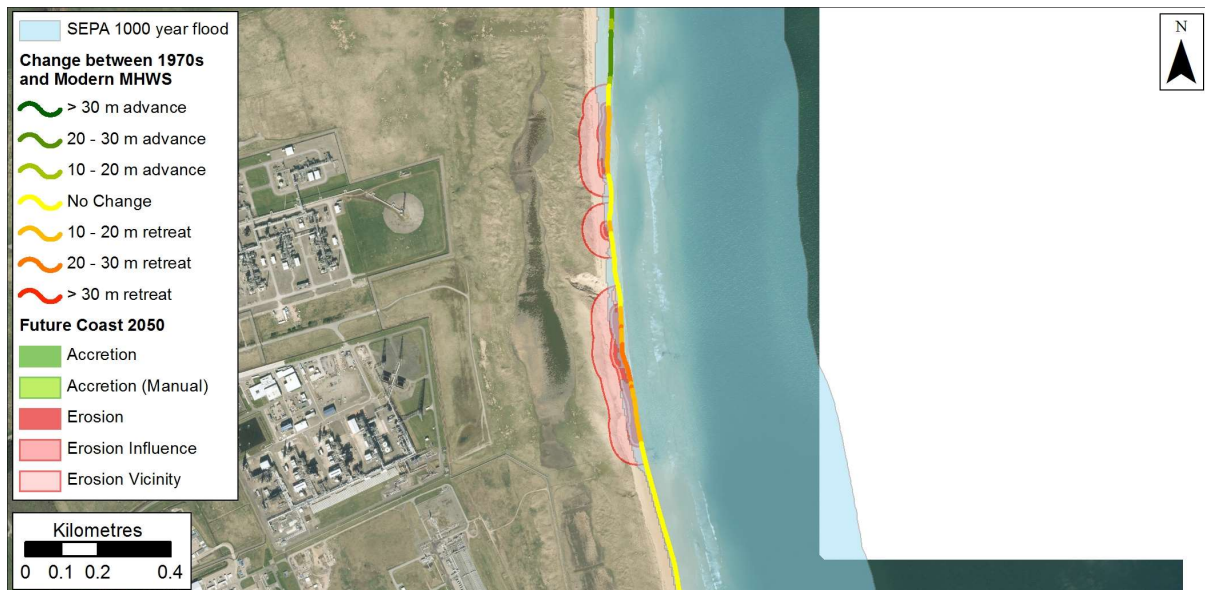
Figure 2.33: Possible future coastline position in 2050 based on rates between 1970 and Modern MHWS data with the SEPA 1000 year flood envelope at St. Fergus Gas Terminal. Getmapping are our current providers of Scotland-wide digital aerial imagery© Getmapping plc.

Vulnerability Assessment: The vulnerability assessment projects the erosion rate that has occurred on the soft coast since the 1970s forward to 2050. Whilst much of the shoreline has remained within 10 m since 1974, the dunes along the northern half of the St Fergus gas terminal have retreated up to 28 m (0.5 m/yr). When this is propagated forward to 2050 the anticipated position of MHW is around 20 m inland (Figure 2.33). Whilst this does overlap with an area of coastal flood risk, at its recent rate it is not anticipated to cause a breach within the main dune ridge either here or at the northern end of the bay where although the rate of erosion is greater, the backing dune cordon is higher, wider and thus more robust. Nevertheless, given the strategic importance of the gas installations at St Fergus and its long and successful tradition of beach and dune management, then

any future erosional threat is likely to be dealt with rapidly, likely by beach feeding and further dune stabilisation
