Dynamic Coast - National Coastal Change Assessment: Cell 6 - Mull of Kintyre to the Mull of Galloway

Please reference this report as follows: Rennie, A.F., Hansom, J.D., and Fitton, J.M. (2017) Dynamic Coast - National Coastal Change Assessment: Cell 6 - Mull of Kintyre to the Mull of Galloway, CRW2014_02.

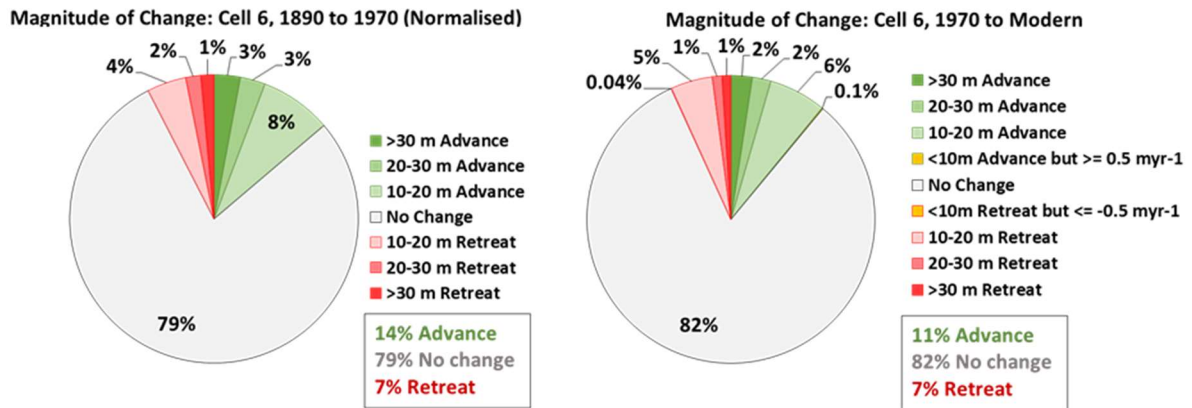
Figure 6.2: Coastal change results for Cell 6 showing the proportional amount of change in the historical (ca. 1890-1970 normalised) and recent (ca. 1970-Present) time periods. Rounding errors may produce small % differences between Figure 2 and Figure 6.2.

When this adjustment is applied the extent of erosion has remained at 7%, the extent of stability has reduced from 79% to 82% and the extent of accretion has fallen from 14% to 10% (Figure 6.2). In addition to the changes in extents in Cell 6, there has been an increase in the rate of change with erosion increasing from 0.3 m/yr to 0.7 m/yr and accretion increasing from 0.3 m/yr to 0.8 m/yr (Figure 5.2). Further statistics for Cell 6 can be found in Table 6.2 and Table 6.3 at the end of this report.

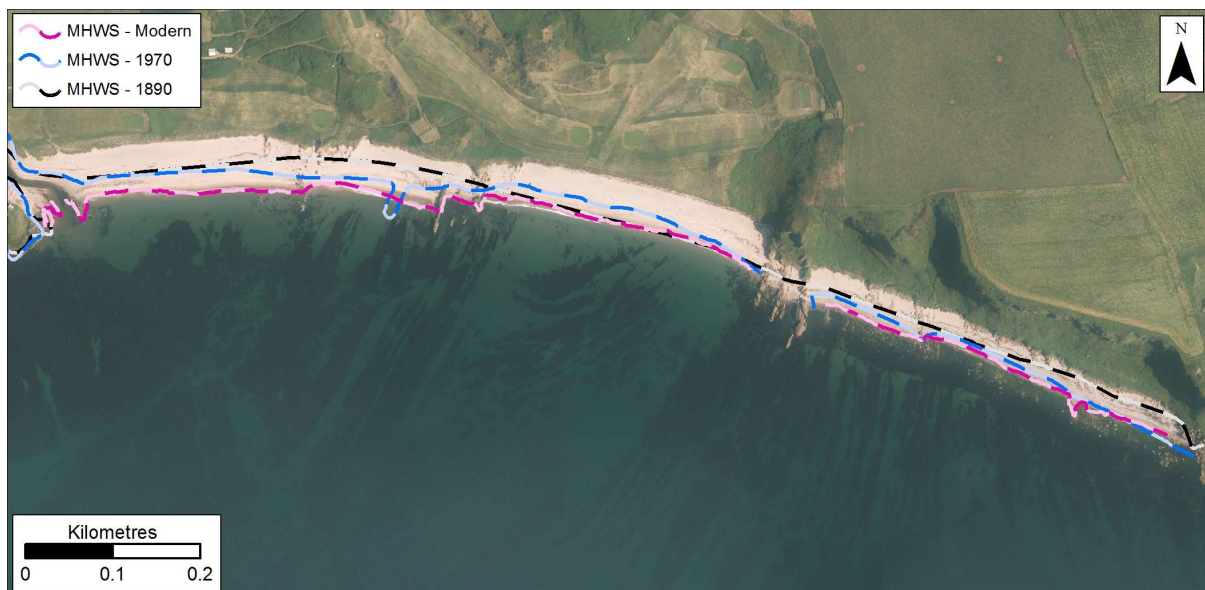
Figure 6.3: MHWS position in 1890, 1970s, and Modern datasets at Brunerican Bay. Getmapping are our current providers of Scotland-wide digital aerial imagery © Getmapping plc.

Historic Change: Brunerican Bay is a 1 km long sand beach backed by sand dunes, lying at the south end of the Mull of Kintyre. Unlike the bay to the west, the 1897 MHWS line lies landward of the 1978 line which suggests accretion of up to 20 m along the west and central sections but erosion in the east (Figure 6.3) of about the same amount (the bay to the west show 13 m of erosion between 1997 and modern). However, the OS modern MHWS line in Brunerican Bay is depicted as lying a further 20 m seaward of the 1978 line and is likely to be unreliable. Given that the vegetation edge shown here on the photography is cliffed, erosional and some 30 m landward of the 1978 line, then this location is likely to be eroding.

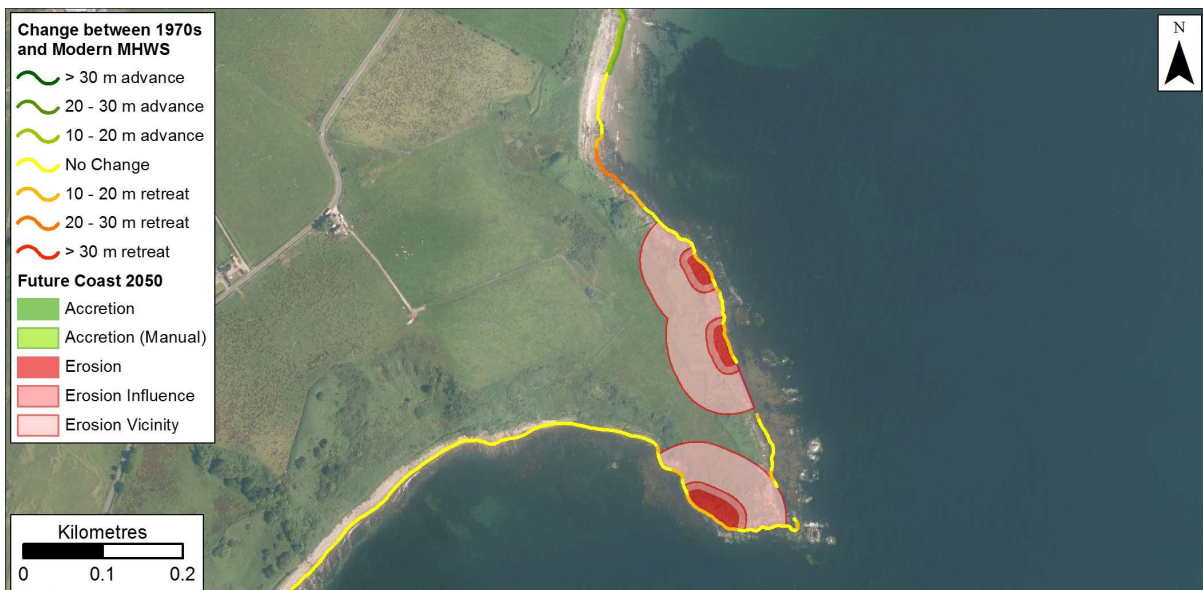
Figure 6.5: Possible future coastline position in 2050 based on rates between 1970 and Modern MHWS data at the North Headland of Campbeltown Bay. Getmapping are our current providers of Scotland-wide digital aerial imagery© Getmapping plc.

Future Vulnerability: Due to the observed erosion within the data, this location is identified as an area of concern for the future (Figure 6.5). These figures however, are likely to be inaccurate given the rocky nature of the shore and the probable mislocation of the 1978. This area falls within the Campbeltown Potentially Vulnerable Area.

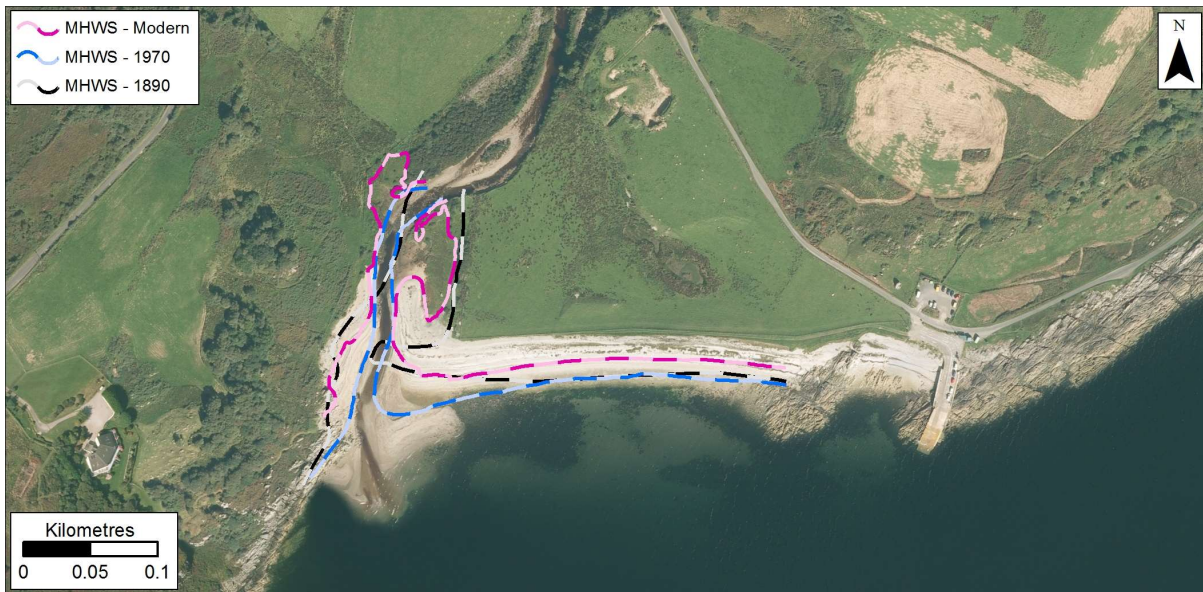
Figure 6.6: MHWS position in 1890, 1970s, and Modern datasets at Claonaig Bay. Getmapping are our current providers of Scotland-wide digital aerial imagery© Getmapping plc.

Historic Change: The 450 m long beach at Claonaig shows the 1890 MHWS to coincide with the 1977 line over much of the small bay except in the west at the river exit, where there has been accretion of up to 30 m over this period (Figure 6.6). This has been followed by landward movement of 14 m to 2014 as depicted by the OS Digital Surface Model. To the east of the beach, outcrops of

rock serve to restrict the rate of erosion before the jetty is reached that services the seasonal ferry to Lochranza on Arran.

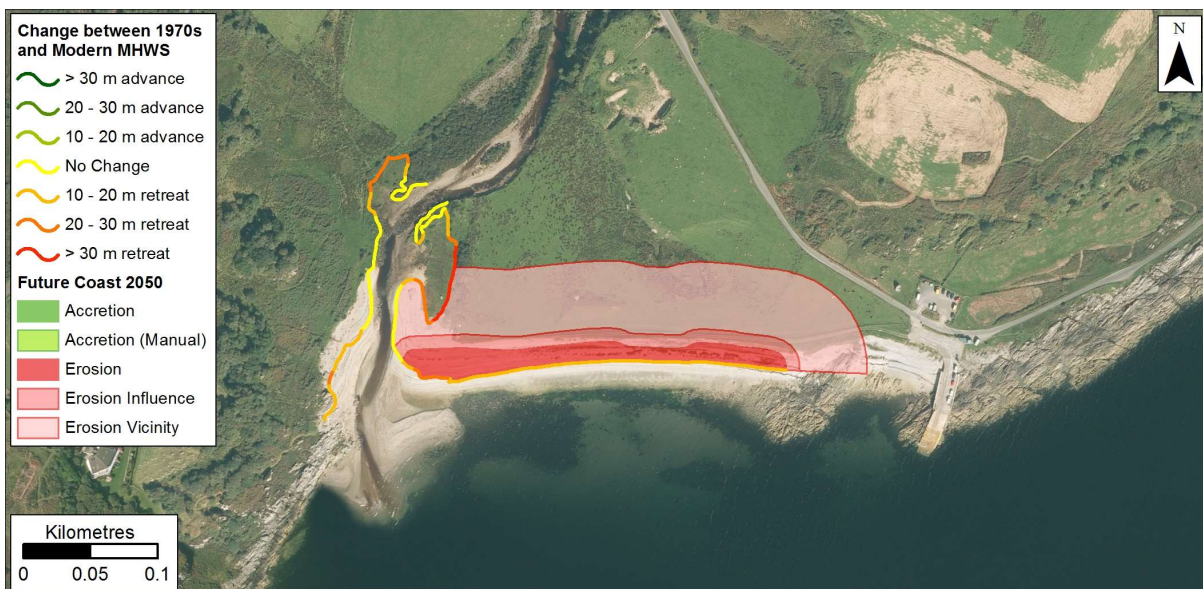
Figure 6.7: Possible future coastline position in 2050 based on rates between 1970 and Modern MHWS data at Claonaig Bay. Getmapping are our current providers of Scotland-wide digital aerial imagery© Getmapping plc.

Future Vulnerability: The projected erosion to 2050 at Claonaig does not directly affect any assets other than a minor access track along the rear of the beach (Figure 6.7). The erosion vicinity zone comes close to the only access road to the ferry car park and jetty as well as the access road to residential properties at Skipness. Thus, whilst the ferry jetty and car park are sited on rock and thus relatively secure, the access road to the landward may be a cause for concern in the future, if erosion begins to threaten the softer and unconsolidated emerged beach deposits that lie to the seaward and upon which it likely rests.

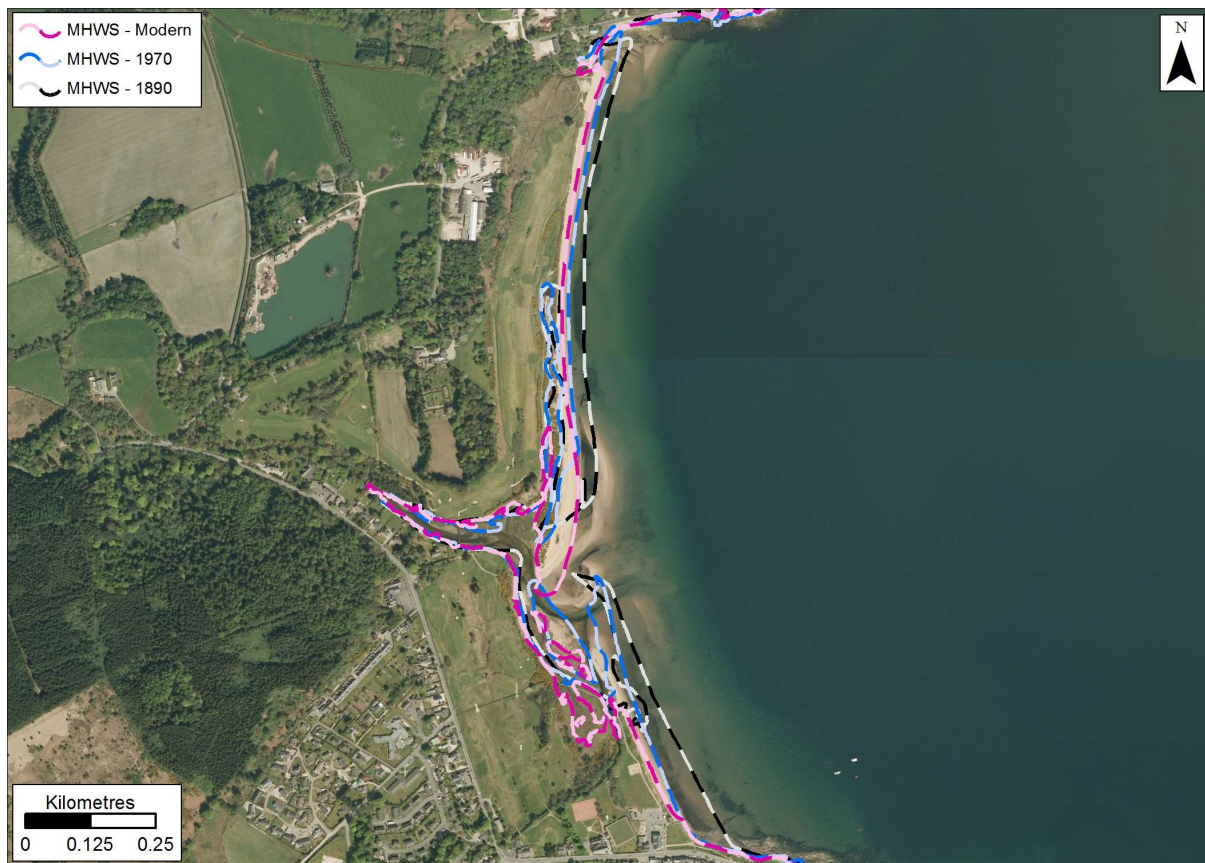
Figure 6.8: MHWS position in 1890, 1970s, and Modern datasets at Brodick Bay. Getmapping are our current providers of Scotland-wide digital aerial imagery © Getmapping plc.

Historic Change: Brodick Bay is approximately 1.5 km long and bisected by the river that exits from Glen Rosa. Behind the sandy beach lies open ground supporting a golf course, and in the south, an access road, car park and playing fields. Almost along its full length, the 1890 MHWS line lies well seaward of the current position; up to 70 m in the south of the bay (Figure 6.8). In 1890 the beach was fronted by a long spit that extended north across the river exit but by 1978 this had retreated landward by 30 m. By 2014 the LiDAR line is a further 20 m landward so that some 70 m has been lost since 1890 in the south. In the north some 30 m of recession occurred between 1890 and 1978 and a further 10 m to 2014 adds up to 40 m of loss 1890-2014. The losses continue in the south with the artificial addition of sand dredged from the replacement pier and fed to the beach in 2016. This sand has subsequently been lost to the north of the river exit which is now accreting as a result. The erosion of Brodick beach is directly attributable to the ill-advised removal of sand from this beach in the 1970s and 1980s. Artificial sand bags have been placed at the back of the beach in 2015 as well as a short stubby rock groyne to slow the rate of erosion, to little avail. There are now plans to protect the shore by the insertion of boulder rip rap and groynes. Brodick is notified as a Potentially Vulnerable Area.

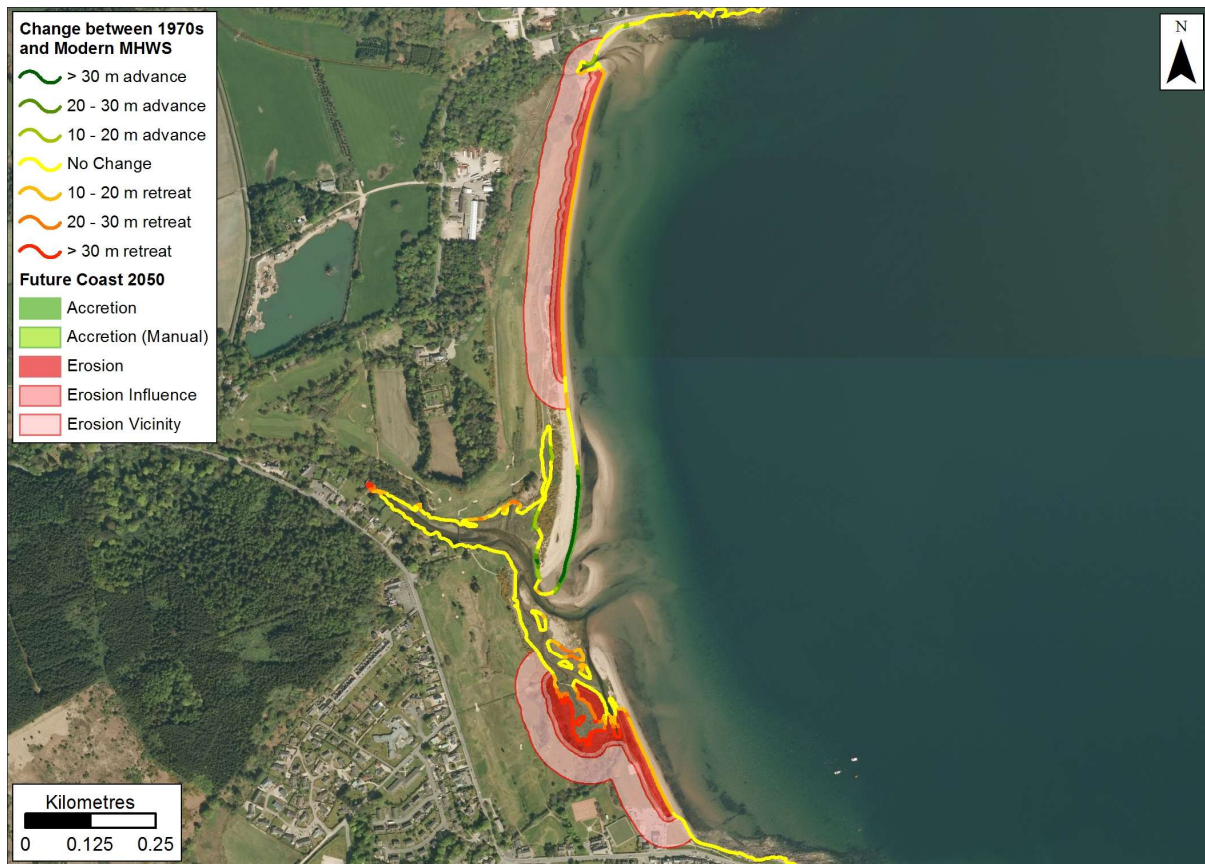
Figure 6.9: Possible future coastline position in 2050 based on rates between 1970 and Modern MHWS data at Brodick Bay. Getmapping are our current providers of Scotland-wide digital aerial imagery © Getmapping plc.

Future Vulnerability: Using the rates of erosion 1978 to 2014 and projecting them forward to 2050 reveal a substantial length of Brodick Bay to be of concern with 600 m of the beach in the north expected to recede by up to 20 m (Figure 6.9). In the south almost 200 m may erode inland by up to 15 m. The beach in the north is backed by sand dune and the northern part of the golf course, with no buildings under threat. In the south, the beach is backed by the southern part of the golf course as well as a pathway, recreational areas, car park and buildings that will be cause for concern in the

future. At the river exit the projected recession of MHWS by 2050 is some 100 m inland but this is generated by the fluctuations in the exit of the river and may well be an overestimate that will change over time.

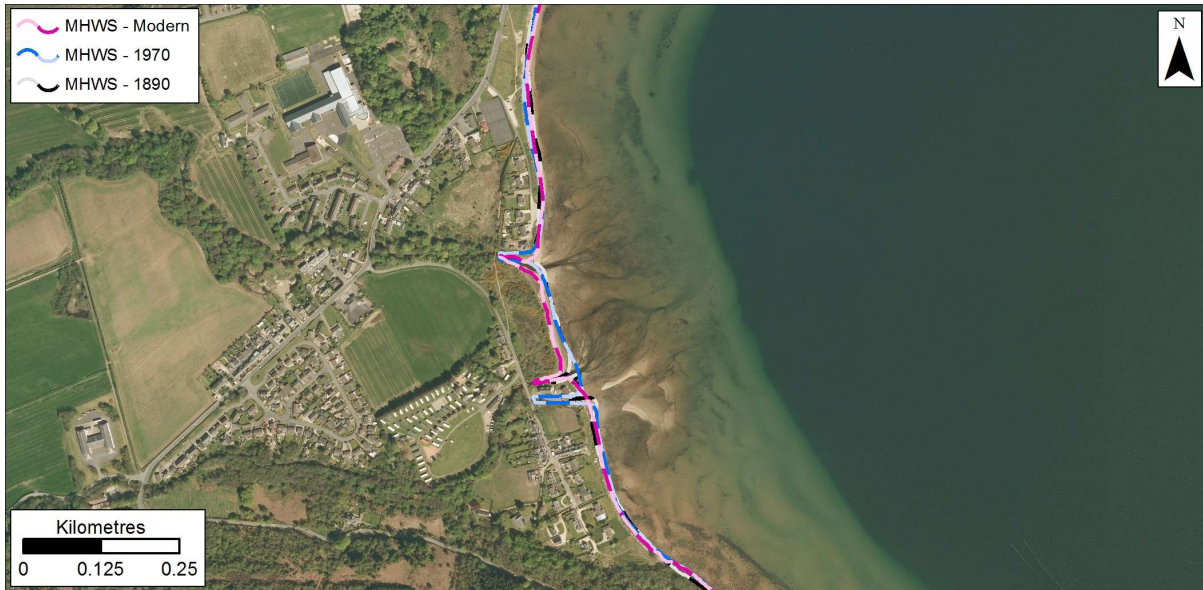
Figure 6.10: MHWS position in 1890, 1970s, and Modern datasets at Lamlash. Getmapping are our current providers of Scotland-wide digital aerial imagery© Getmapping plc.

Historic Change: At Lamlash, the 1895 MHWS coincides with the 1978 position showing no real change over that time period. Since 1978 and 2014 however, there has been up to 15 m (0.4 m/yr) of recession over the 200 m central section of shore that lies between the two river exits (Figure 6.10). Lamlash Bay is notified as a Potentially Vulnerable Area.

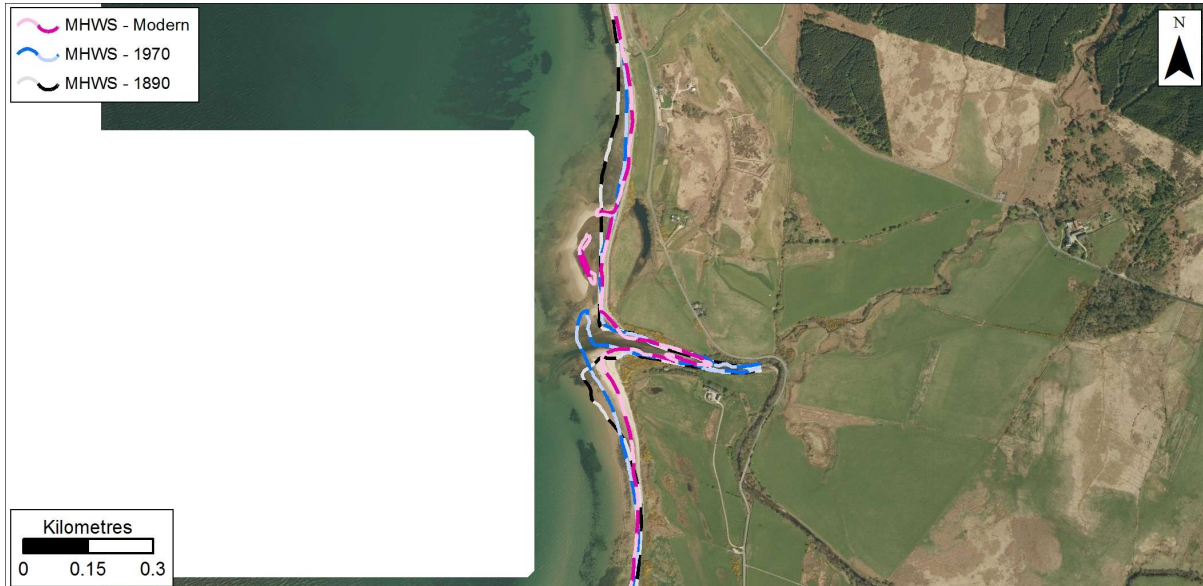
Figure 6.12: MHWS position in 1890, 1970s, and Modern datasets at Machrie. Getmapping are our current providers of Scotland-wide digital aerial imagery© Getmapping plc.

Historic Change: Two areas at Machrie have shown recession since 1895. In the south, where the river exits, the shore has receded by 25 m from 1895 to 1979 and a further 25 m to 2014 LiDAR (Figure 6.12). In the north, at the Machrie golf course, the MHWS has retreated by 40 m between 1895 and 1979 and then by 10 m to 2014 over 400 m. This is despite coarse gravels being placed on the upper shore at the toe of the vegetated erosional scarp.

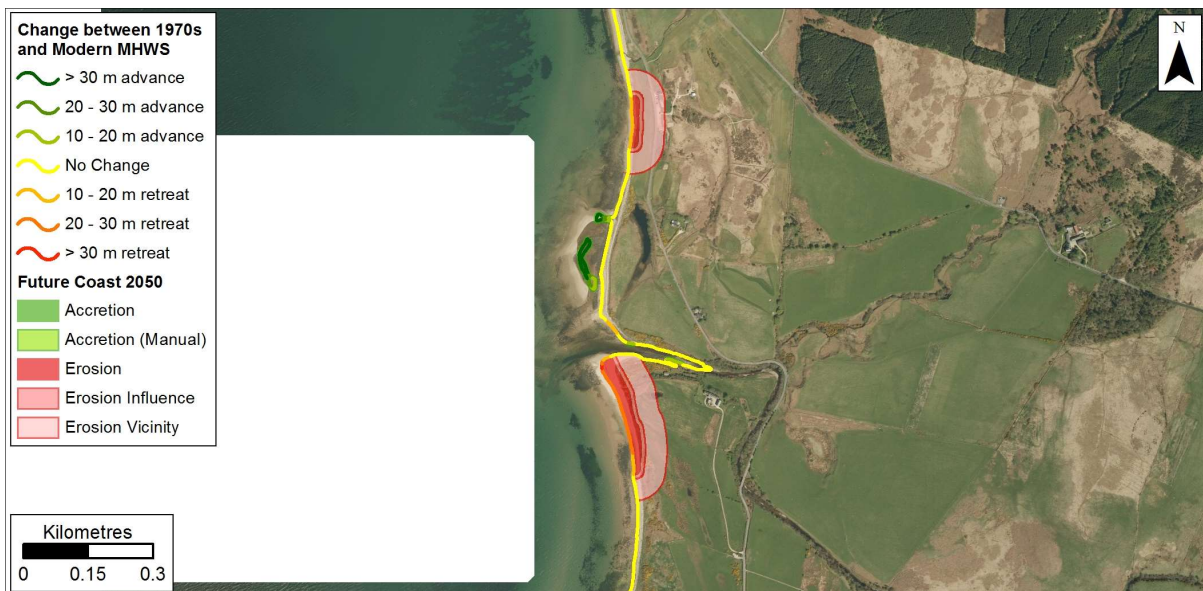
Figure 6.13: Possible future coastline position in 2050 based on rates between 1970 and Modern MHWS data at Machrie. Getmapping are our current providers of Scotland-wide digital aerial imagery© Getmapping plc.

Future Vulnerability: In the south, there are no assets under threat at the stream exit. In the north at the Machrie golf course, the projected loss by 2050 over 120 m of coast is 16 m, with the erosion influenced zone extending over 140 m and the erosion vicinity to over 240 m and 80 m inland. The erosion influenced zone includes golf course buildings (Figure 6.13). Crucially, the only perimeter

access road along the west coast of Arran is unprotected, very close to MHWS, and is of potential concern in the future should rates of erosion change.

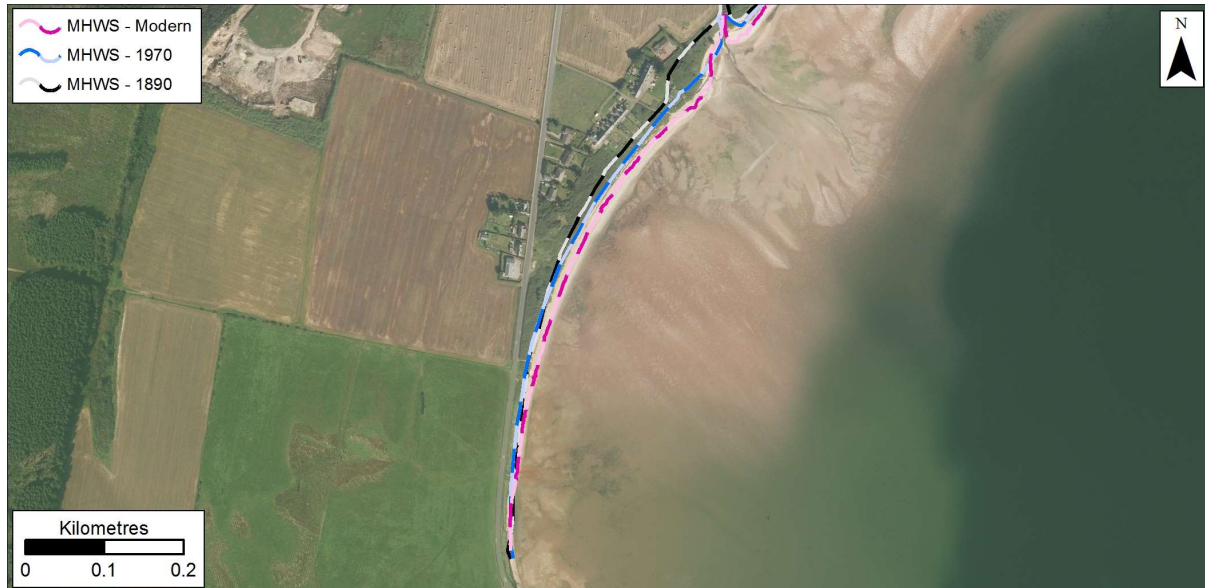
Figure 6.14: MHWS position in 1890, 1970s, and Modern datasets at Kilchattan Bay. Getmapping are our current providers of Scotland-wide digital aerial imagery © Getmapping plc.

Historic Change: Kilchattan Bay lies on the south-east corner of Bute with a sand beach of approximately 1.6 km in length. In general terms, accretion dominated the entire beach between 1890 and the 1970s but since then the north has shown some erosion of up to 8m. The southern part of the beach has accreted by up to 13m over a 500m stretch in front of the houses and roadway. At the extreme south end, the position of MHWS has remained stable over the time periods. Beyond this the shore becomes rocky and is protected by a sea wall fronting the coastal access road and several houses.

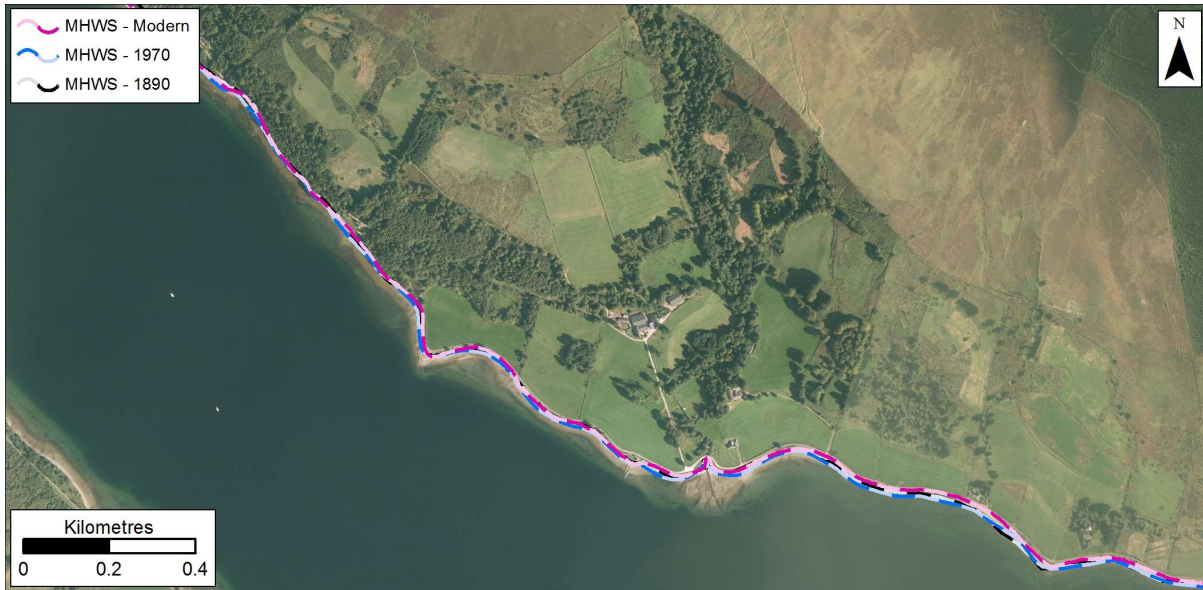
Figure 6.15: MHWs position in 1890, 1970s, and Modern datasets at Bargehouse Point and South Hall shore. Getmapping are our current providers of Scotland-wide digital aerial imagery© Getmapping plc.

Historic Change: Over a 1.1 km stretch of the north shore of the Kyles of Bute to the south of Colintraive and east of Strone Point, the current shoreline lies some 20 m landward of the shore as depicted in 1890 and 1978. There is no evidence to suggest that it is inaccurate (Figure 6.15).

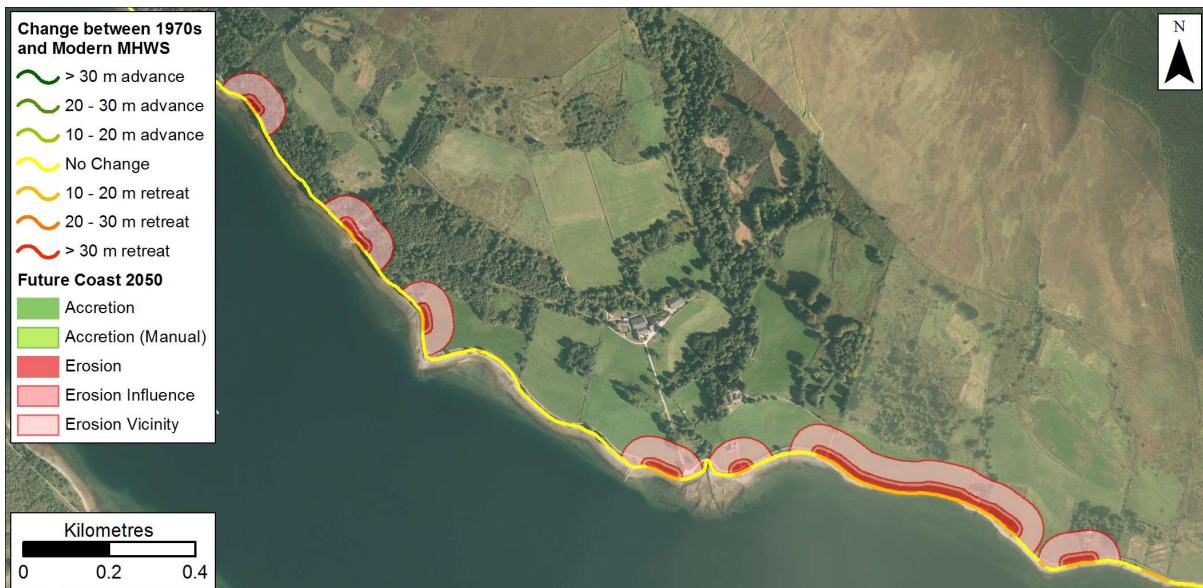
Figure 6.16: Possible future coastline position in 2050 based on rates between 1970 and Modern MHWs data at Bargehouse Point and South Hall shore. Getmapping are our current providers of Scotland-wide digital aerial imagery© Getmapping plc.

Future Vulnerability: This shore is relatively undeveloped, however, one farmhouse and some 1 km of the coastal access road lies within the zone of erosion anticipated by 2050 (Figure 6.16).

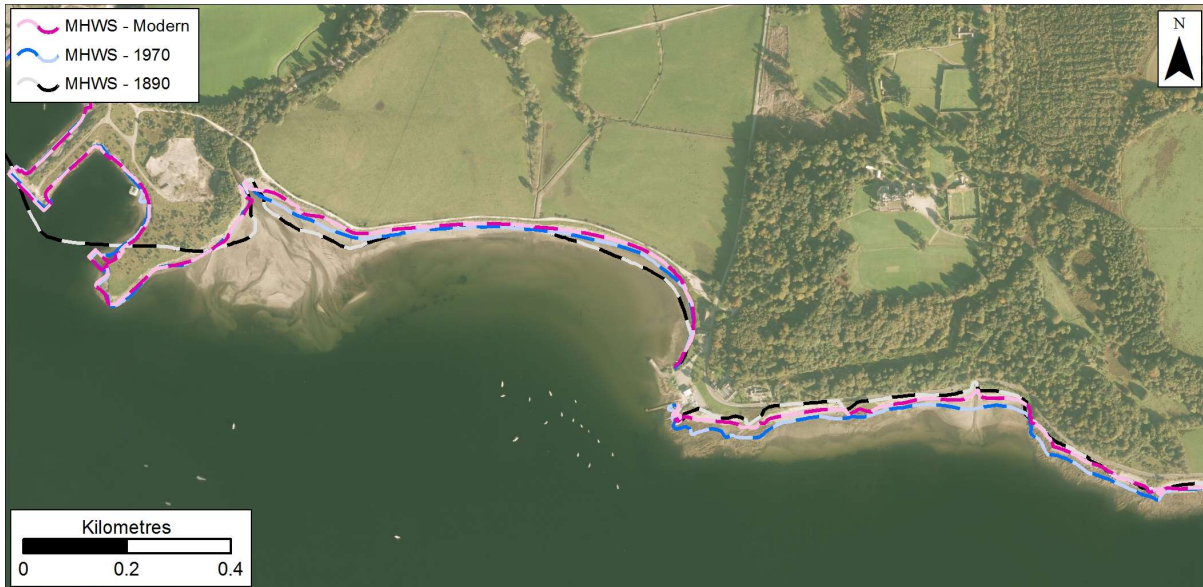
Figure 6.17: MHWs position in 1890, 1970s, and Modern datasets. Getmapping are our current providers of Scotland-wide digital aerial imagery© Getmapping plc.

Historic Change: Along several parts of the shore between Toward Point and Toward Quay the 1898 MWHs position lies some 25 m seaward of the 1964 line suggesting accretion, followed by 7 m of landward erosion by 2011, although in some places this reached 20 m of erosion over this time period (Figure 6.17). To the east of this section and west of Toward Point, the 1890 line lies landward of both the 1964 and 2011 line suggesting accretion to 1964 followed by erosion to 2011. The coastal road (A815) runs along the shoreline and is often very close to MHWs. Castle Toward's gardens are notified as a Garden of Designed Landscape.

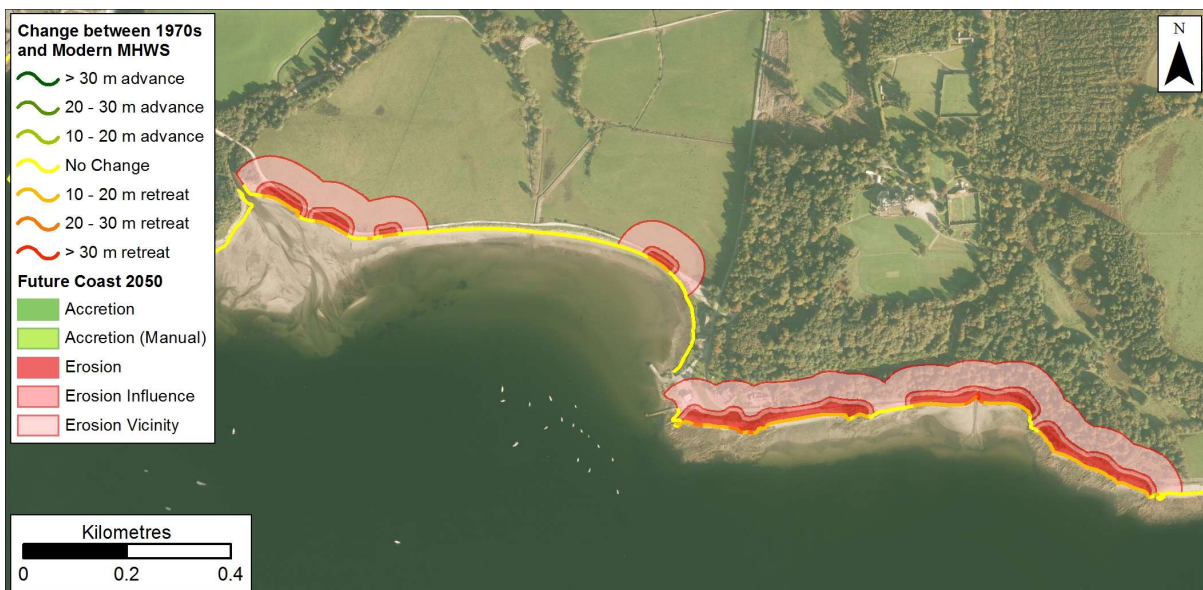
Figure 6.18: Possible future coastline position in 2050 based on rates between 1970 and Modern MHWs data between Toward Point and Toward Quay. Getmapping are our current providers of Scotland-wide digital aerial imagery© Getmapping plc.

Future Vulnerability: The shore between Toward Point and Toward Quay supports the main road A815 extension to Loch Striven. The road closely parallels a largely unprotected shore. In the west some 200 m of this roadway lies within the projected erosion zone that may extend inland by 12 m by 2050 (Figure 6.18). In the east, a further 1km of road is directly affected by the projected erosion zone, together with three properties.

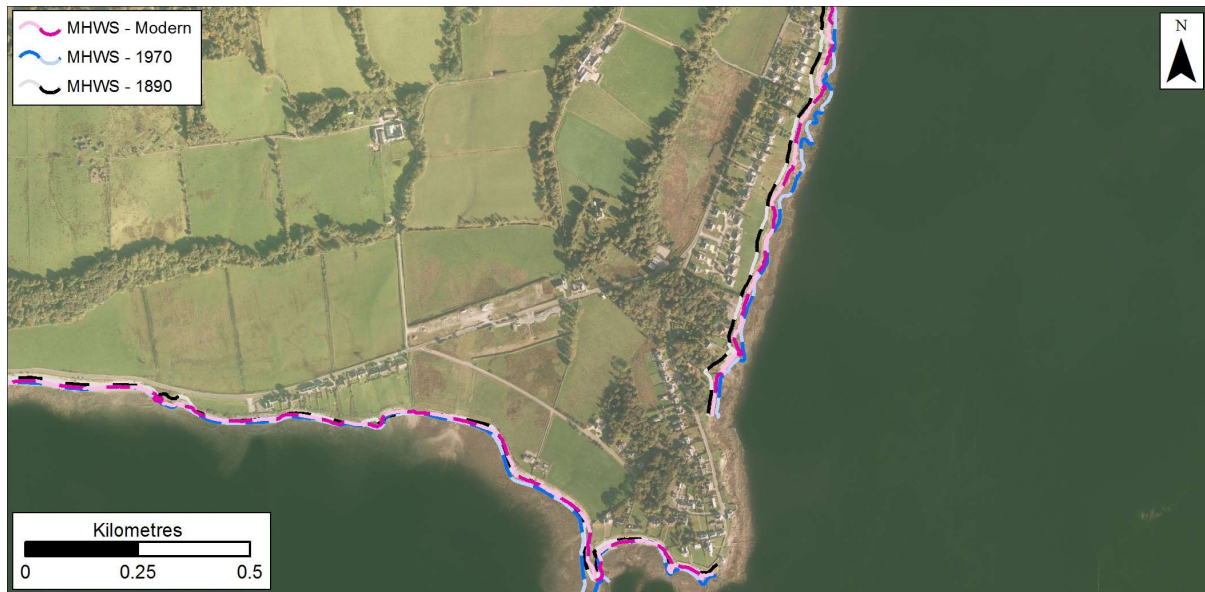
Figure 6.19: MHWS position in 1890, 1970s, and Modern datasets at Toward. Getmapping are our current providers of Scotland-wide digital aerial imagery© Getmapping plc.

Historic Change: Much of the shoreline north of Toward is artificially defended by seawalls along which the A815 runs. However, at Toward itself the shore is undefended and although was subject to accretion between 1890 and 1964, it has subsequently undergone recession to 2011 by up to 25 m (Figure 6.19). This has reduced the extent of the gardens that lie to the seaward of the long line

of residential properties that parallel the road, which at this point lies some 130 m inland. Two other smaller areas of recent recession affect farm buildings to the west of the point.

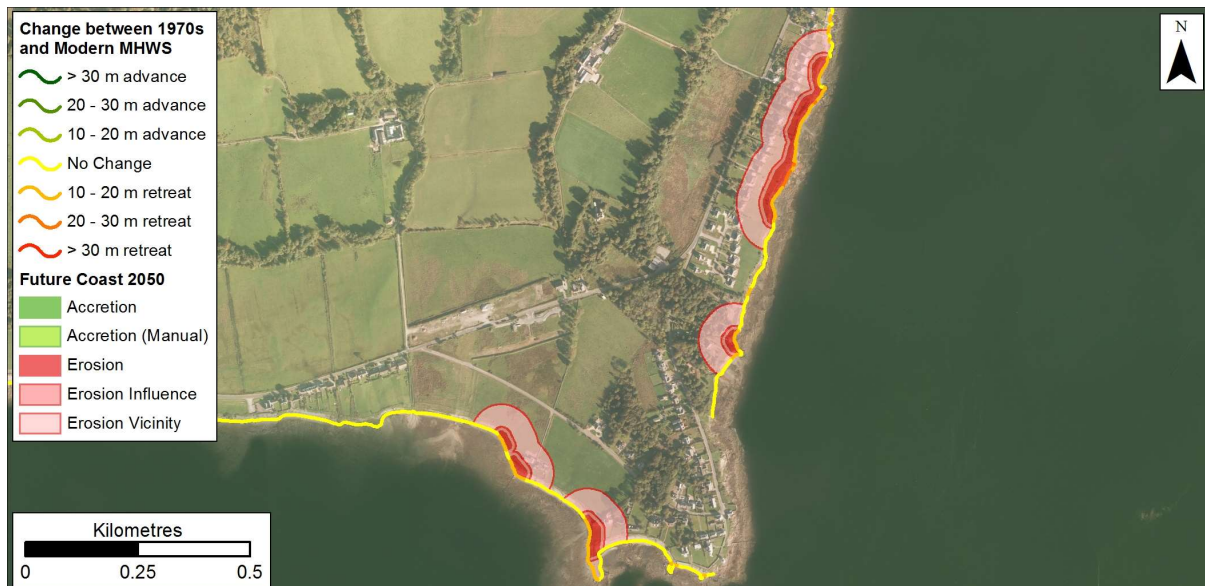
Figure 6.20: Possible future coastline position in 2050 based on rates between 1970 and Modern MHWS data at Toward. Getmapping are our current providers of Scotland-wide digital aerial imagery© Getmapping plc.

Future Vulnerability: Some 500 m of shore is projected to be eroding by 2050 and although the affected zone mainly comprises residential gardens, the erosion affected zone is more extensive (Figure 6.20). The erosion vicinity extends 80 m inland over 500 m of coast length, with 18 residential properties falling within the zone.

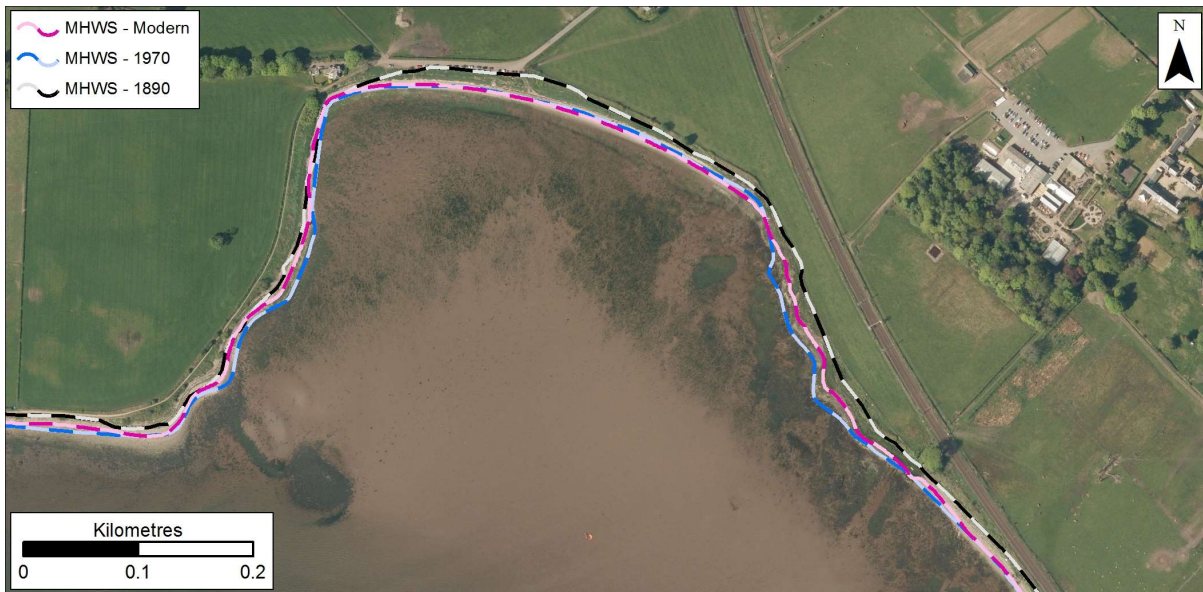
Figure 6.21: MHWs position in 1890, 1970s, and Modern datasets east of Ardmore Point. Getmapping are our current providers of Scotland-wide digital aerial imagery© Getmapping plc.

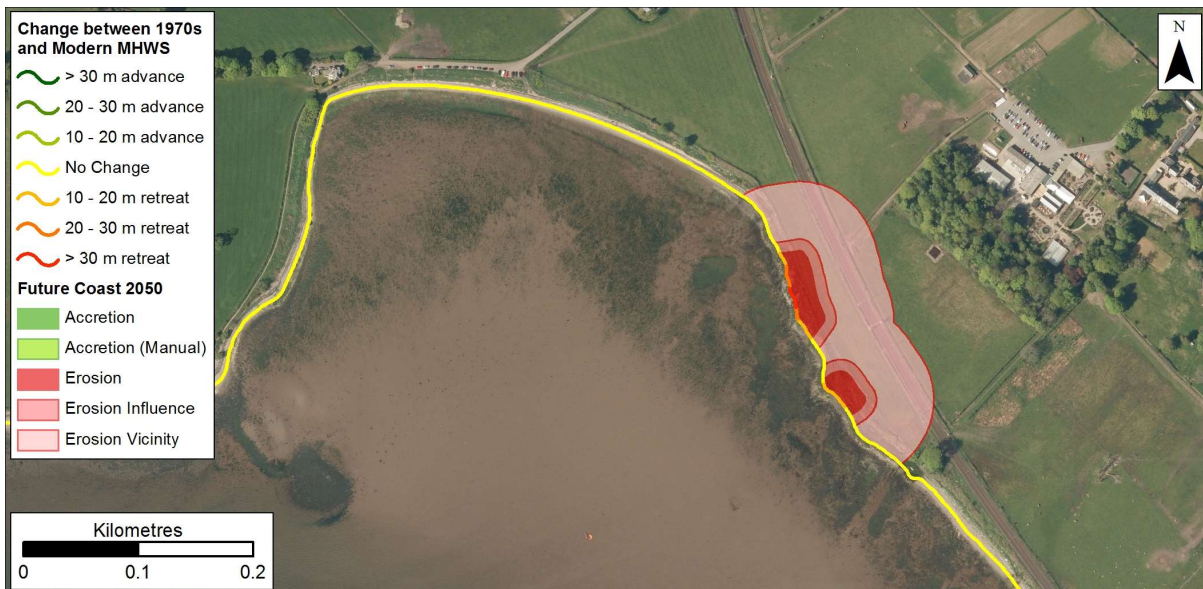
Figure 6.22: Possible future coastline position in 2050 based on rates between 1970 and Modern MHWs data east of Ardmore Point. Getmapping are our current providers of Scotland-wide digital aerial imagery© Getmapping plc.

Future Vulnerability: For over 250 m of shore length, the projected erosion vicinity zone extends 50 m inland and overlaps the rail line (Figure 6.22). This section remains unprotected and although the rail line to the east lies closer to the shore and is protected artificially, the entire stretch of shore is a cause for future concern.

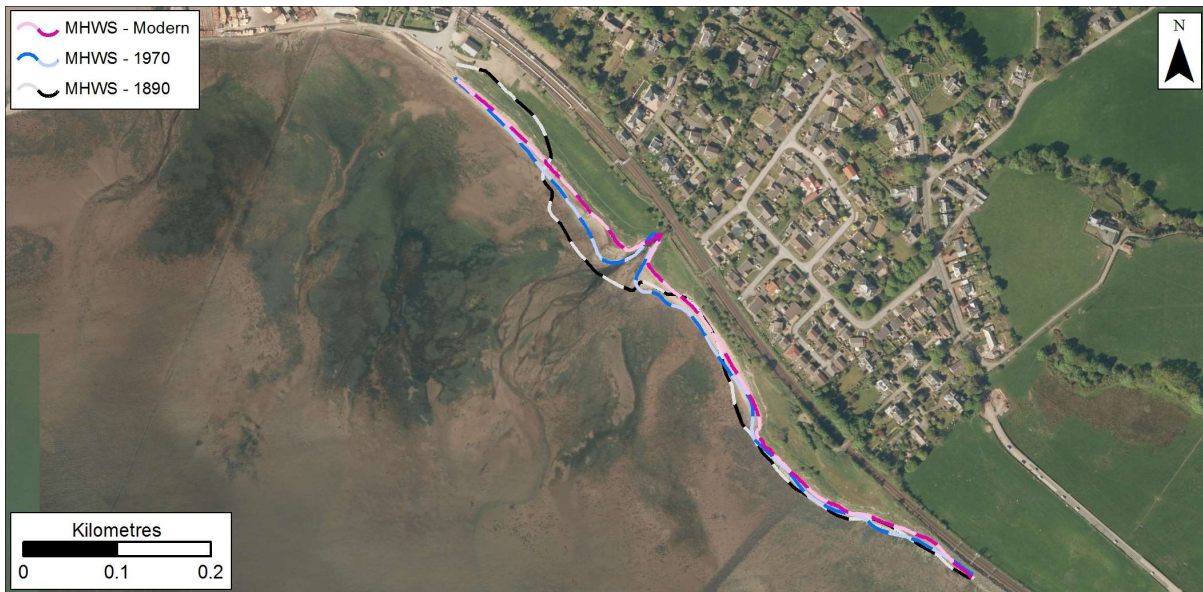
Figure 6.23: MHWS position in 1890, 1970s, and Modern datasets at Cardross. Getmapping are our current providers of Scotland-wide digital aerial imagery© Getmapping plc.

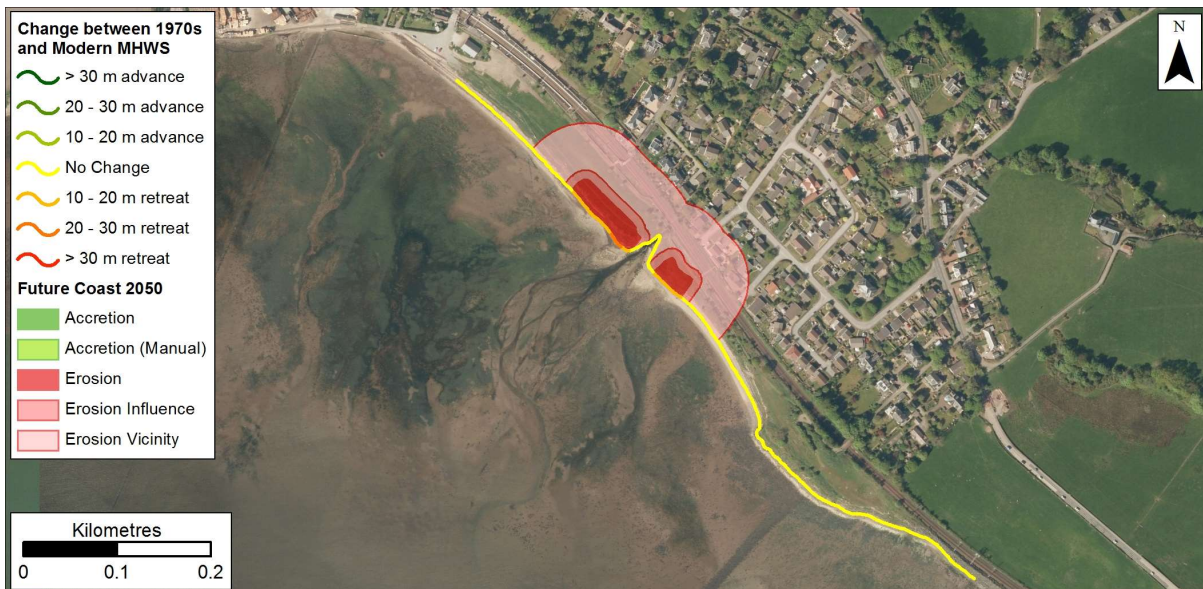
Figure 6.24: Possible future coastline position in 2050 based on rates between 1970 and Modern MHWS data at Cardross. Getmapping are our current providers of Scotland-wide digital aerial imagery© Getmapping plc.

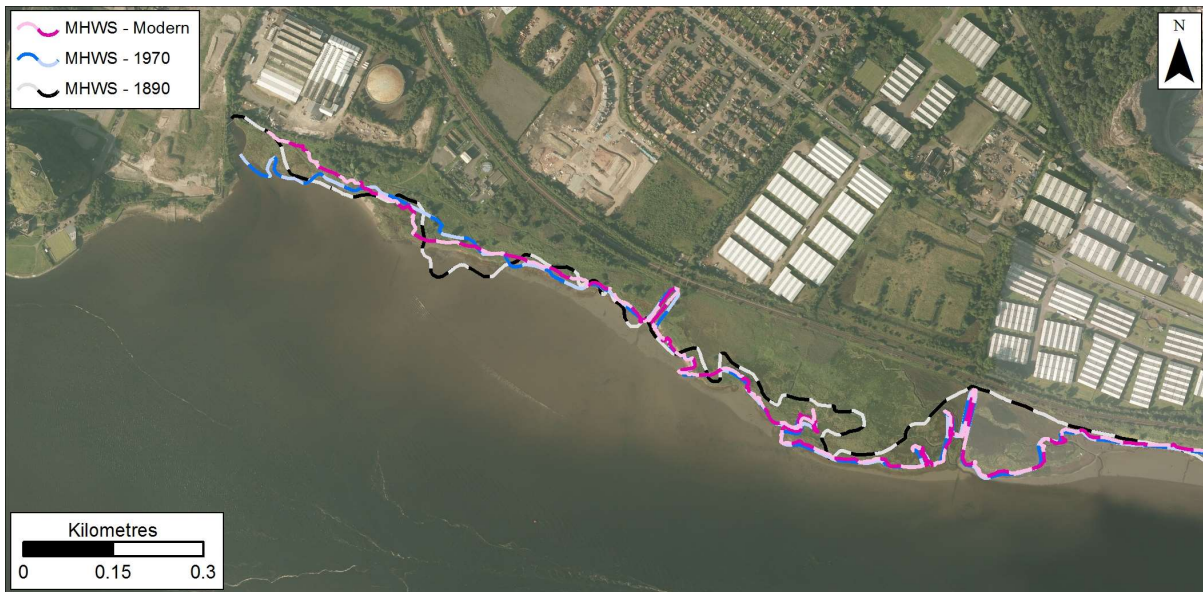
Figure 6.25: MHWS position in 1890, 1970s, and Modern datasets at Dumbarton Castle Bay. Getmapping are our current providers of Scotland-wide digital aerial imagery© Getmapping plc.

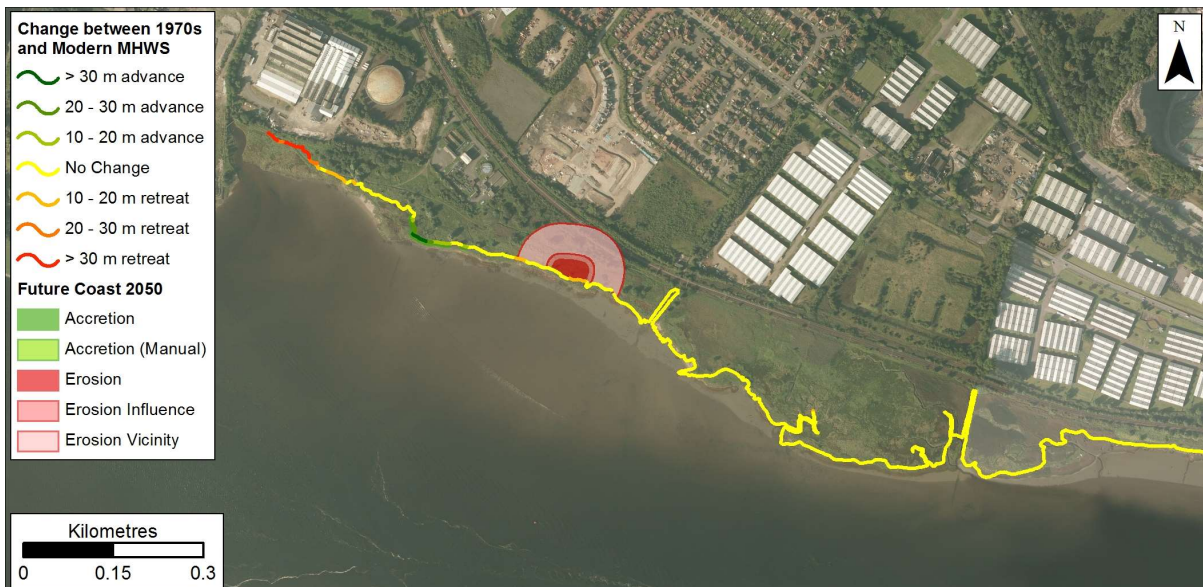
Figure 6.26: Possible future coastline position in 2050 based on rates between 1970 and Modern MHWS data at Dumbarton Castle Bay. Getmapping are our current providers of Scotland-wide digital aerial imagery© Getmapping plc.

Future Vulnerability: Although the erosion zone here affects undefended saltmarsh, the erosion vicinity captures some 100 m of mainline rail track that lies 70 m landward and is a cause for concern in the future (Figure 6.26). This section of shore has been the subject of more detailed study commissioned by the Firth of Clyde Forum and conducted by ARUP and Glasgow University (SNH, 2016).

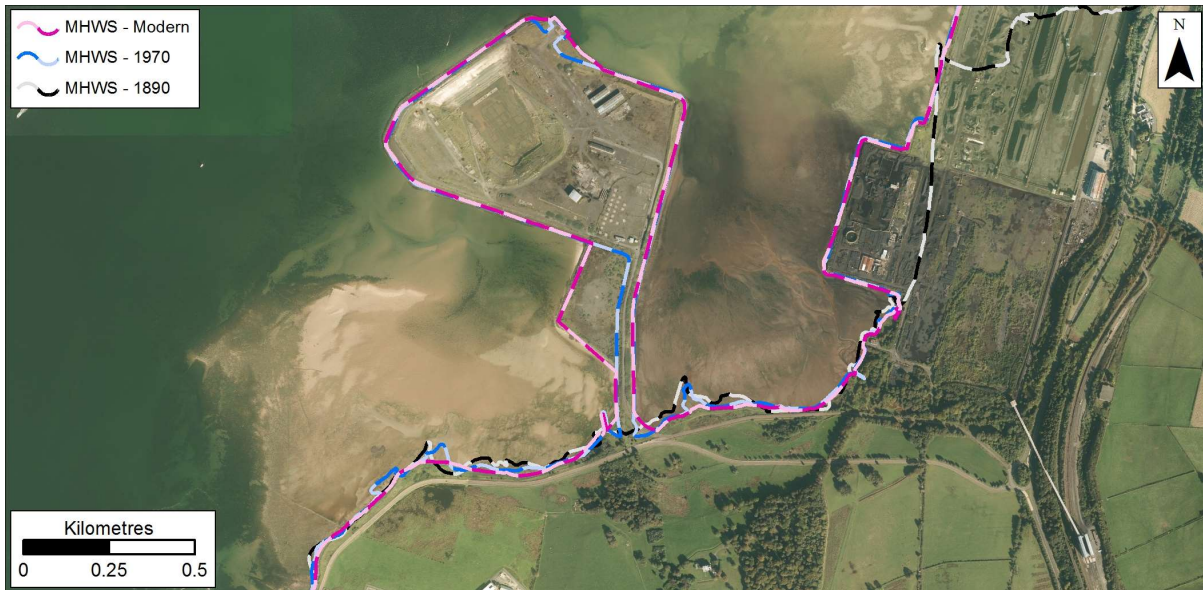
Figure 6.27: MHWS position in 1890, 1970s, and Modern datasets at Hunterston B Nuclear Power Station. Getmapping are our current providers of Scotland-wide digital aerial imagery© Getmapping plc.

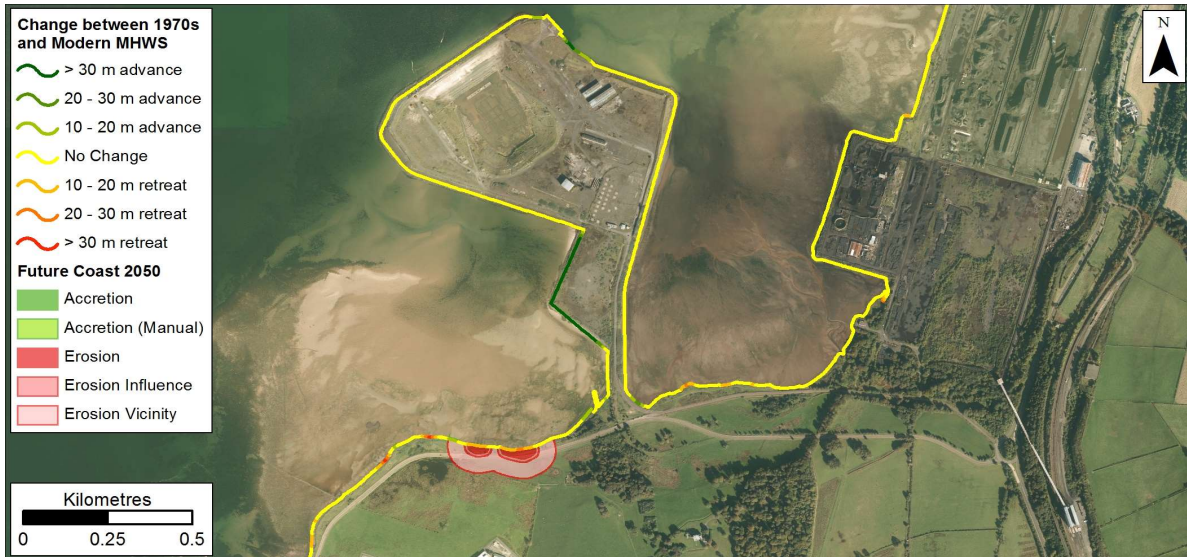
Figure 6.28: Possible future coastline position in 2050 based on rates between 1970 and Modern MHWS data at Hunterston B Nuclear Power Station. Getmapping are our current providers of Scotland-wide digital aerial imagery© Getmapping plc.
