Dynamic Coast - National Coastal Change Assessment: Cell 6 - Mull of Kintyre to the Mull of Galloway

Please reference this report as follows: Rennie, A.F., Hansom, J.D., and Fitton, J.M. (2017) Dynamic Coast - National Coastal Change Assessment: Cell 6 - Mull of Kintyre to the Mull of Galloway, CRW2014_02.

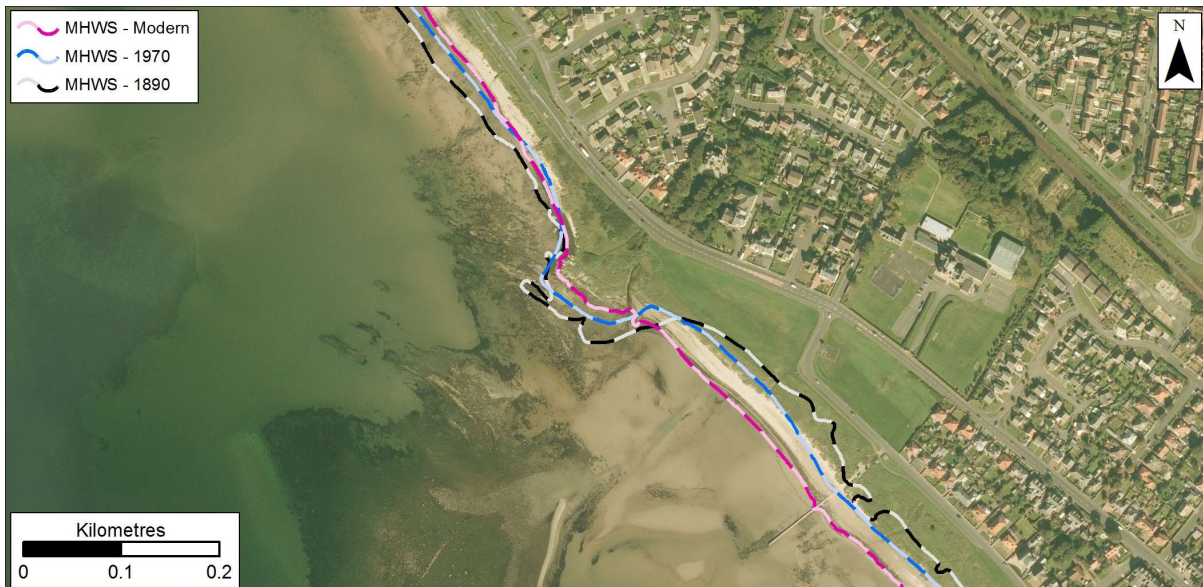
Figure 6.29: MHWS position in 1890, 1970s, and Modern datasets north of Ardrossan. Getmapping are our current providers of Scotland-wide digital aerial imagery© Getmapping plc.

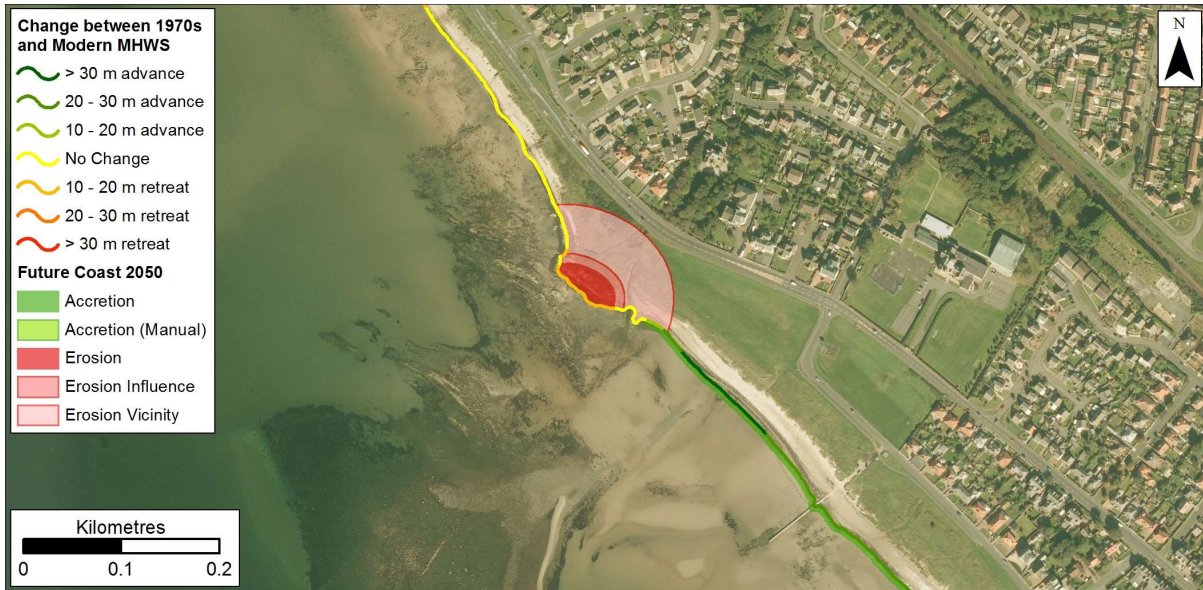
Figure 6.30: Possible future coastline position in 2050 based on rates between 1970 and Modern MHWS data north of Adrossan. Getmapping are our current providers of Scotland-wide digital aerial imagery© Getmapping plc.

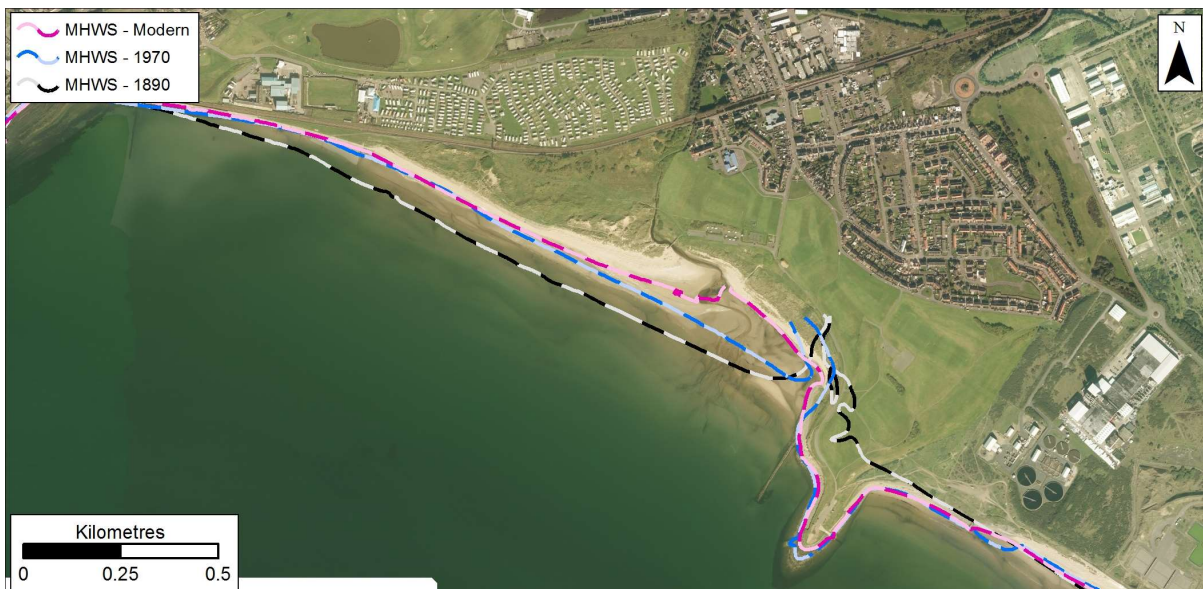
Figure 6.31: MHWS position in 1890, 1970s, and Modern datasets at Saltcoats. Getmapping are our current providers of Scotland-wide digital aerial imagery© Getmapping plc.

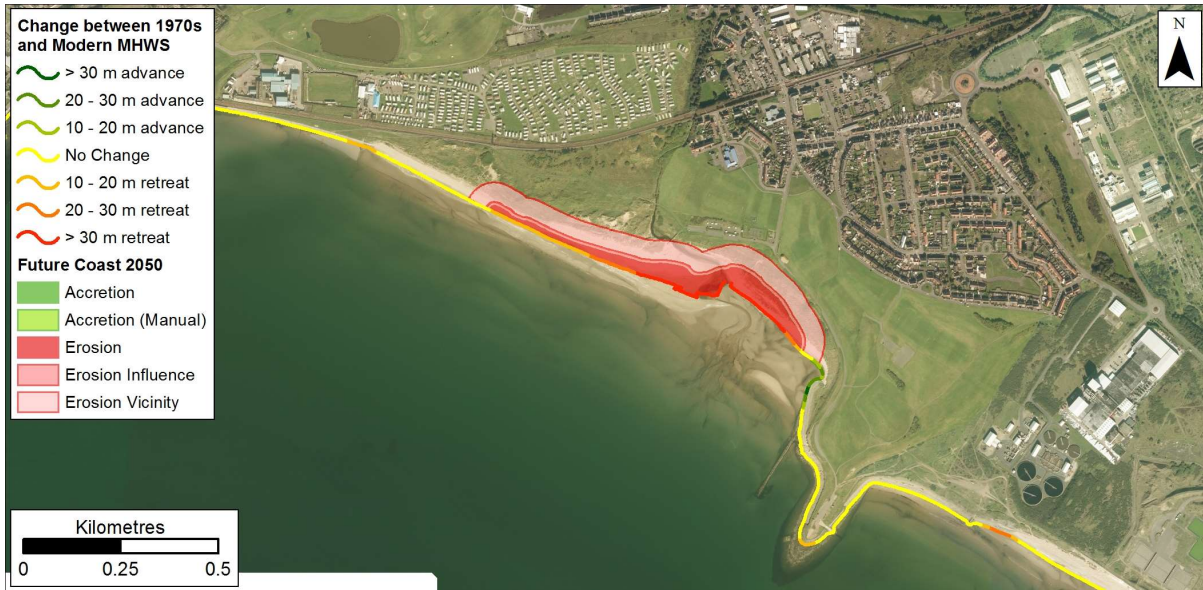
Figure 6.32: Possible future coastline position in 2050 based on rates between 1970 and Modern MHWS data at Saltcoats. Getmapping are our current providers of Scotland-wide digital aerial imagery© Getmapping plc.

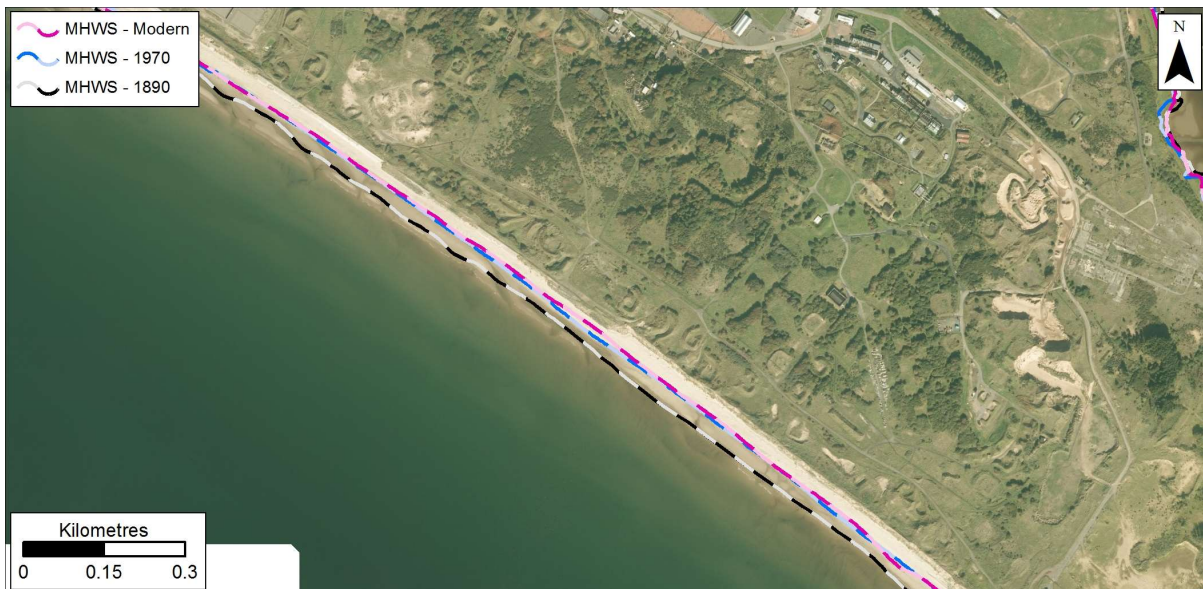
Figure 6.33: MHWS position in 1890, 1970s, and Modern datasets at Ardeer. Getmapping are our current providers of Scotland-wide digital aerial imagery© Getmapping plc.

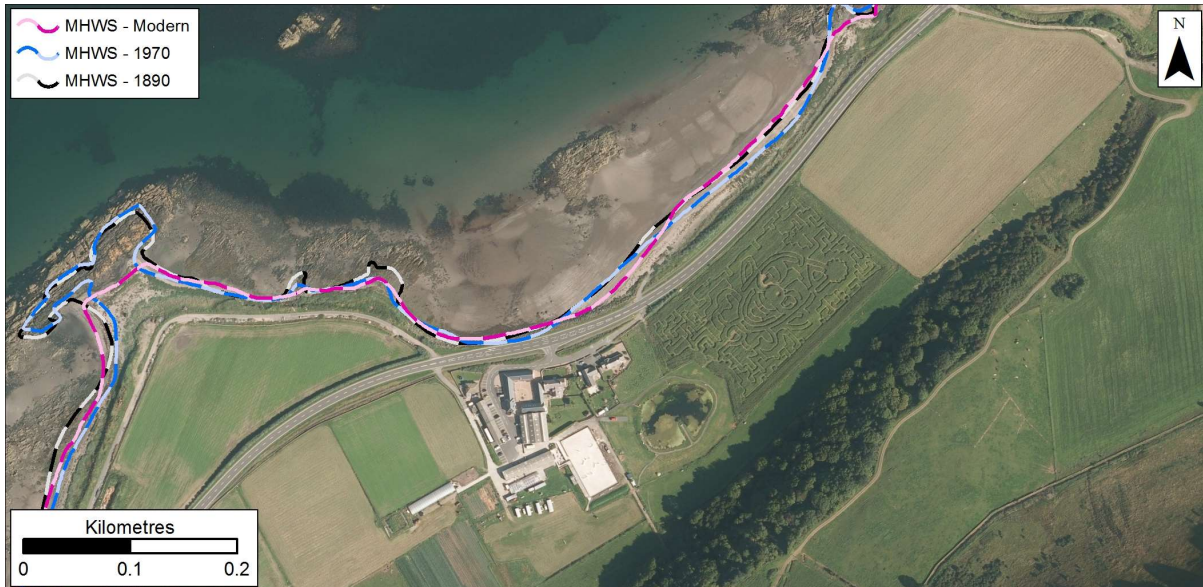
Figure 6.35: MHWs position in 1890, 1970s, and Modern datasets at Woodland Bay. Getmapping are our current providers of Scotland-wide digital aerial imagery© Getmapping plc.

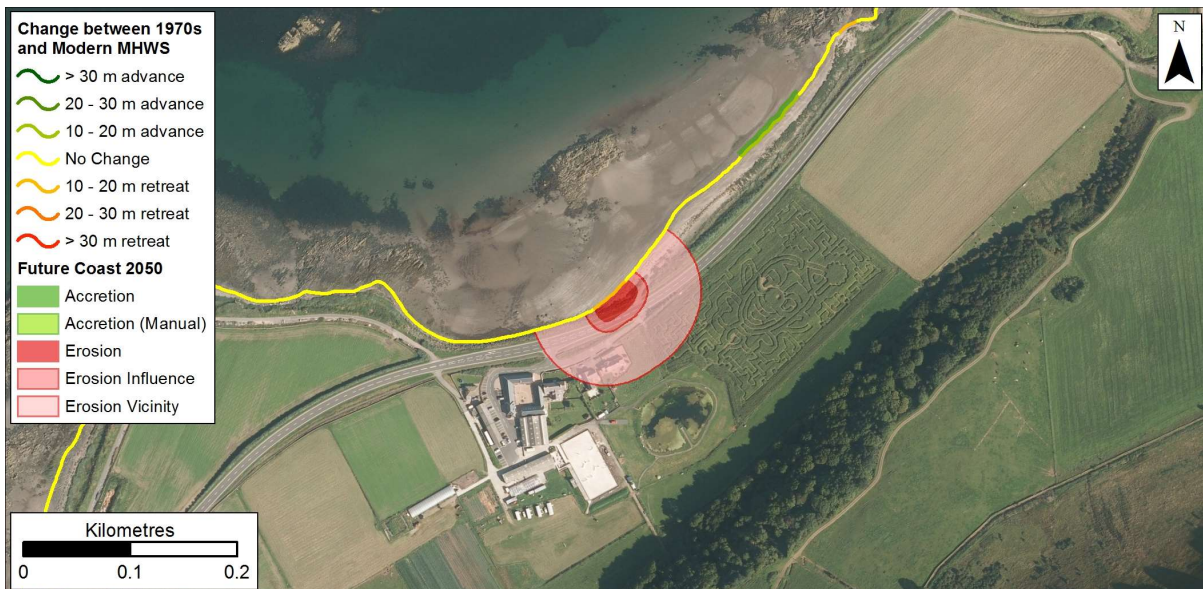
Figure 6.36: Possible future coastline position in 2050 based on rates between 1970 and Modern MHWs data at Woodland Bay. Getmapping are our current providers of Scotland-wide digital aerial imagery© Getmapping plc.

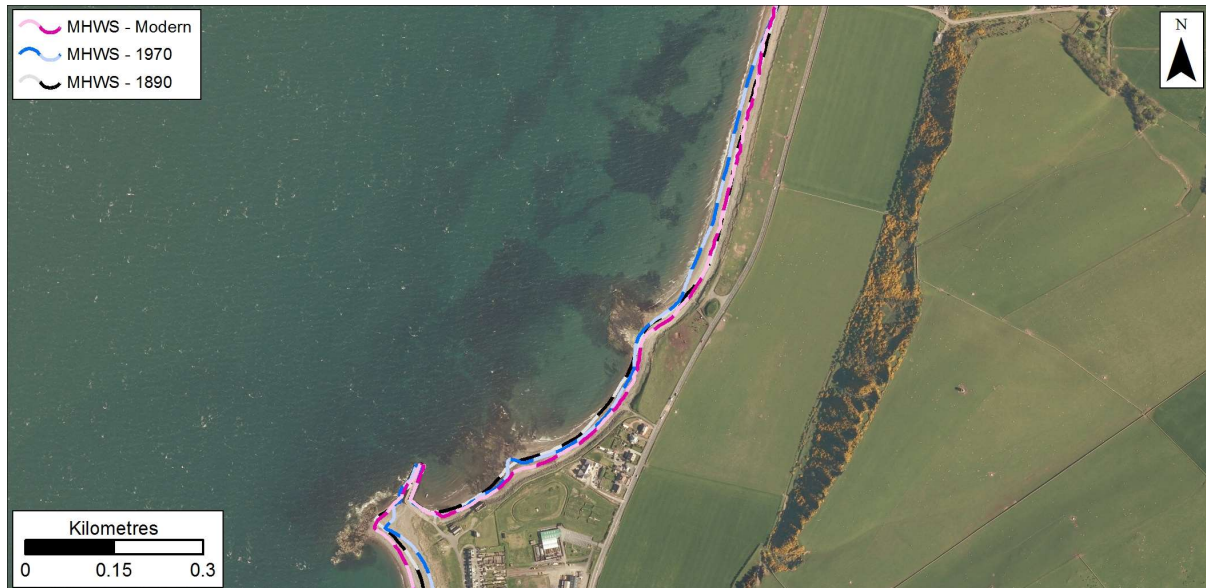
Figure 6.37: MHWS position in 1890, 1970s, and Modern datasets at Ballantrae. Getmapping are our current providers of Scotland-wide digital aerial imagery© Getmapping plc.

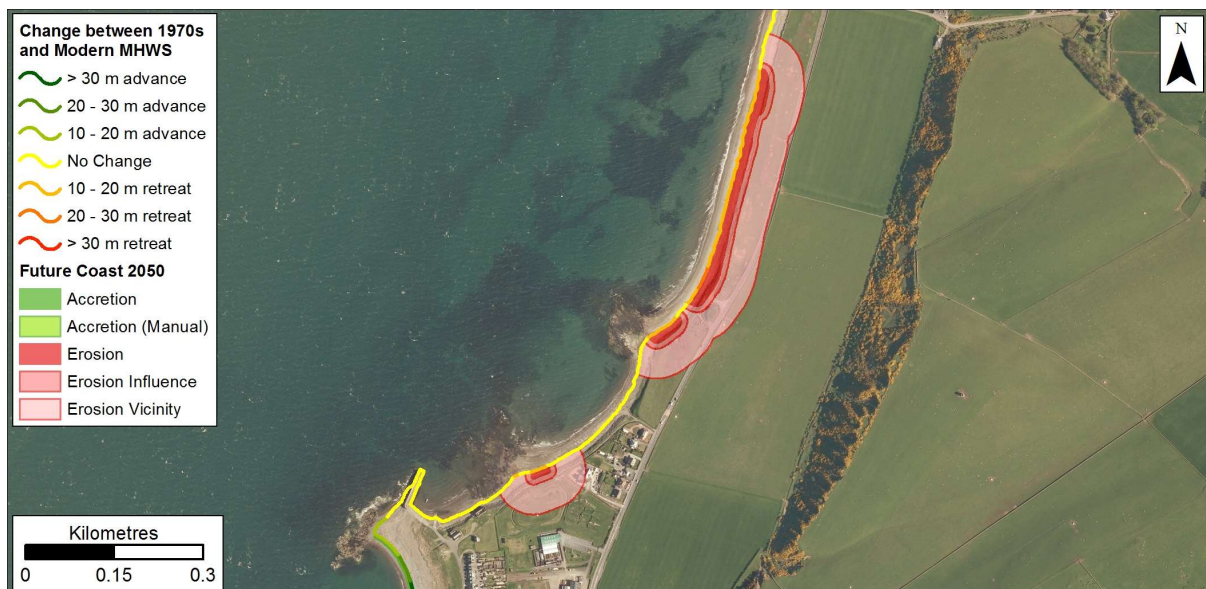
Figure 6.38: Possible future coastline position in 2050 based on rates between 1970 and Modern MHWS data at Ballantrae. Getmapping are our current providers of Scotland-wide digital aerial imagery© Getmapping plc.

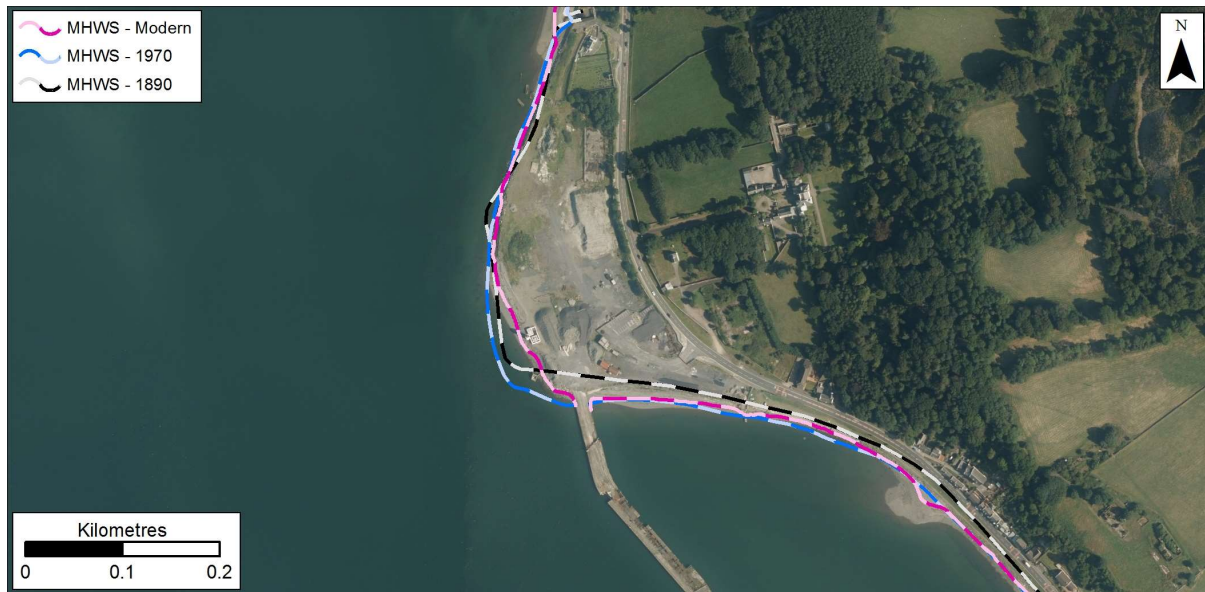
Figure 6.39: MHW position in 1890, 1970s, and Modern datasets at Cairnryan Old Pier. Getmapping are our current providers of Scotland-wide digital aerial imagery© Getmapping plc.

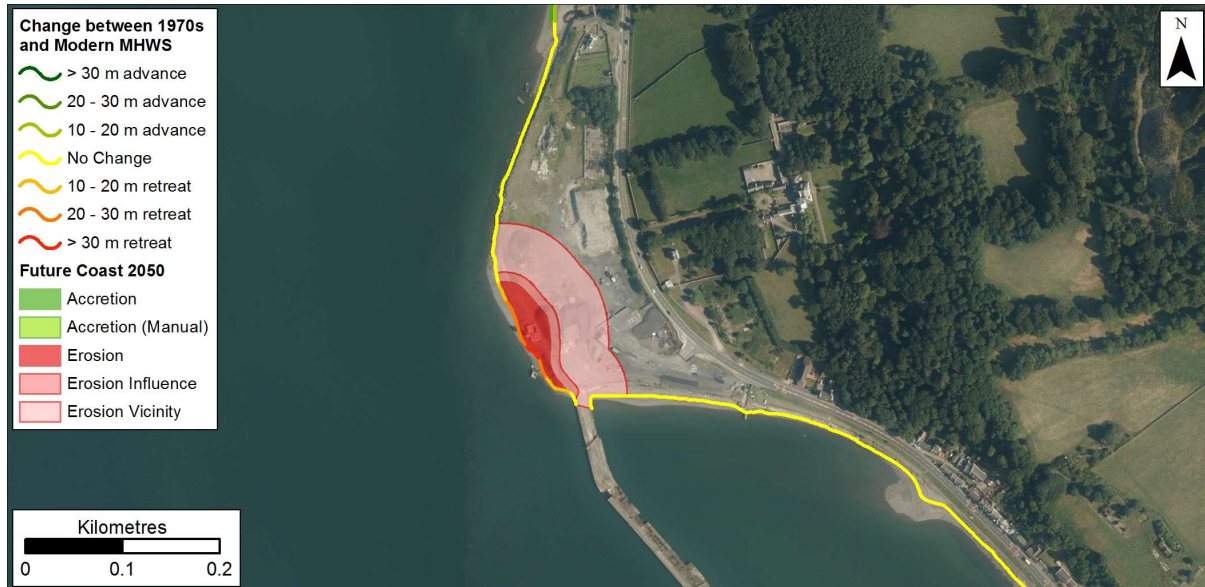
Figure 6.40: Possible future coastline position in 2050 based on rates between 1970 and Modern MHWS data at Cairnryan Old Pier. Getmapping are our current providers of Scotland-wide digital aerial imagery© Getmapping plc.
