Dynamic Coast - National Coastal Change Assessment: Cells 8 and 9 - The Western Isles

Please reference this report as follows: Hansom, J.D., Fitton, J.M., and Rennie, A.F., (2017) Dynamic Coast - National Coastal Change Assessment: Cells 8 and 9 - The Western Isles, CRW2014_02.

Dynamic Coast – Scotland's National Coastal Change Assessment

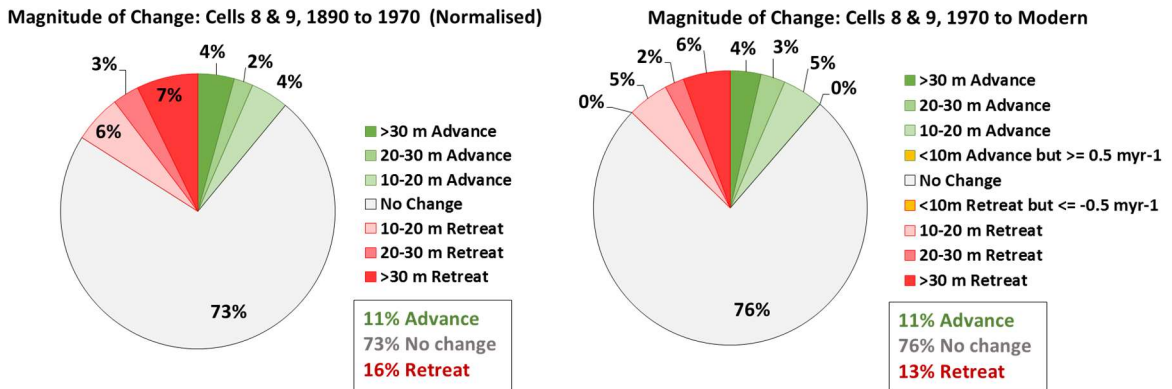
Figure 8.9.2: Coastal change results for Cells 8 and 9 showing the proportional amount of change in the historical (ca. 1890-1970 normalised) and recent (ca. 1970-Present) periods. Rounding errors may produce small % differences between Figure 2 and Figure 8.9.2.

When this adjustment has been applied the extent of erosion has reduced from 16% historical period to 13% post 1970s, the extent of stability has reduced from 73% to 76% and the extent of accretion has increased from 11% to 12%. The average rate of retreat has quickened from the historical to the recent period (0.6 m/yr to 1.3 m/yr) whilst accretion has fallen slightly from 0.9 m/yr to 0.8 m/yr. Such

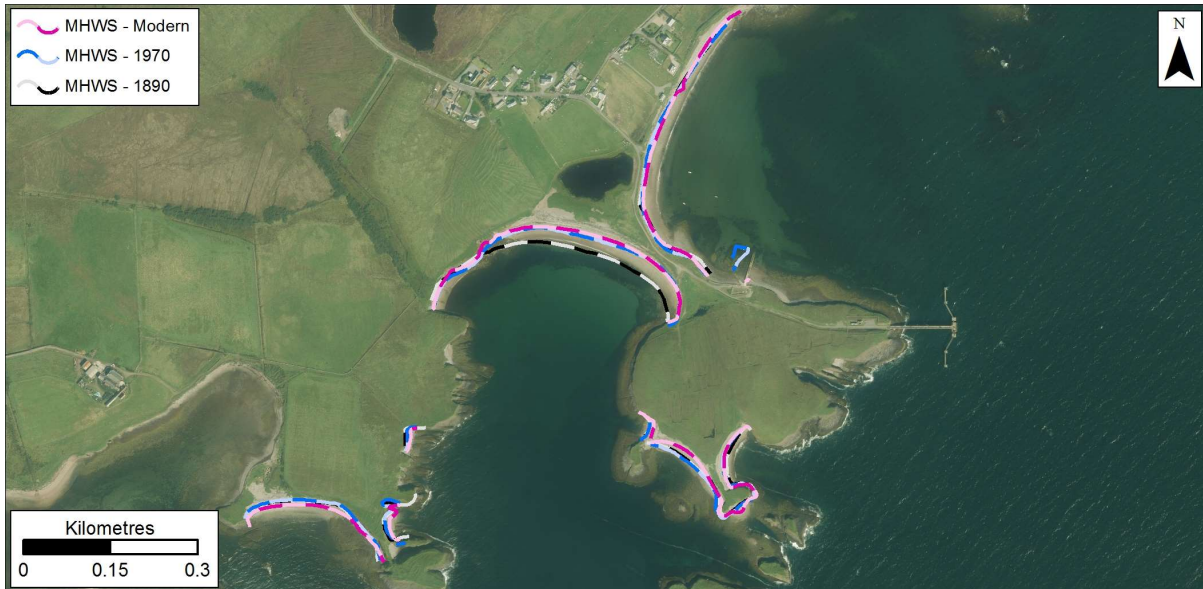
Figure 8.3: MHWS position in 1890, 1970s, and Modern datasets at Holm. Getmapping are our current providers of Scotland-wide digital aerial imagery© Getmapping plc.

Historic Change: The small tombolo at Holm has undergone erosion on both sides between 1895 and 1964, with the maximum occurring on the south side of up to 30 m and then a further 10 m between 1964 and 2013 (Figure 8.3). The north coast lost up to 6m on average up to 1964 but has since been protected by boulder defences and a seaward movement of MHWS.

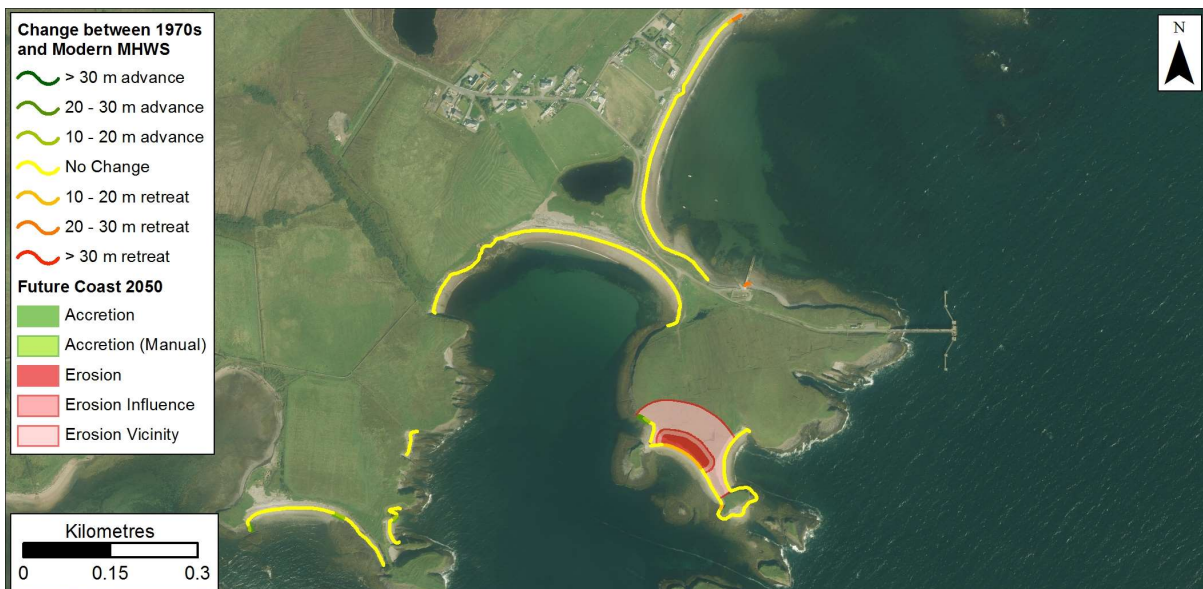
Figure 8.4: Possible future coastline position in 2050 based on rates between 1970 and Modern MHWS data at Holm. Getmapping are our current providers of Scotland-wide digital aerial imagery© Getmapping plc.

Future Vulnerability: Although recent erosion is limited on the south side of the tombolo, and is not flagged as an issue at present, the tombolo itself houses an oil pipeline and access road from a landing stage situated at the end of the islet to the east. As a result, it is an area that may be of concern in the

future if these rates change (Figure 8.4). The northern side is already protected and it may be that the south side requires similar protection in the future.

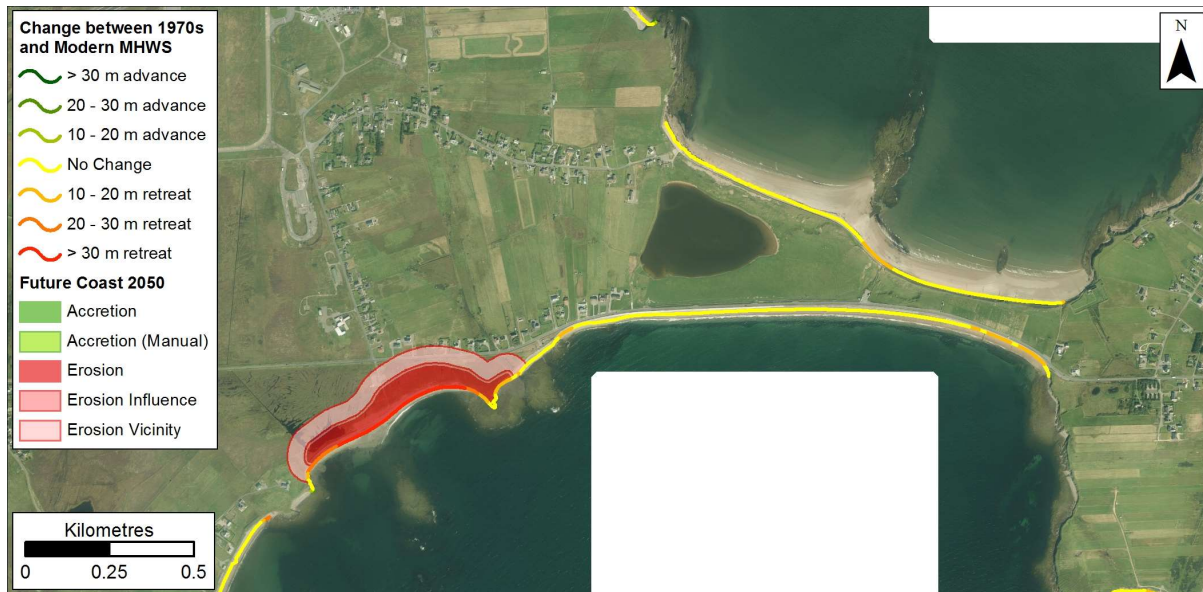
Figure 8.6: Possible future coastline position in 2050 based on rates between 1970 and Modern MHWS data at the Braigh. Getmapping are our current providers of Scotland-wide digital aerial imagery © Getmapping plc.

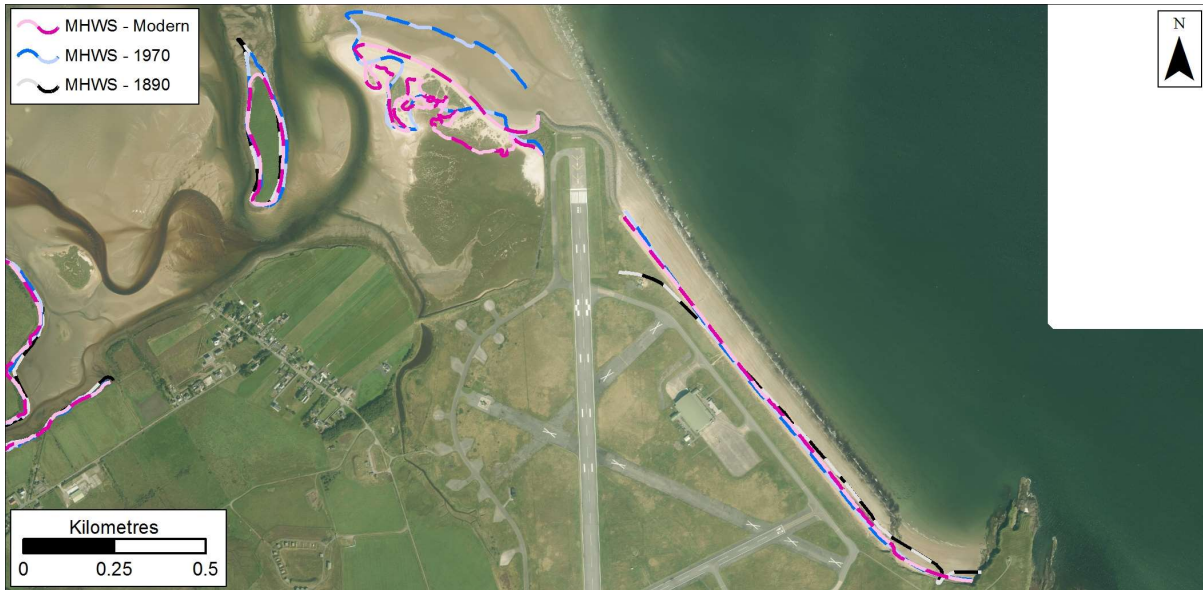
Figure 8.7: MHWS position in 1890, 1970s, and Modern datasets at Stornoway Airport. Getmapping are our current providers of Scotland-wide digital aerial imagery© Getmapping plc.

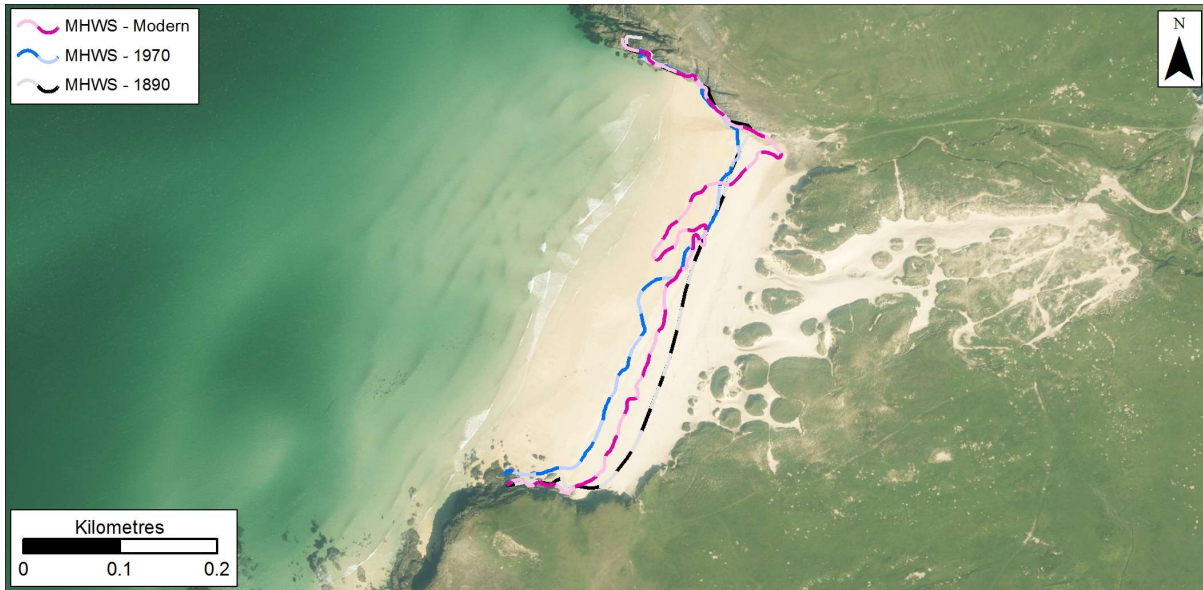
Figure 9.1: MHWS position in 1890, 1970s, and Modern datasets at Eorpie. Getmapping are our current providers of Scotland-wide digital aerial imagery© Getmapping plc.

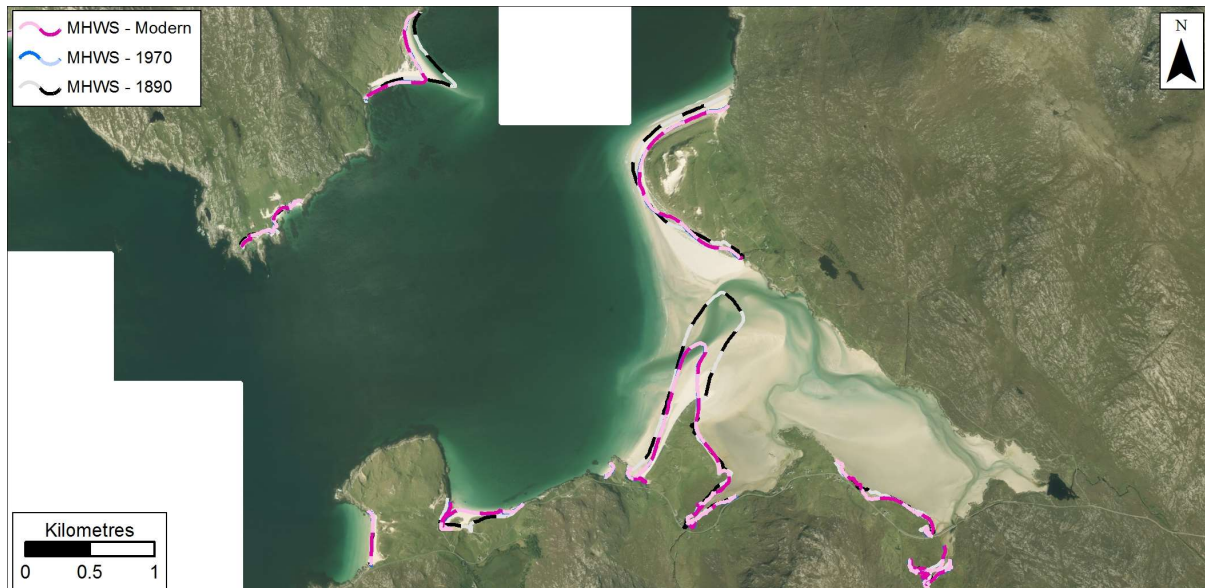
Figure 9.3: MHWS position in 1890, 1970s, and Modern datasets at Luskentyre and Taransay. Getmapping are our current providers of Scotland-wide digital aerial imagery© Getmapping plc.

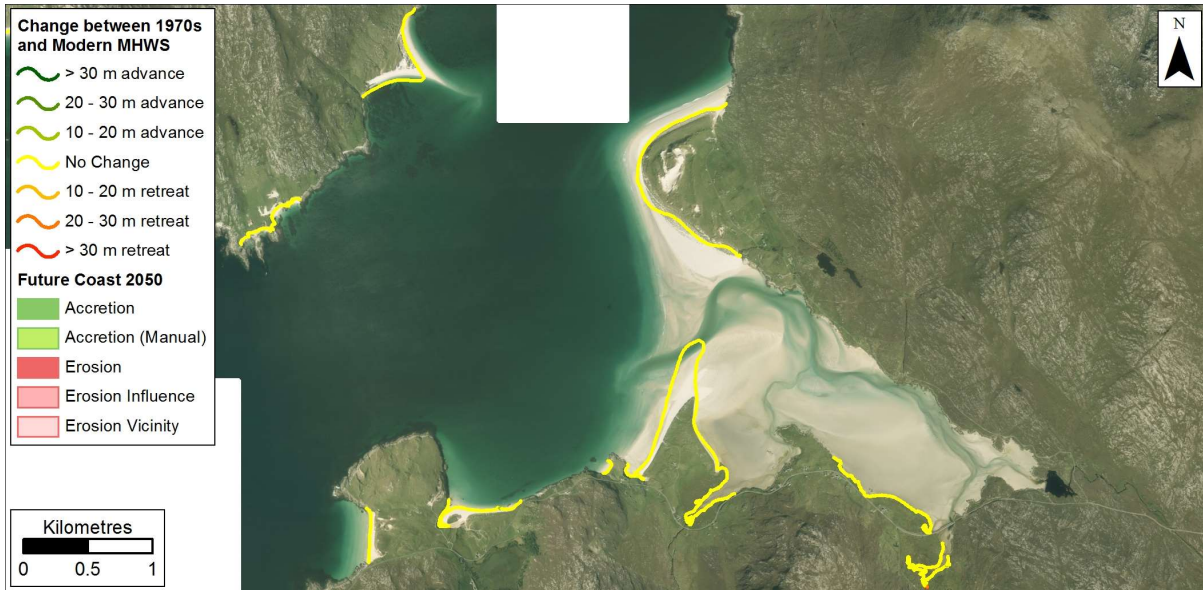
Figure 9.4: Change between the 1970 and Modern MHWS data at Luskentyre and Taransay. Getmapping are our current providers of Scotland-wide digital aerial imagery© Getmapping plc.

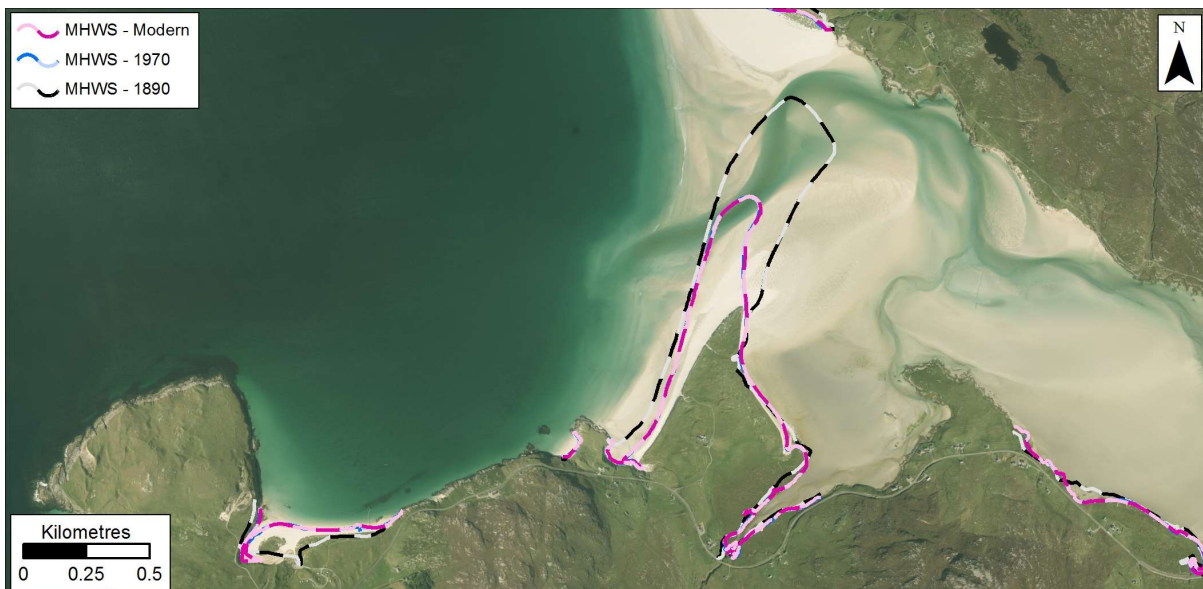
Figure 9.5: MHWS position in 1890, 1970s, and Modern datasets at Seilebost. Getmapping are our current providers of Scotland-wide digital aerial imagery© Getmapping plc.

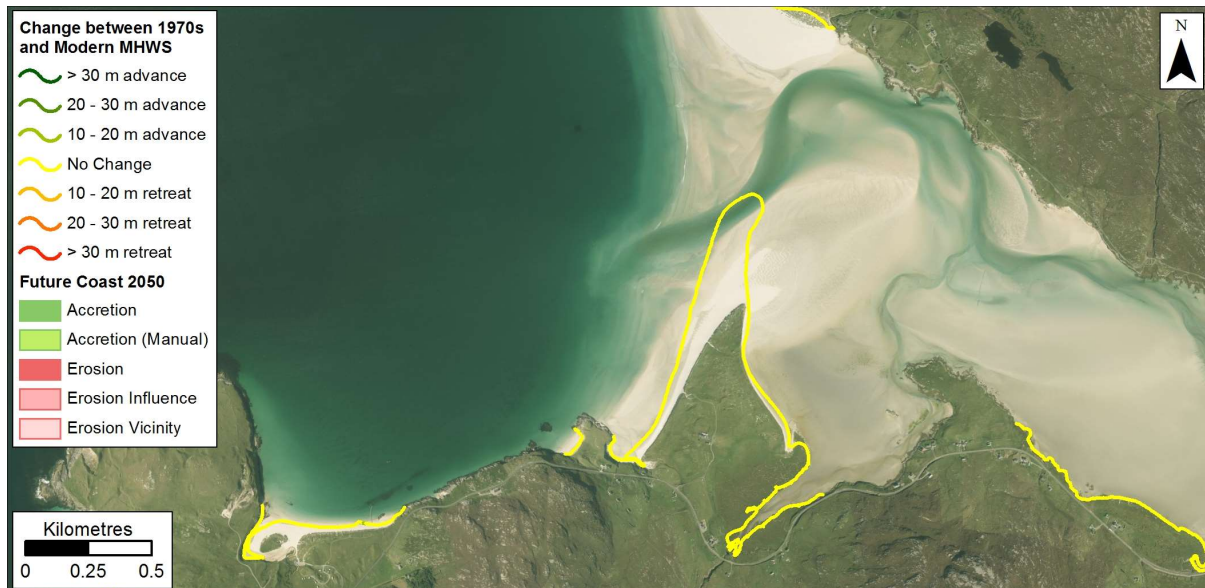
Figure 9.6: Change between the 1970 and Modern MHWS data at Seilebost. Getmapping are our current providers of Scotland-wide digital aerial imagery© Getmapping plc.

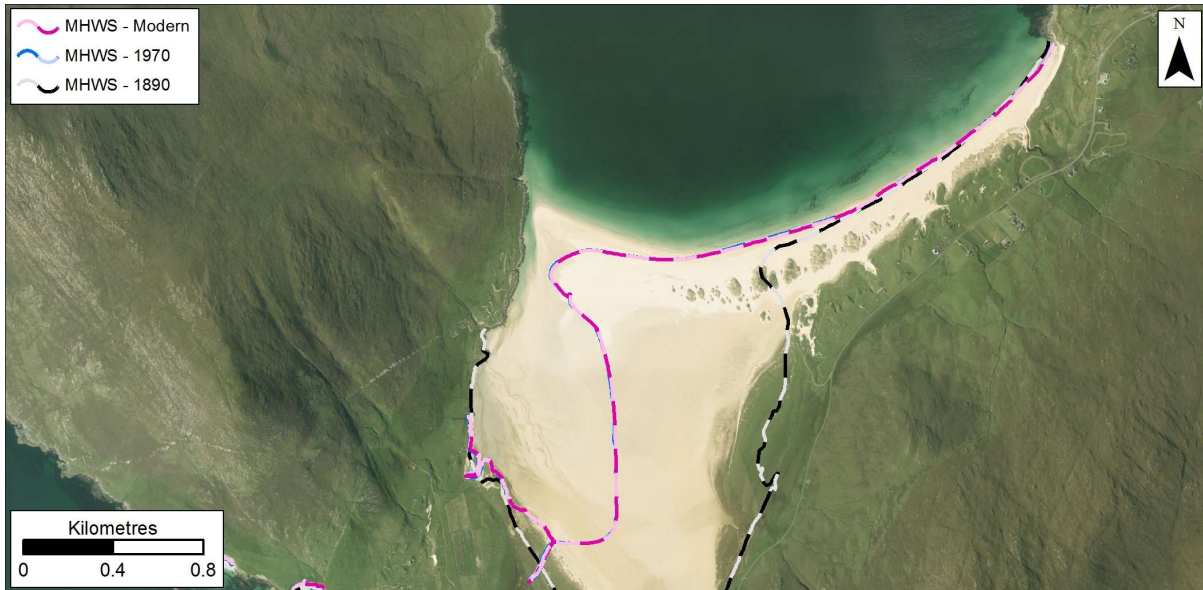
Figure 9.7: MHWs position in 1890, 1970s, and Modern datasets at Northton Bay. Getmapping are our current providers of Scotland-wide digital aerial imagery© Getmapping plc.

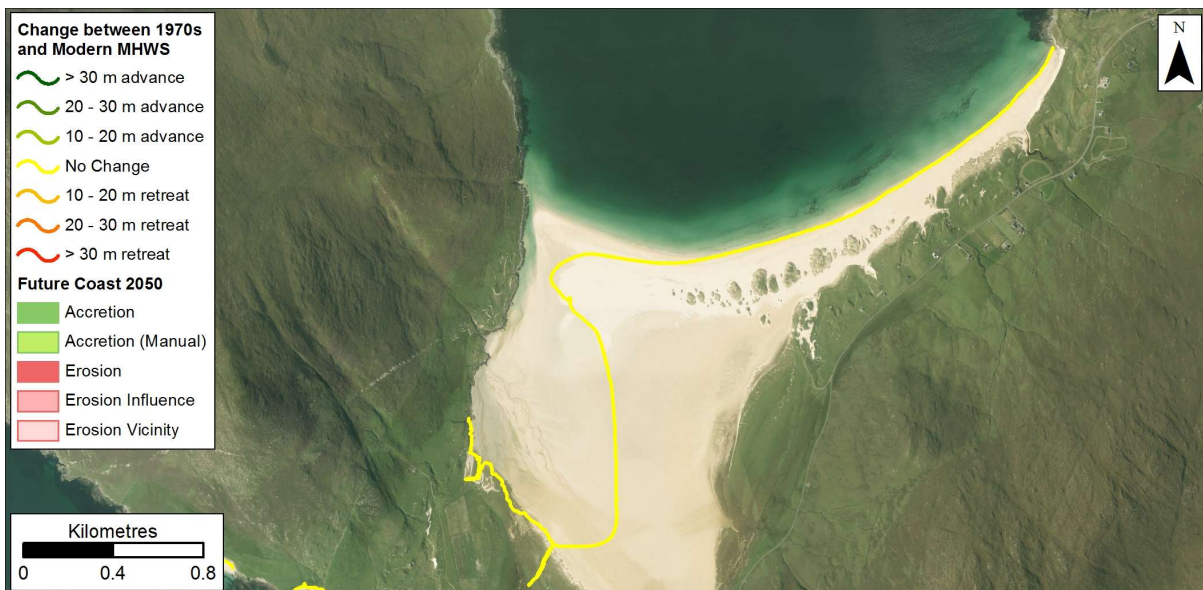
Figure 9.8: Change between the 1970 and Modern MHWs data at Northton Bay. Getmapping are our current providers of Scotland-wide digital aerial imagery© Getmapping plc.

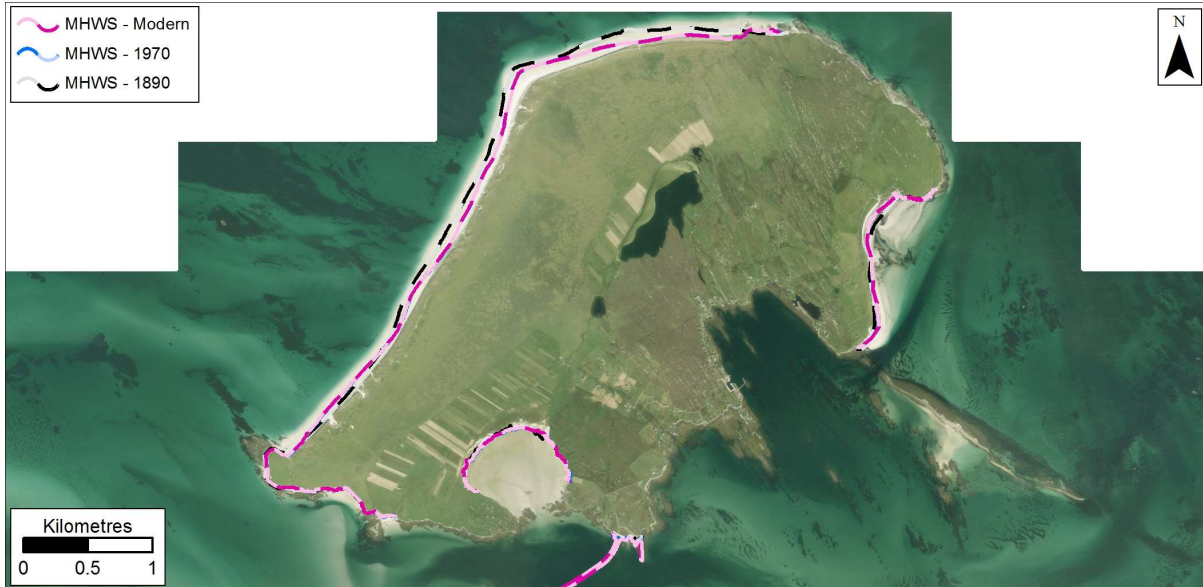
Figure 9.9: MHWS position in 1890, 1970s, and Modern datasets at Berneray. Getmapping are our current providers of Scotland-wide digital aerial imagery© Getmapping plc.

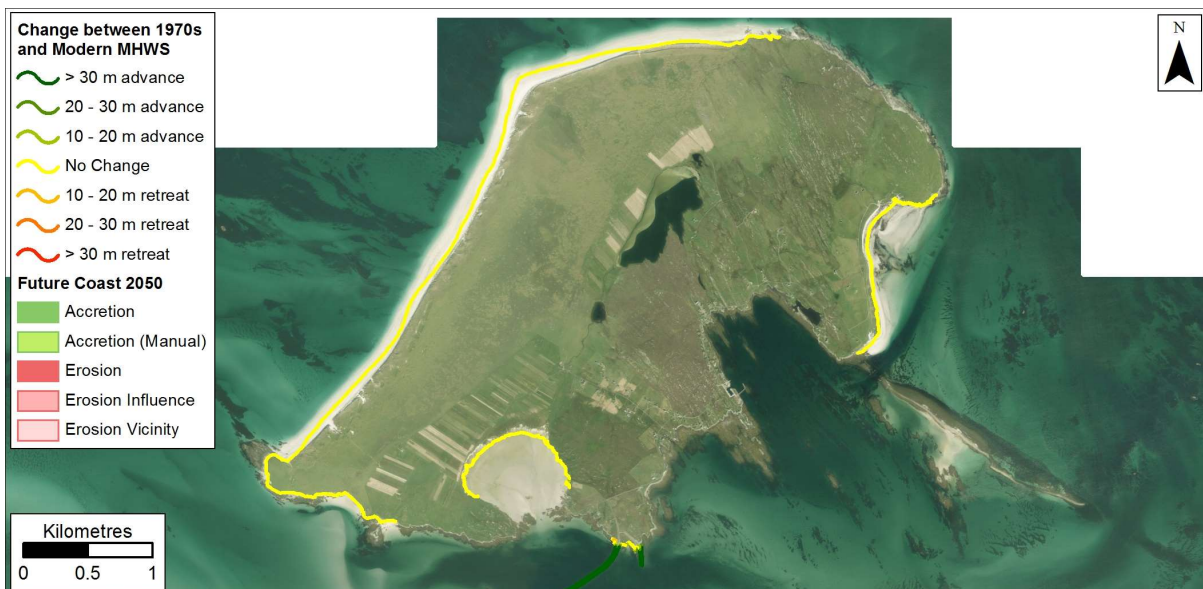
Figure 9.10: Change between the 1970 and Modern MHWS data at Berneray. Getmapping are our current providers of Scotland-wide digital aerial imagery© Getmapping plc.

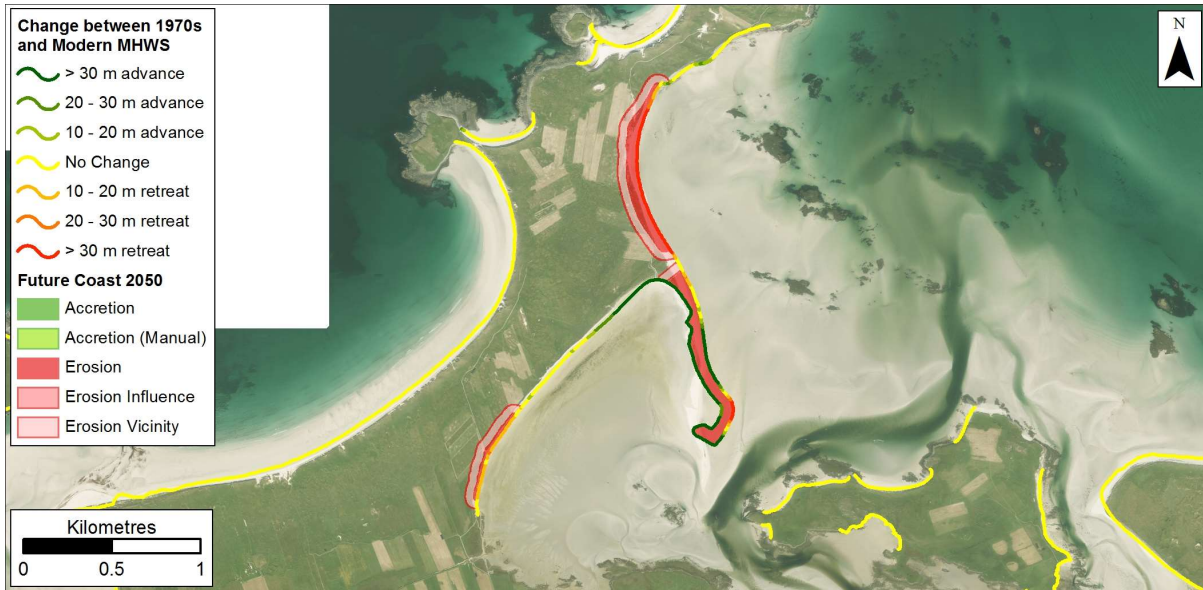
Figure 9.12: Possible future coastline position in 2050 based on rates between 1970 and Modern MHWS data at Udal and Solas Peninsula. Getmapping are our current providers of Scotland-wide digital aerial imagery© Getmapping plc.

Future vulnerability: Over a distance of 2 km, the valuable agricultural machair land on the east side of Udal is vulnerable to future erosion that may extend inland by 50 m by 2050 (Figure 9.12). Loss of productive machair land continues and in places the protective low dune cordon has been eroded and overwash has occurred. Sand infilling of the eroded gap and dune repairs occurred in 2014 along with realignment of the coastal access track. . In the north, at the two headlands, there exists considerable archaeological interest that is vulnerable to further landward erosion of the dune line south of the recently breached tombolo at the north headland. Vulnerability is gauged to be low at Udal and Solas given the lack of built assets, although losses of machair land that is locally valuable for agriculture and has a high conservation status is of concern.

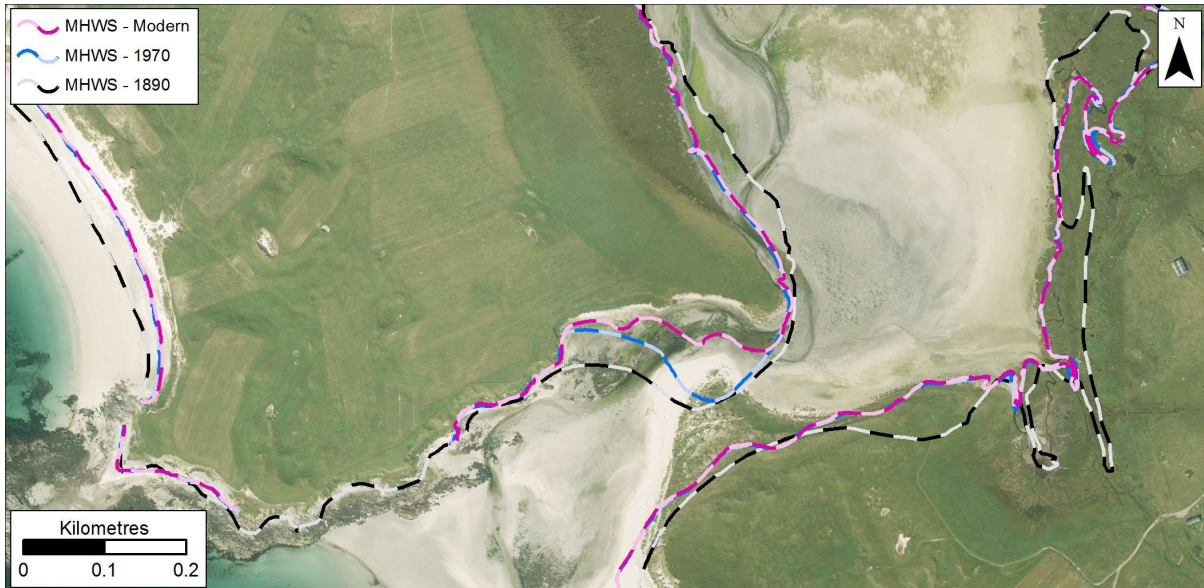
Figure 9.13: MHWS position in 1890, 1970s, and Modern datasets at Paible. Getmapping are our current providers of Scotland-wide digital aerial imagery© Getmapping plc.

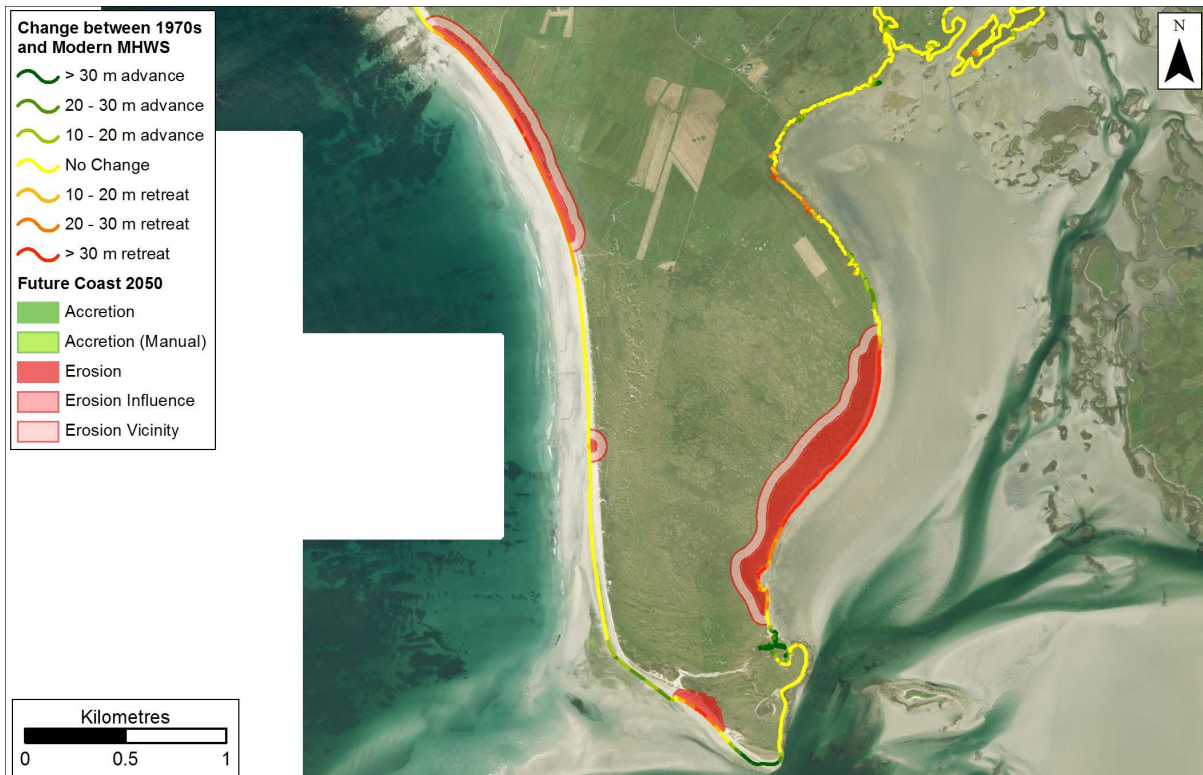
Figure 9.18: Possible future coastline position in 2050 based on rates between 1970 and Modern MHWs data at Baleshare. Getmapping are our current providers of Scotland-wide digital aerial imagery© Getmapping plc.

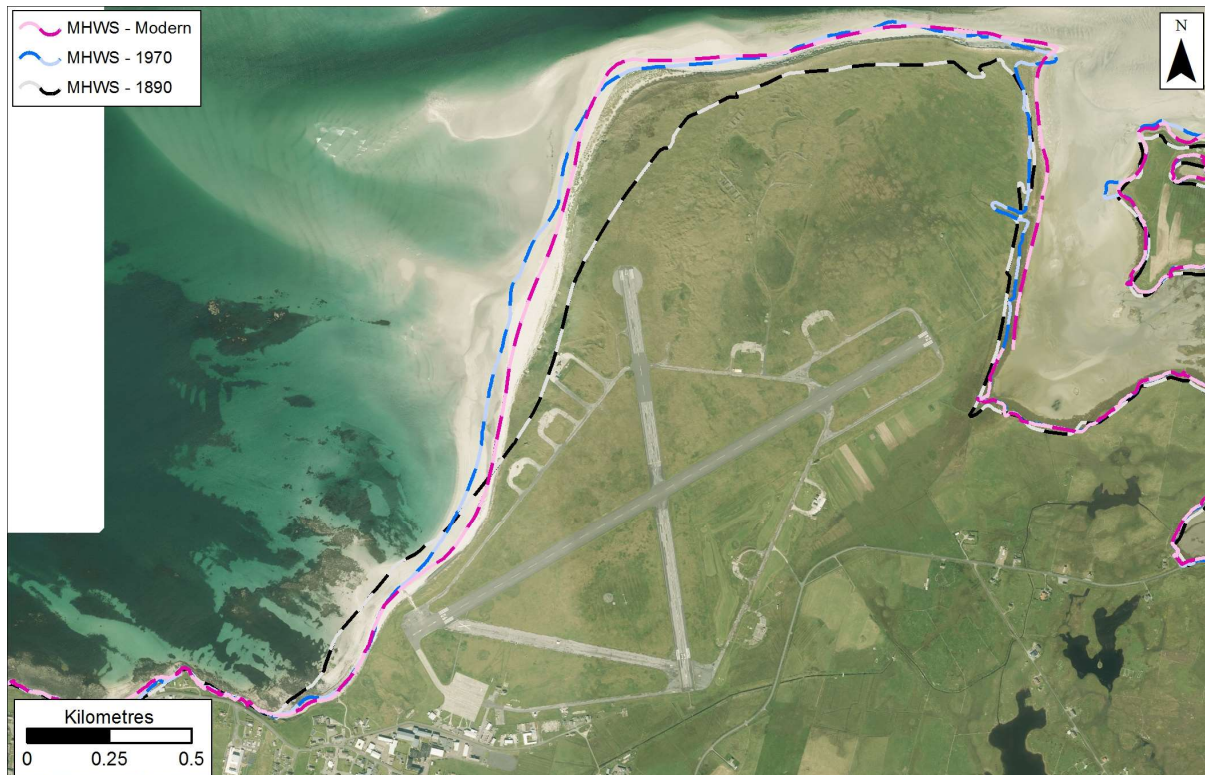
Figure 9.19: MHW position in 1890, 1970s, and Modern datasets at Benbecula Airport and Balivanich. Getmapping are our current providers of Scotland-wide digital aerial imagery© Getmapping plc.

Historic Change: Substantial changes have taken place on the sandy peninsula that now houses Benbecula airport. The 1901 position of MHWS in the south at Balivanich eroded landward by 70 m up to 1967 whilst the northern part had apparently advanced seaward by 250 m over the same period (Figure 9.19). However, the construction of the RAF airfield early in WW2 on the site (Figure 9.20 and Figure 9.21) of an earlier grass airstrip led to levelling of the dunes and deposition of the sand spoil to seaward and so at least some, and possibly all, of the accretion noted before 1967 may be artificial. There exists anecdotal evidence that, within the last 150 years, machair extended to seaward of the islet of Sgeir a Cheothian now located 500 m offshore of Balivanich. This is consistent with ongoing long-term loss of land at Balivanich. Nevertheless, between 1967 and 2006 ongoing accretion seems to have occurred in the north and stability in the south, the latter as a function of coast defences to protect the south west corner of the runway. Since 2006, the air photography shows there has been erosion of up to 60m north of the end of the extended runway defences and up to 80m of erosion at the northern end of the north/south runway. The defences at Balivanich have been progressively extended in response to erosional bights that have developed at the north end of the defences. This is a common failing where defences end and the erosion continues. There is now a developing bight at the end of the 1.1km of defences that protect the western taxiway where it runs near the coastal edge

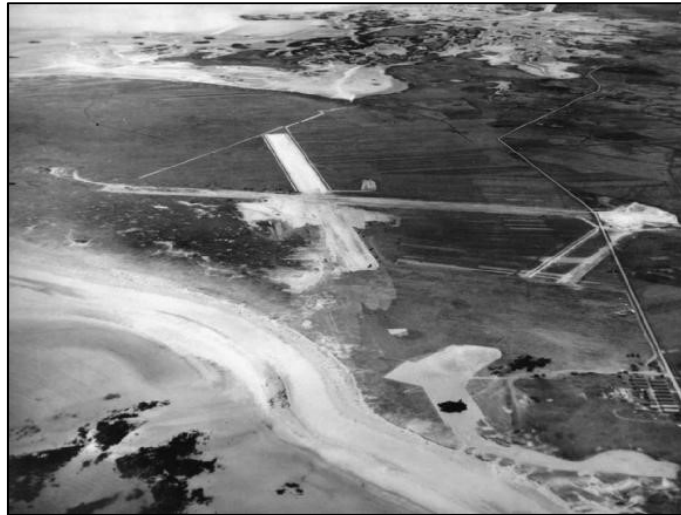
Figure 9.20: Oblique aerial view of RAF Benbecula, from west-south-west, while the runways were under construction in 1941-1942. The method used was known as 'sand carpet', which consisted of bitumen laid directly over compacted sand, resulting in a flexible surface. (© IWM (HU 92989))

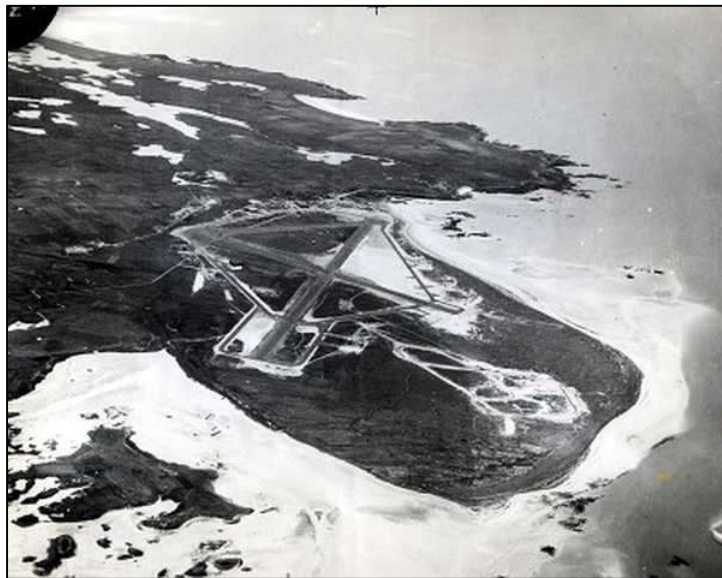
Figure 9.21: Undated, but believed to be 1940s photo of RAF Benbecula from the north (coastalcommand206.com).

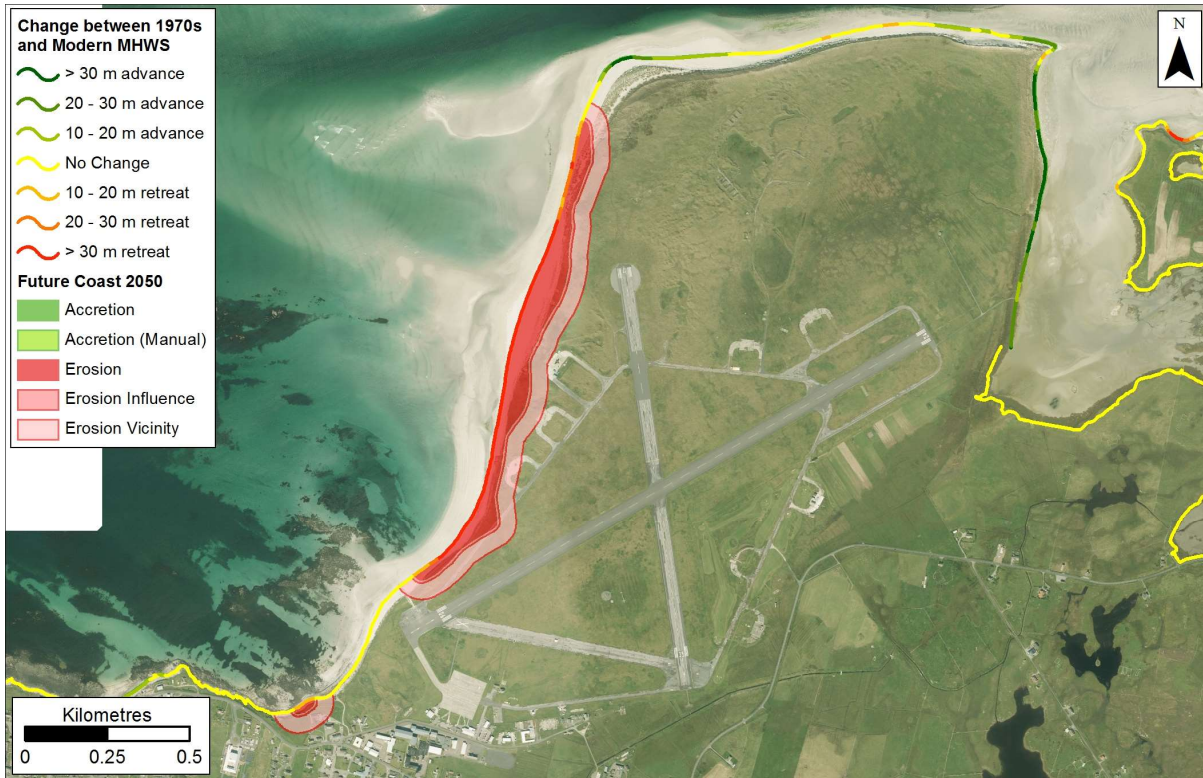
Figure 9.22: Possible future coastline position in 2050 based on rates between 1970 and Modern MHWS data at Benbecula Airport and Balivanich. Getmapping are our current providers of Scotland-wide digital aerial imagery© Getmapping plc.

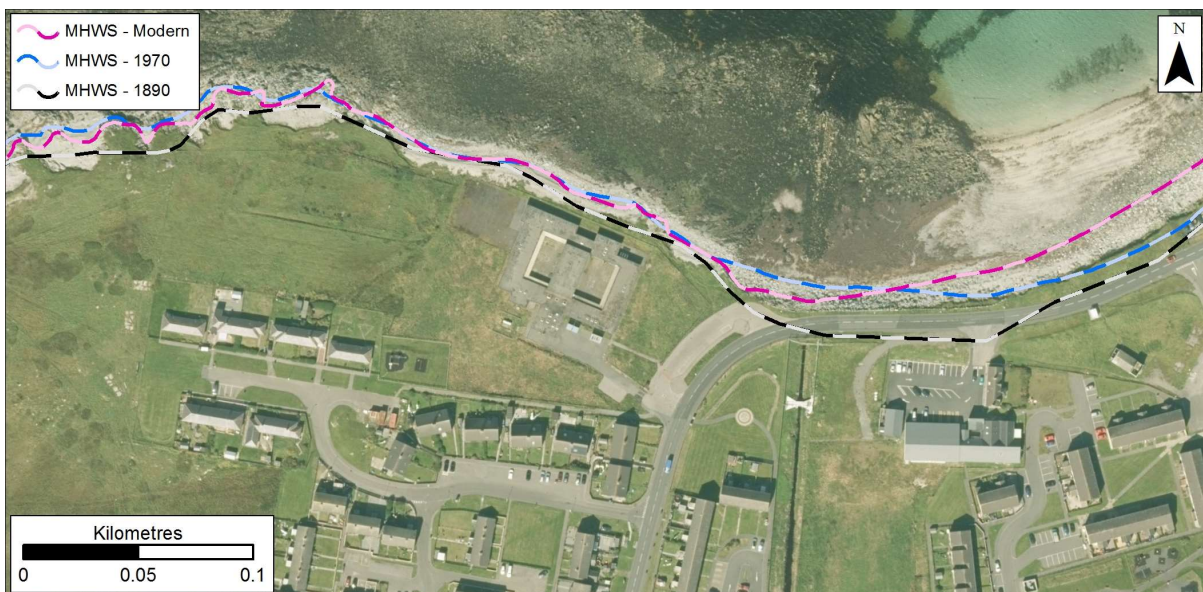
Figure 9.23: MHWS position in 1890, 1970s, and Modern datasets at Balivanich Primary School. Getmapping are our current providers of Scotland-wide digital aerial imagery© Getmapping plc.

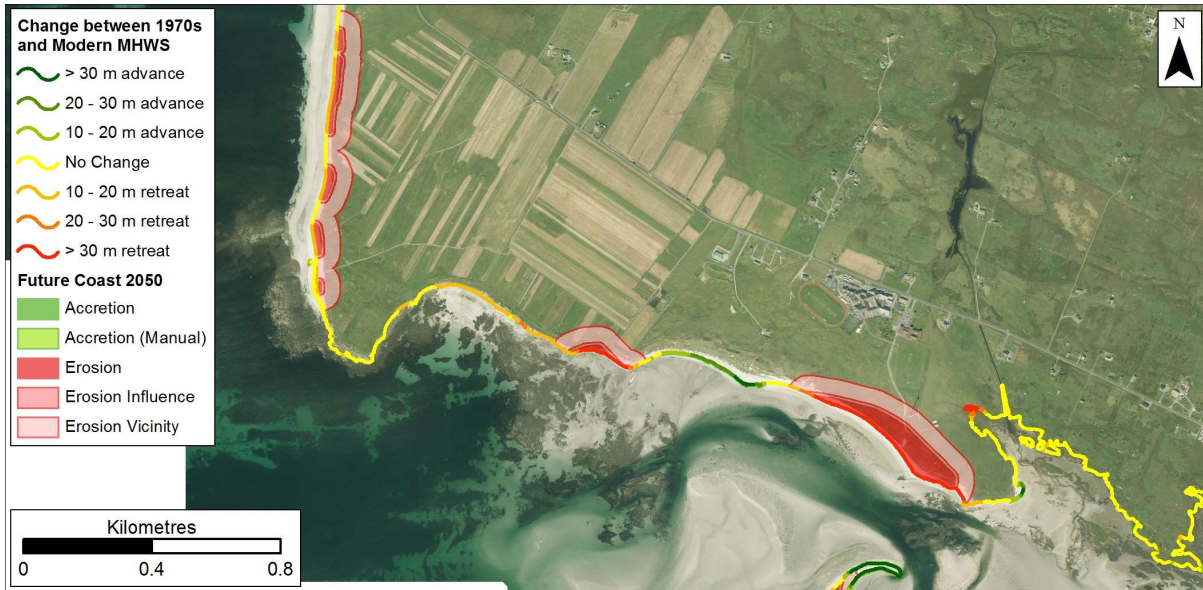
Figure 9.25: Possible future coastline position in 2050 based on rates between 1970 and Modern MHWS data at Borve to Lincilte. Getmapping are our current providers of Scotland-wide digital aerial imagery© Getmapping plc.

Future Vulnerability: By 2050 some 600 m of shore may erode up to 50 m inland at Liniclate if current rates persist (Figure 9.25), possibly exacerbated by enhanced flooding due to the proximity of a flood drain channel to the east of the eroding area. No built assets are directly vulnerable along this shore yet the position of the only secondary school in the Uists, sited on low-lying land behind an eroding shore, suggests that there may be cause for concern if erosion rates change in the future.

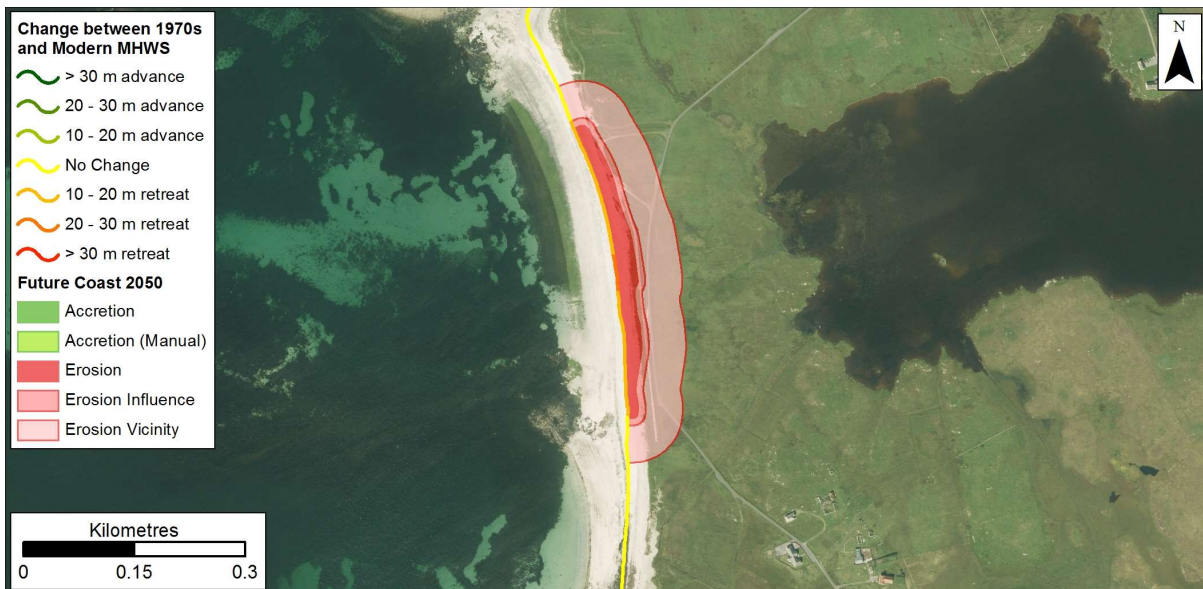
Figure 9.29: Possible future coastline position in 2050 based on rates between 1970 and Modern MHWs data at Stoneybridge. Getmapping are our current providers of Scotland-wide digital aerial imagery© Getmapping plc.

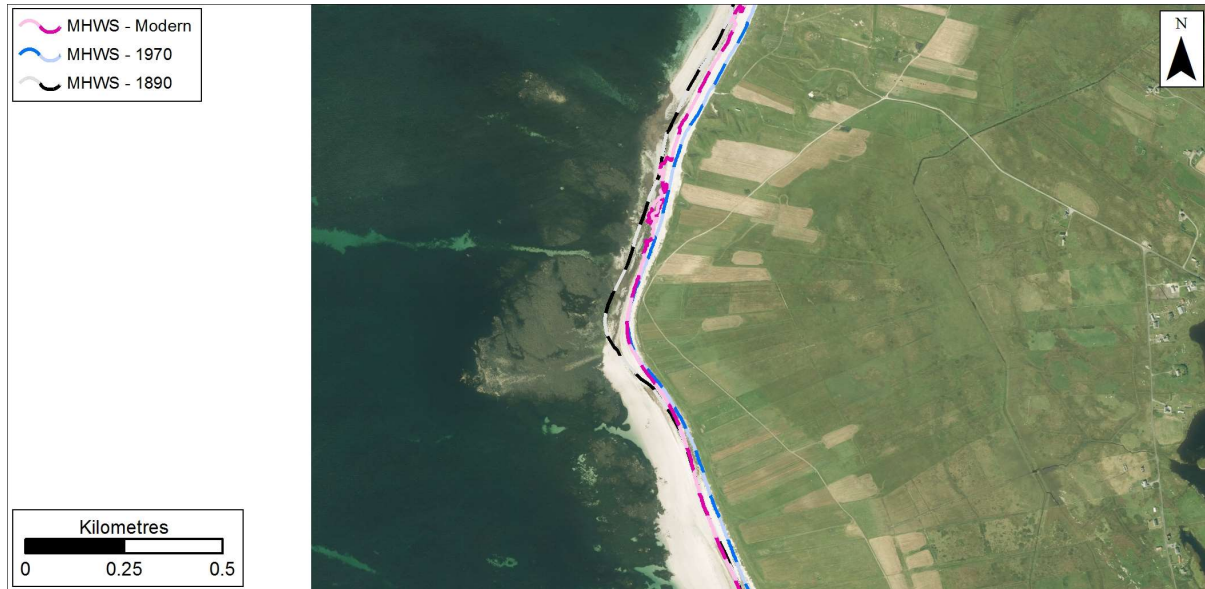
Figure 9.30: MHWS position in 1890, 1970s, and Modern datasets at Kilpheder. Getmapping are our current providers of Scotland-wide digital aerial imagery© Getmapping plc.

but lies seaward of it both to the north and south (Figure 9.30). At the point itself, recession and storm overwash was such that the Local Authority gave permission to insert a 300 m long gravel bund to protect the productive machair land that lies behind. The inland slope here (negative gradient) would mean that if the dune cordon or its replacement defence bund were to be eroded, then the inundation potential during storms would be enhanced. The bund has been progressively eroded and undermined by wave activity and erosional bights have developed at either extremity, but it has slowed erosion rates at the point itself and temporarily arrested any immediate threat of overwash and breaching.

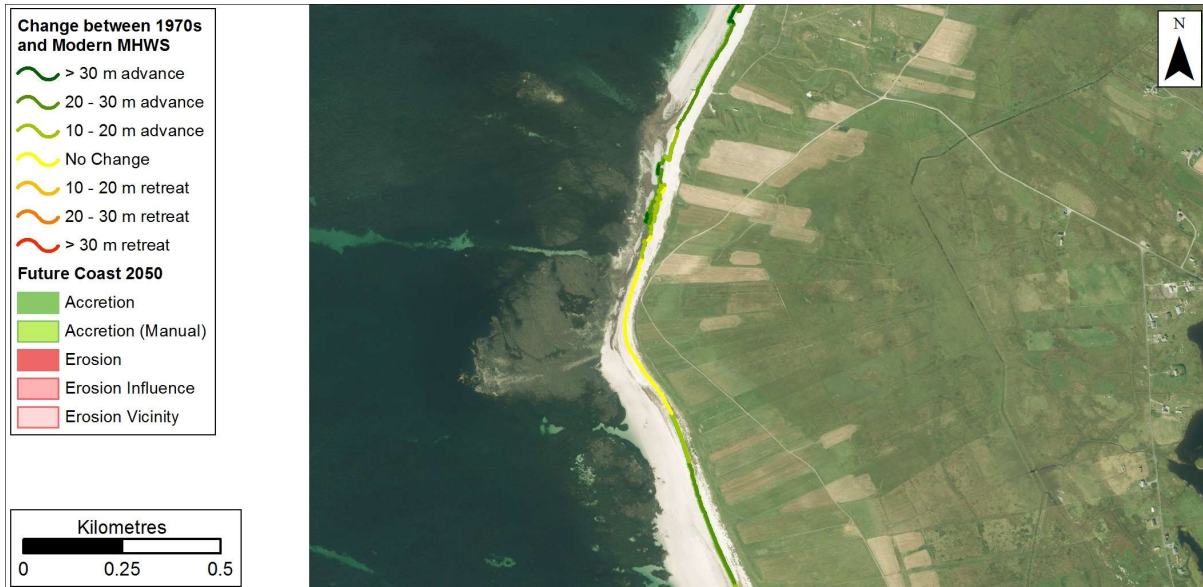
Figure 9.31: Change between the 1970 and Modern MHWS data at Kilpheder. Getmapping are our current providers of Scotland-wide digital aerial imagery© Getmapping plc.

If recent erosion rates persist, much of this shore is likely to be vulnerable by 2050 at either side of, and including, the revetment. As a result, the allied issue is that the negative landward gradient beyond the low dune cordon renders the hinterland vulnerable to erosion-related flooding. Thus, the integrity of the coastal fringe (whether natural or artificial) takes on a more strategic and greater significance. There are extensive low-lying areas within the interior of the South Uist which form a network of winter lochs, where the winter elevated water table causes freshwater flooding. Historical research identifies that these were once more extensive and used for inland navigation, prior to their draining in the nineteenth century (Angus, 2017). The negative gradient and absolute altitude in these areas raises significant questions about their inherent vulnerability given the past and anticipated relative sea level rise (Figure 9.32). The issue of 'negative gradients' are considered further in the recommendation section of the national overview.

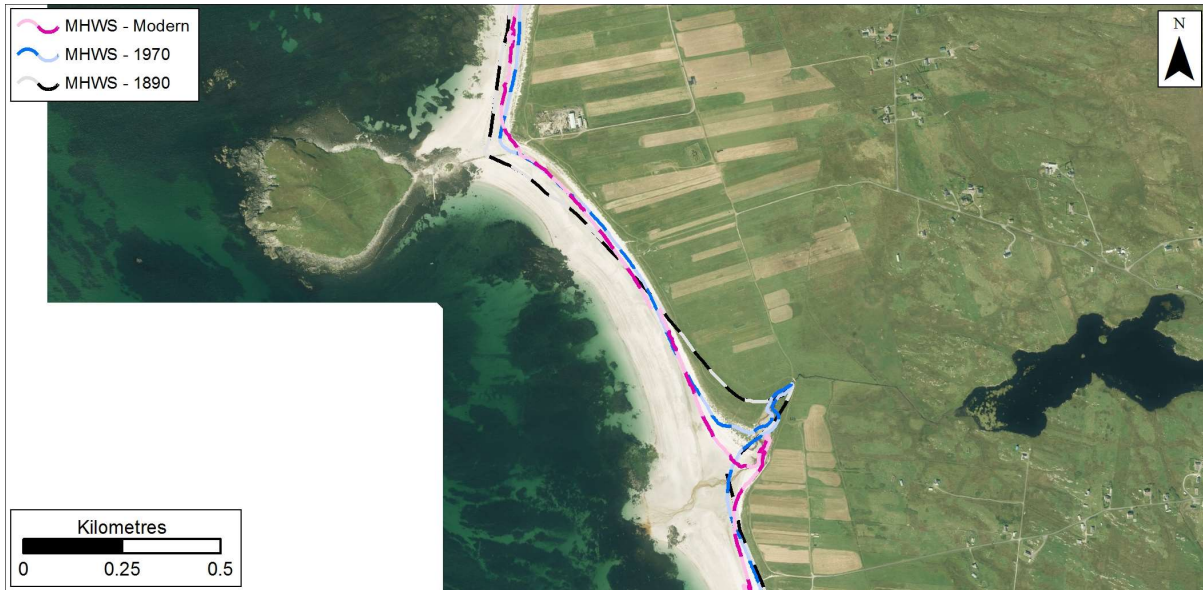
Figure 9.33: MHWS position in 1890, 1970s, and Modern datasets at North Boisdale. Getmapping are our current providers of Scotland-wide digital aerial imagery© Getmapping plc.

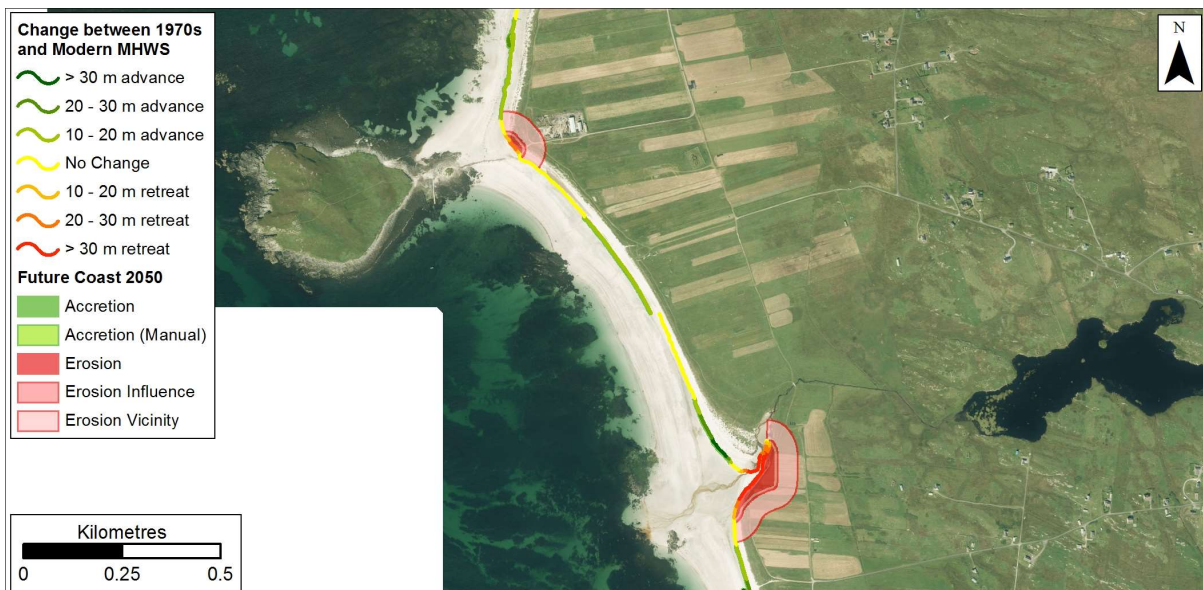
Figure 9.34: Possible future coastline position in 2050 based on rates between 1970 and Modern MHWS data at North Boisdale. Getmapping are our current providers of Scotland-wide digital aerial imagery© Getmapping plc.
