Dynamic Coast - National Coastal Change Assessment: Cells 8 and 9 - The Western Isles

Please reference this report as follows: Hansom, J.D., Fitton, J.M., and Rennie, A.F., (2017) Dynamic Coast - National Coastal Change Assessment: Cells 8 and 9 - The Western Isles, CRW2014_02.

Dynamic Coast – Scotland's National Coastal Change Assessment

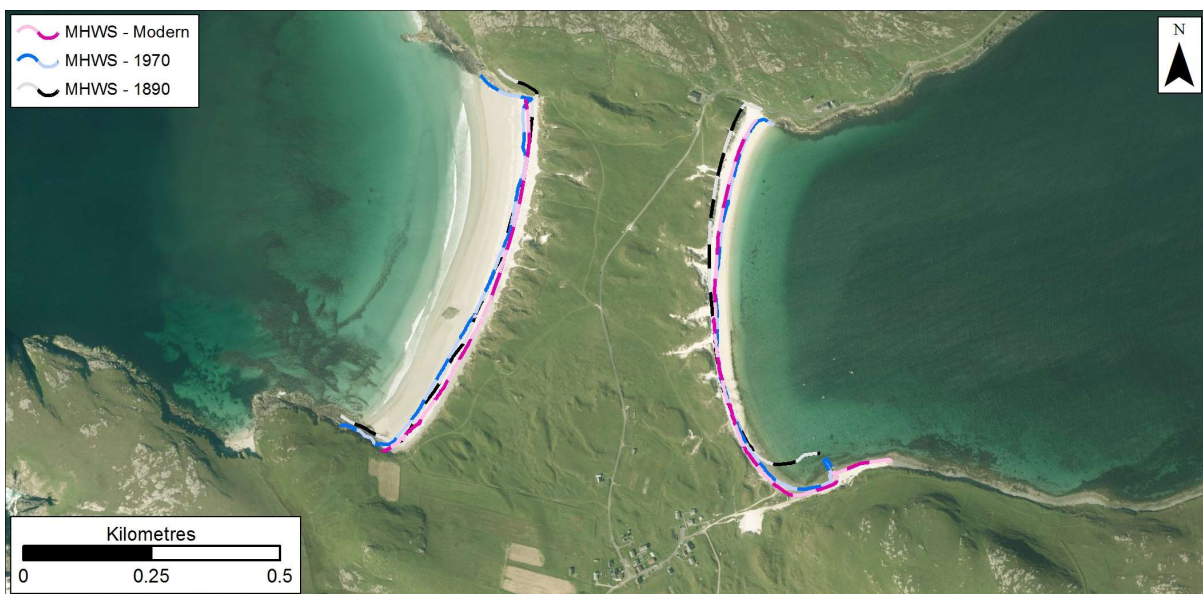
Figure 9.37: MHWS position in 1890, 1970s, and Modern datasets at Vatersay tombolo. Getmapping are our current providers of Scotland-wide digital aerial imagery © Getmapping plc.

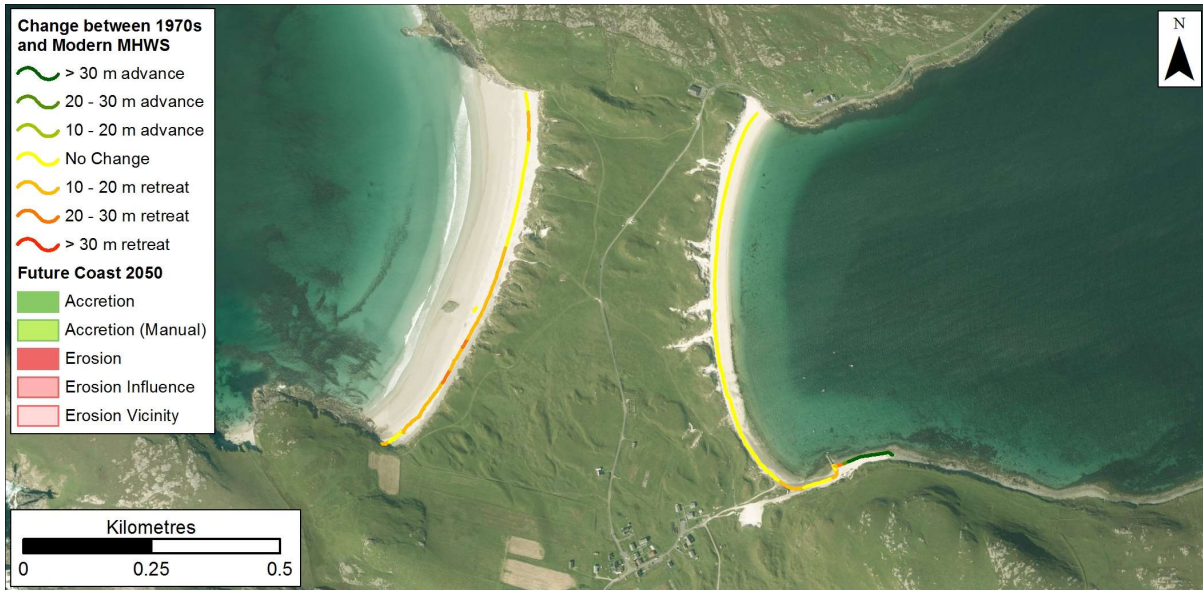
Figure 9.38: Change between the 1970 and Modern MHWS data at Veteransay tombolo. Getmapping are our current providers of Scotland-wide digital aerial imagery © Getmapping plc.

Future Vulnerability: No assets are close to the areas that might be affected by erosion in the future although wind-blown sand frequently veneers the roadway (Figure 9.38). It is also likely that any erosion of the east face can be addressed with soft coastal management techniques such as dune rehabilitation. Although, erosion is noted on the western bay, this is not expected to continue in the future due to the resilience of the hinterland as estimated by the Underlying Physical Susceptibility Model (Fitton et al., (2016)).
